PHASE I

# Lower West Branch Susquehanna River ADA and Universal Accessibility Access Study

A PROJECT OF THE SUSQUEHANNA GREENWAY PARTNERSHIP

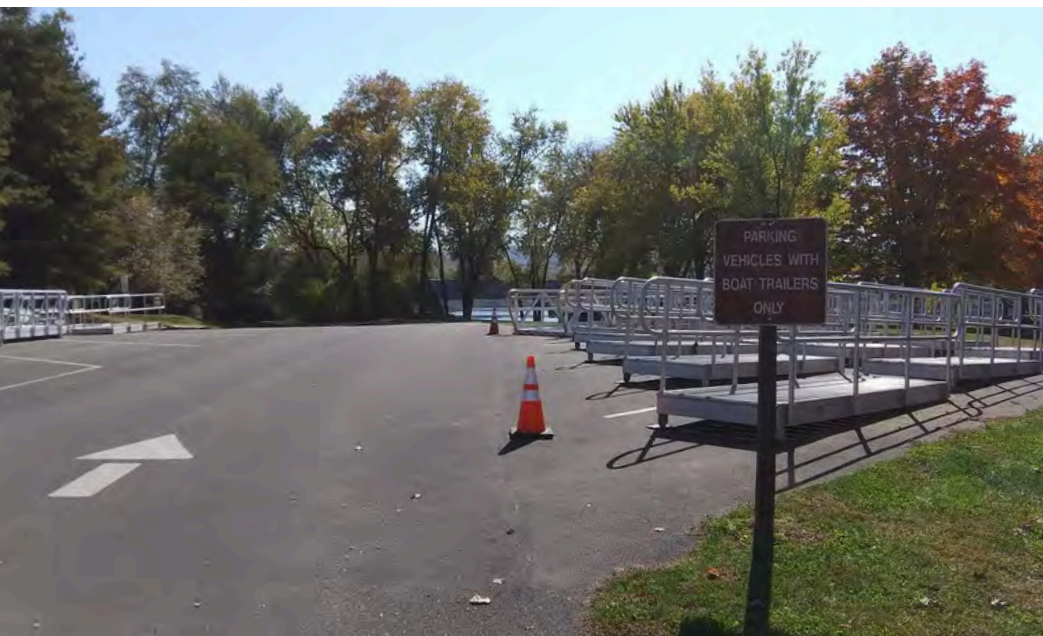
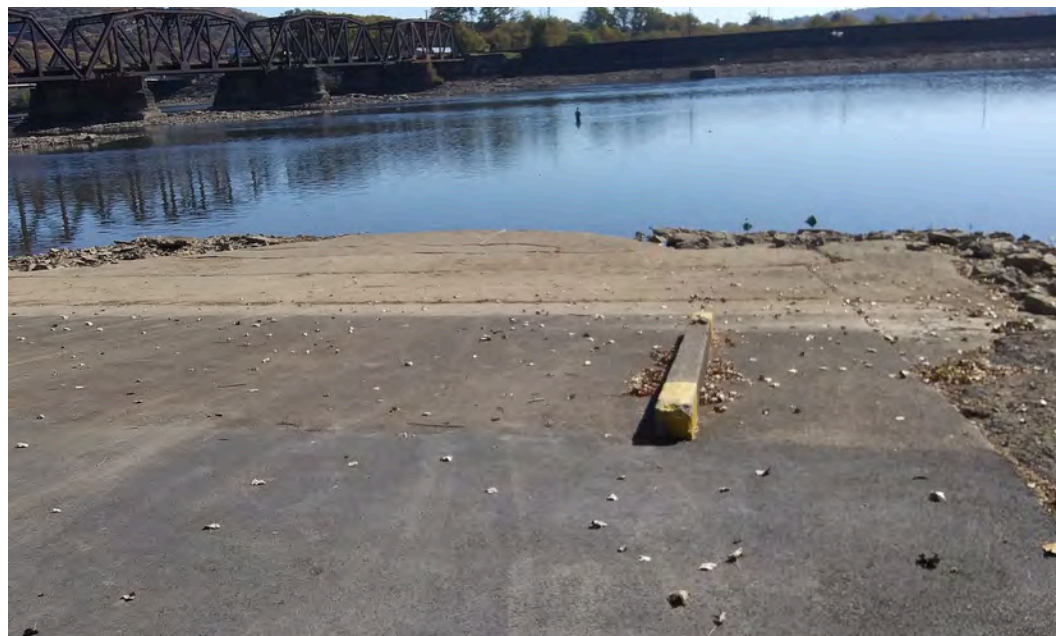
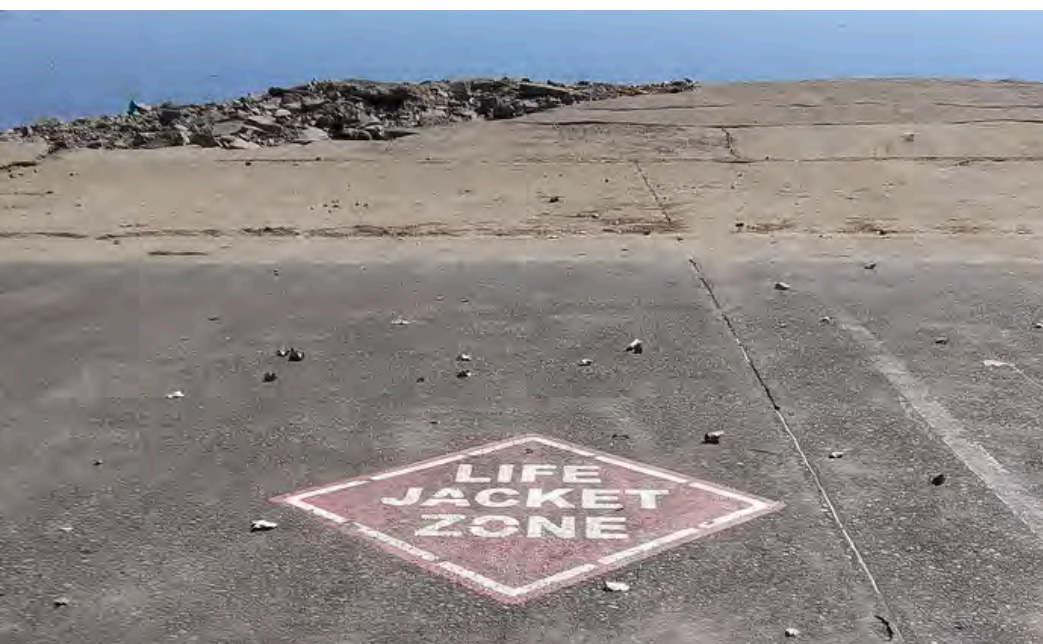
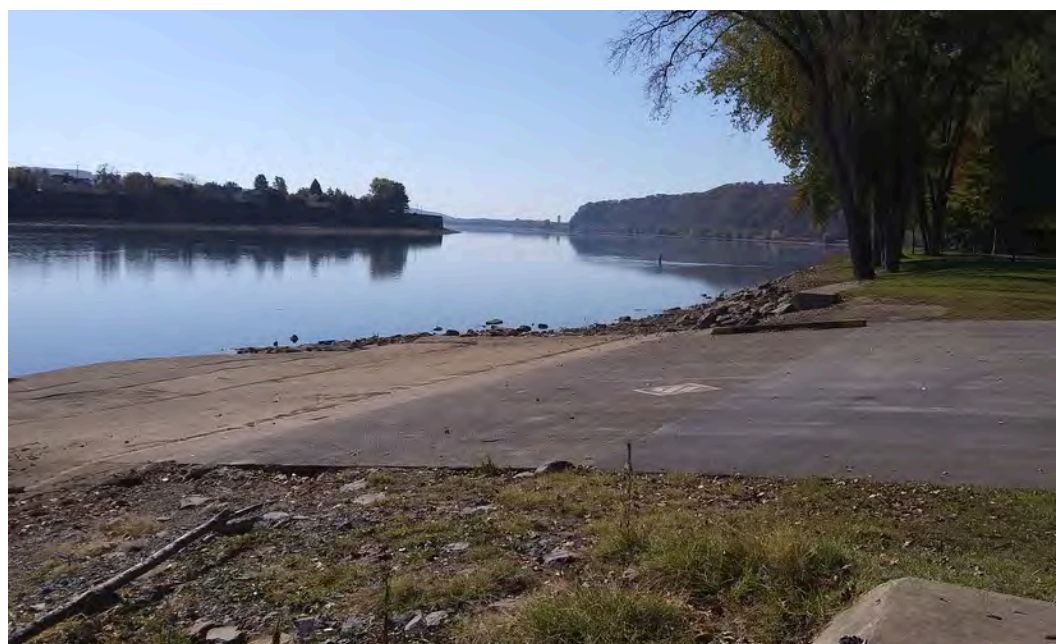
293 Marina Rd, Sunbury, PA 17801 | River Mile: 125, River Left | Owner: PA DCNR

The primary barrier is the lack of ADA-accessible parking at the launch. The paved lot contains no designated accessible spaces, access aisles, or compliant signage, and circulation between site features requires pedestrians to travel within the roadway. No continuous accessible route connects parking, launch ramp, and amenities. Existing paved paths contain cracking, surface uplift, and slopes exceeding allowable standards, creating challenges for individuals with mobility limitations. Distances between site elements, approximately 215 feet to the launch and over 600 feet to restrooms further limit usability.

The launch consists of a wide concrete ramp with a steep slope. A seasonal aluminum dock system provides potential boarding access but is removed during the off-season, eliminating consistent accessible use. Water entry conditions include shallow, slow-moving water and an uneven riprap shoreline, limiting stable access. Amenities are present and partially compliant but not fully accessible in practice. Restrooms appear to meet ADA requirements internally but are not connected by a compliant route (Note: This study officially only evaluates accessibility to the door). One picnic table meets ADA standards, and features such as the water fountain, trash receptacles, and pet waste stations are compliant, though accessible seating near the launch is limited. Wayfinding is primarily informational, with no signage identifying accessible routes or features.

Key improvement priorities include establishing ADA-compliant parking at the launch, developing a continuous accessible route connecting key site elements, and addressing surface and slope deficiencies. Additional improvements include enhancing wayfinding, increasing accessible seating near the launch, and evaluating options for consistent accessible docking.

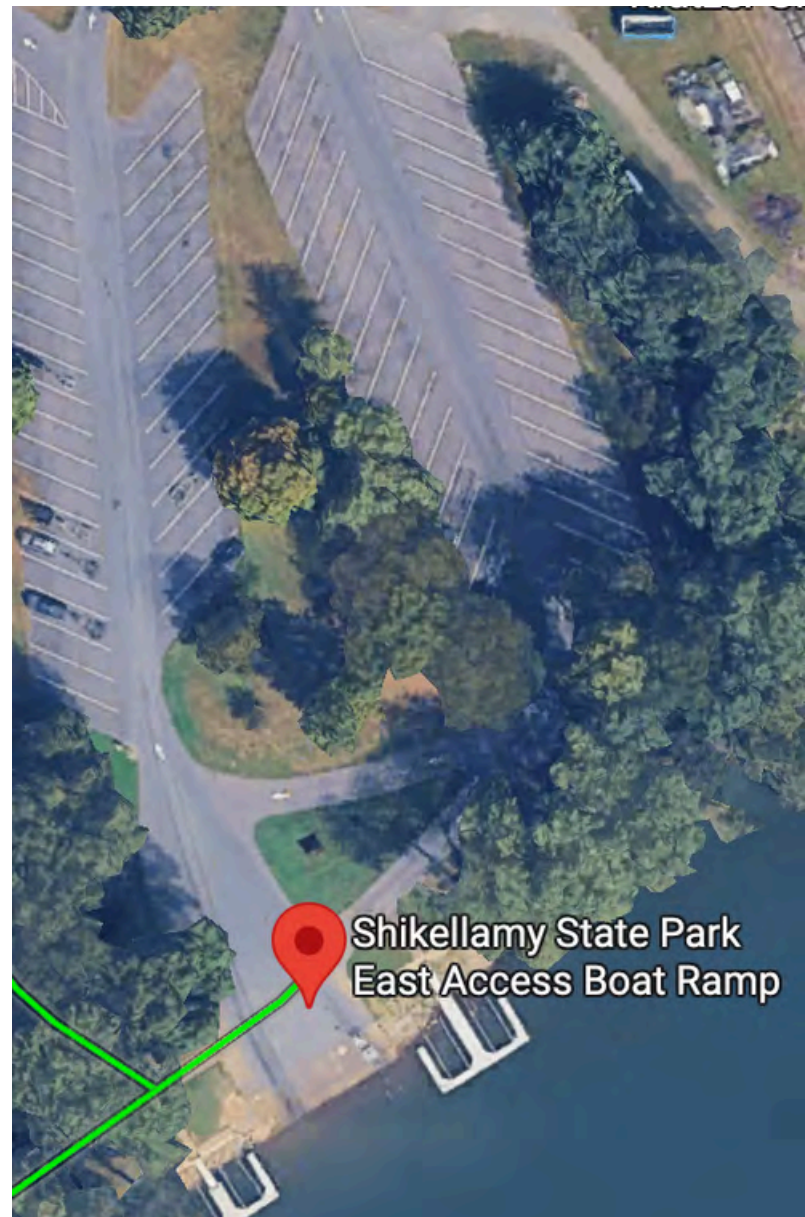
**Shikellamy State Park  
East Access Boat Ramp**

Overall, Shikellamy East Access provides valuable recreational opportunities but currently offers limited accessibility due to gaps in parking, route connectivity, and launch conditions. Targeted improvements in these areas would significantly enhance usability and expand access for a wider range of visitors. In the short term, Shikellamy West Access, located nearby, does provide an alternative with better ADA-accessible features.

| PRIORITY | IMPROVEMENT | DESCRIPTION / NOTES |
|---|---|---|
| | Accessible Route (Parking → Launch) | Develop a continuous, firm, and stable accessible route; repair cracks and uplift; address slope exceedances where feasible. |
| <b>Medium<br/>(1–3 years)</b> | Accessible Route to Amenities | Improve and formalize accessible connection between launch and restroom facilities, addressing slope and surface deficiencies. |
| <b>Early Implementation Opportunities</b> | Pathway Maintenance | Repair cracks, surface uplift, and minor slope issues along primary travel routes. |

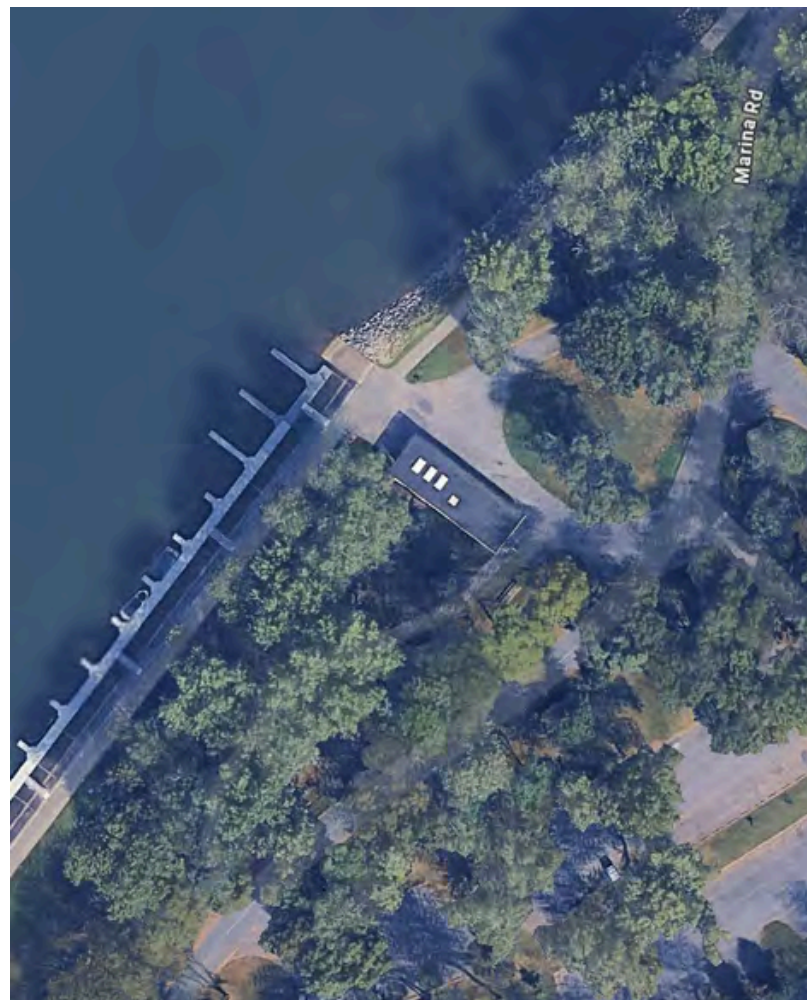
Overall, Shikellamy West Access provides a simple and functional river access point, but accessibility is constrained by specific design deficiencies and limited amenities. Addressing these issues would improve usability and support more inclusive access to the site.

| PRIORITY | IMPROVEMENT | DESCRIPTION / NOTES |
|---|---|---|
| | Transition Repair (Parking to Path) | Remove vertical lip greater than 1” at the connection between parking area and pathway to meet ADA transition requirements. |
| Early Implementation Opportunities | Minor Surface Adjustments | Perform grading and small-scale surface repairs to address transition issues and improve accessibility. |

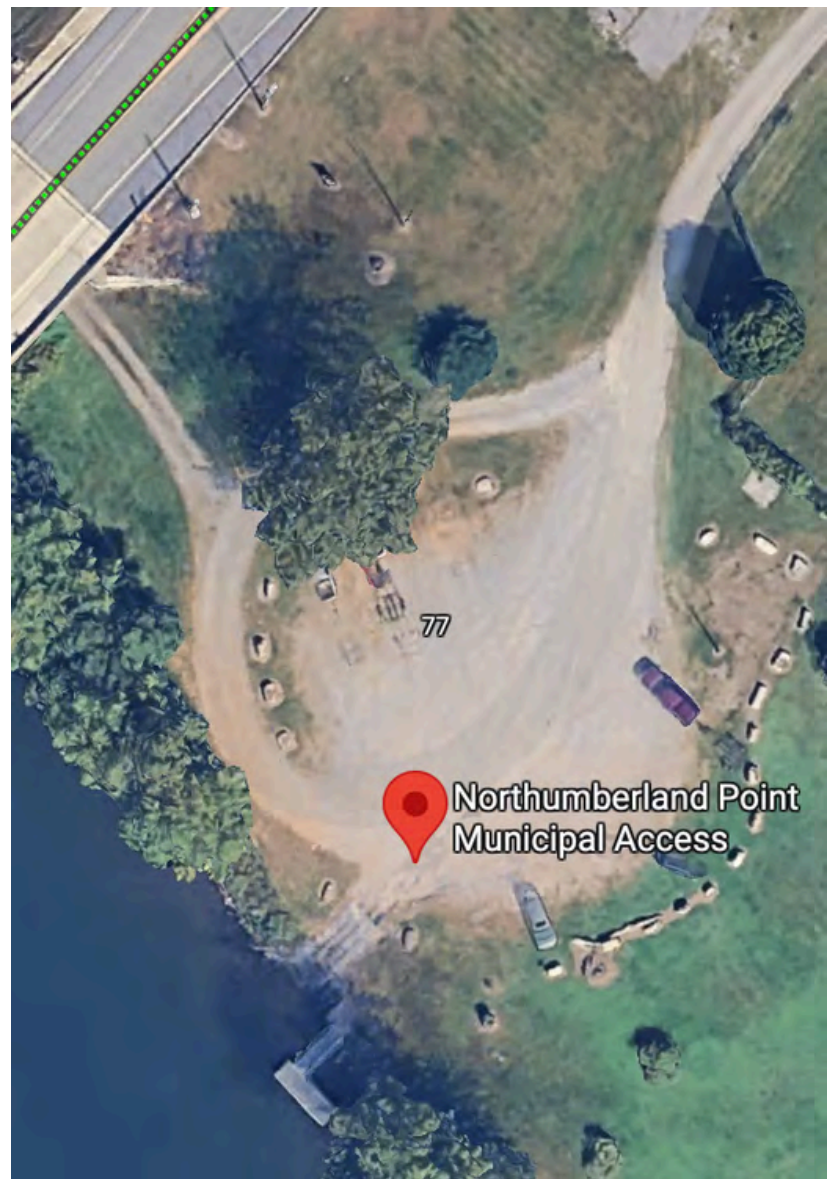
The primary barrier at the site is the absence of ADA-compliant parking. The existing lot is unorganized, with no designated spaces, striping, or accessible features, and consists of loose gravel and dirt surfaces that do not meet ADA requirements. Without defined circulation or accessible accommodations, users with mobility limitations may have difficulty safely navigating the site from arrival.

No accessible route connects parking to the launch or nearby amenities. Users must traverse uneven dirt and gravel surfaces over a short distance to reach the ramp, and informal paths provide the only connection to restroom facilities and other park features located approximately 500 feet away. These conditions do not meet standards for firm, stable, and continuous accessible routes and limit independent use.

The launch consists of a concrete ramp with a moderate slope and a relatively narrow width. Seasonal dock infrastructure is not consistently available, and water entry conditions include shallow, slow-moving water with exposed rocks and uneven substrate. Debris and unstable ground conditions near the ramp further reduce usability. These factors create challenges for individuals requiring stable footing or assisted entry.

Overall, Northumberland Point Municipal Access provides basic river access but currently offers limited accessibility due to the absence of organized infrastructure and accessible connections. Targeted improvements focused on parking, route development, and site stabilization would significantly enhance usability and support more inclusive access.

Key improvement priorities include establishing ADA-compliant parking, developing a continuous accessible route connecting the launch to parking and nearby amenities, and improving ramp and site surface conditions. Additional opportunities include introducing accessible seating, enhancing site organization, and improving wayfinding signage.

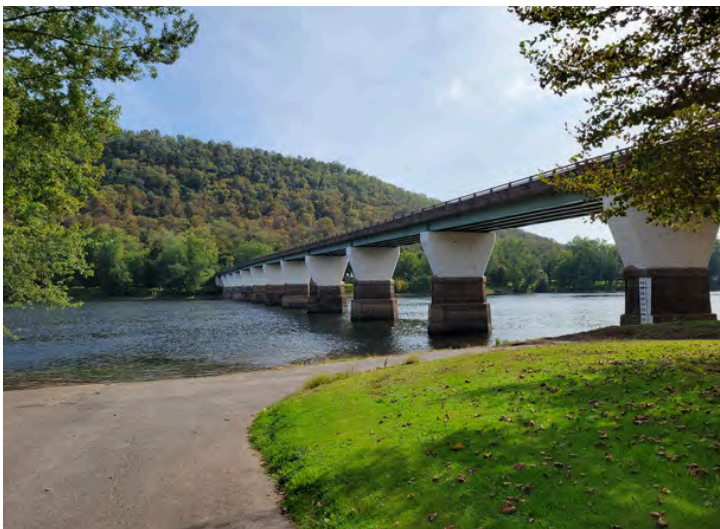
The boat ramp is structurally sound and notably wide, supporting a range of users. However, it is a medium slope, and the absence of boarding infrastructure limits independent water access. Shoreline conditions, consisting of rocky and vegetated surfaces, may further reduce stability for users entering the water.

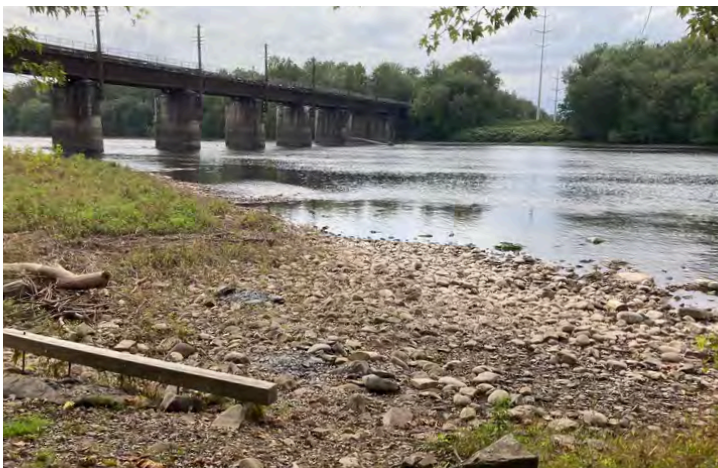
Water entry is informal and constrained by natural conditions. The shoreline consists of rocky, uneven terrain with shallow water, light vegetation, and exposed stones, particularly near nearby bridge structures. The absence of a defined launch or stabilized surface significantly limits the site's suitability for watercraft use and reinforces its function as a shoreline access point rather than a launch facility.
