PHASE I

# Lower West Branch Susquehanna River ADA and Universal Accessibility Access Study

A PROJECT OF THE SUSQUEHANNA GREENWAY PARTNERSHIP

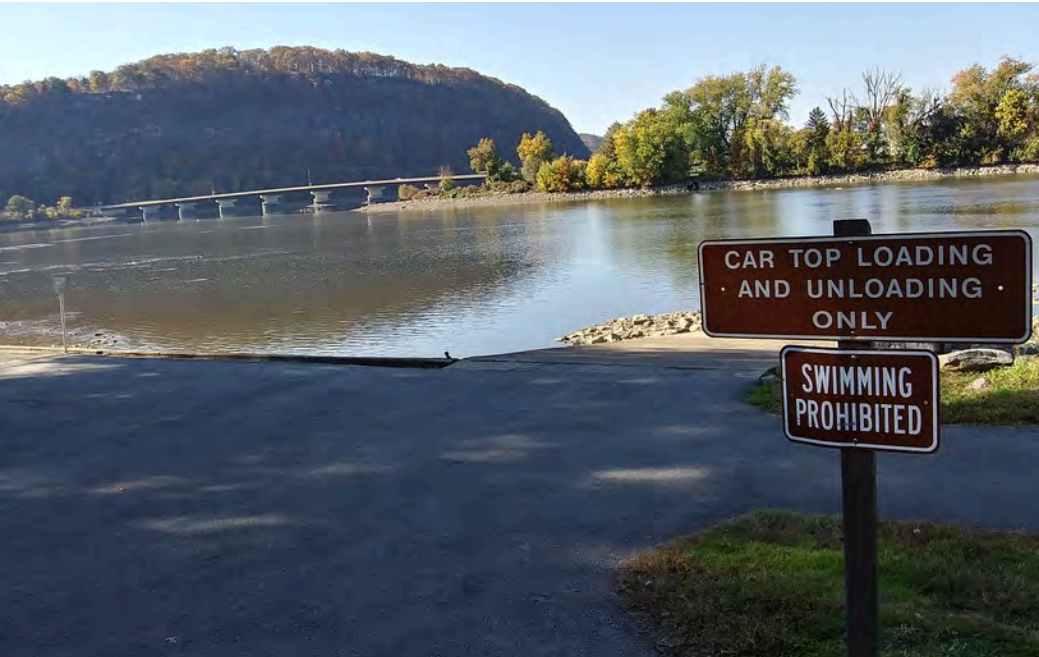
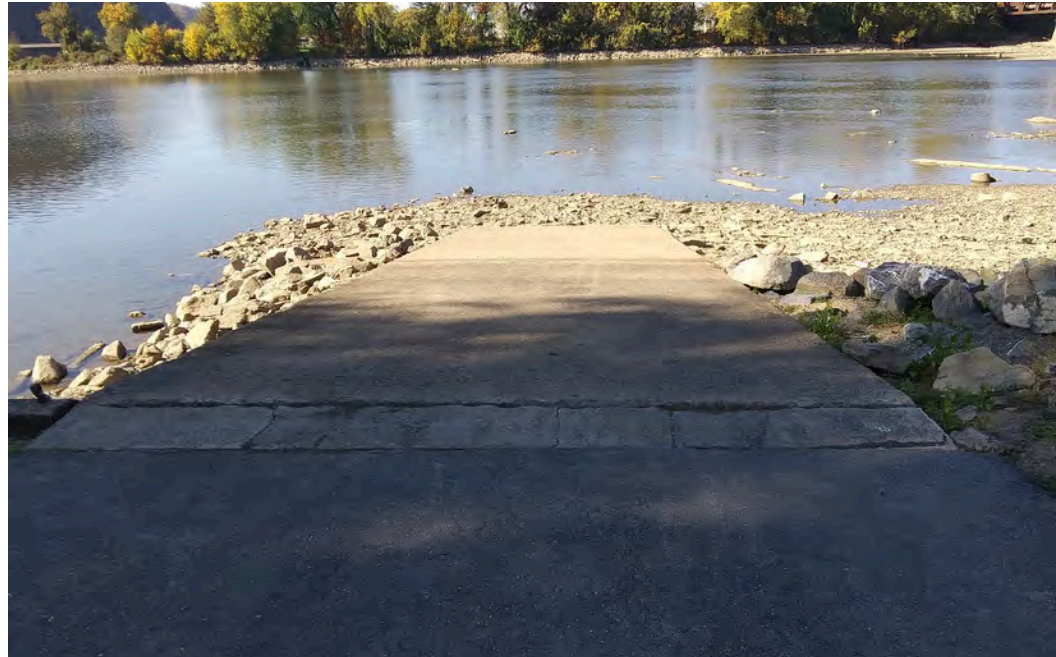
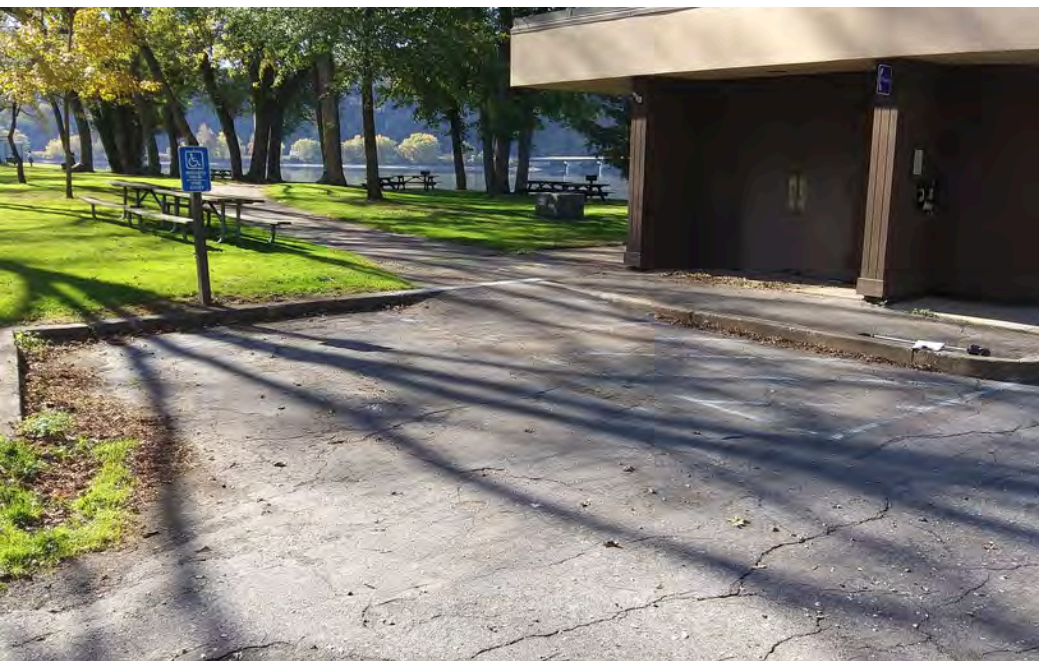
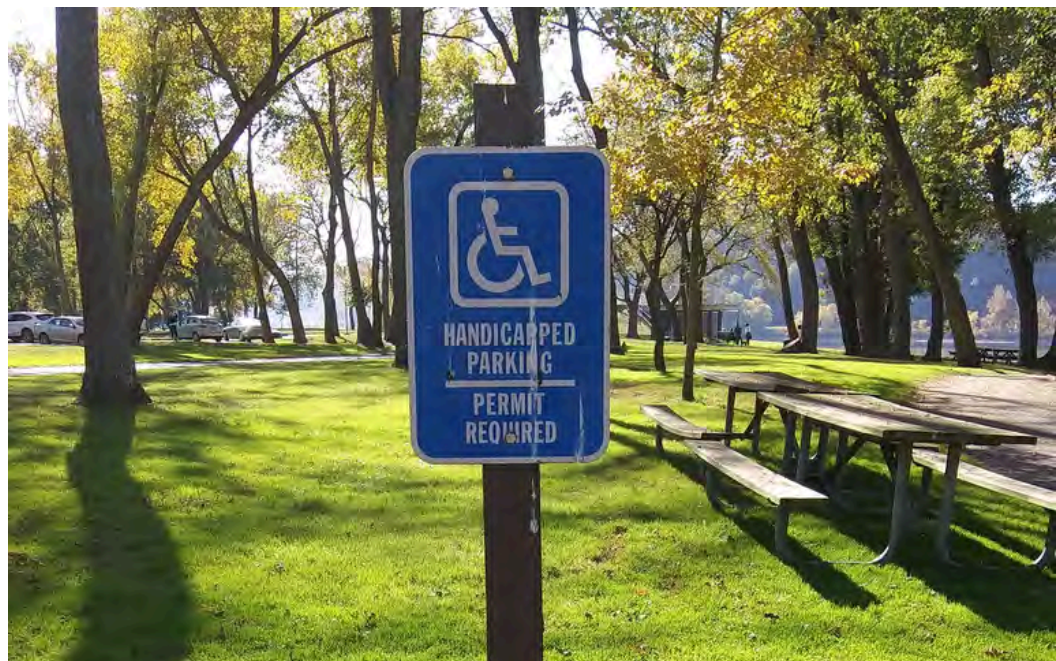
# Shikellamy West Boat Access

Shikellamy West Access provides river access for primarily car-top boat users along the Susquehanna River. The site includes a single paved ADA-designated parking space, a concrete boat ramp, and minimal supporting infrastructure. Lighting and basic safety features are present, though overall amenities are limited. While the short distance between parking and the launch supports accessibility, design issues within the parking area and route transitions limit full compliance and usability.

The launch consists of a short concrete ramp with a moderate slope and sufficient maneuvering space at the top for loading and unloading. No dock or boarding structure is present, and water entry conditions include shallow, slow-moving water with a mix of riprap and structural shoreline. These conditions may require assistance for some users due to the slope and lack of accessible boarding features.

Overall, Shikellamy West Access provides a simple and functional river access point, but accessibility is constrained by specific design deficiencies and limited amenities. Addressing these issues would improve usability and support more inclusive access to the site.

| PRIORITY | IMPROVEMENT | DESCRIPTION / NOTES |
|---|---|---|
| | Transition Repair (Parking to Path) | Remove vertical lip greater than 1” at the connection between parking area and pathway to meet ADA transition requirements. |
| Early Implementation Opportunities | Minor Surface Adjustments | Perform grading and small-scale surface repairs to address transition issues and improve accessibility. |

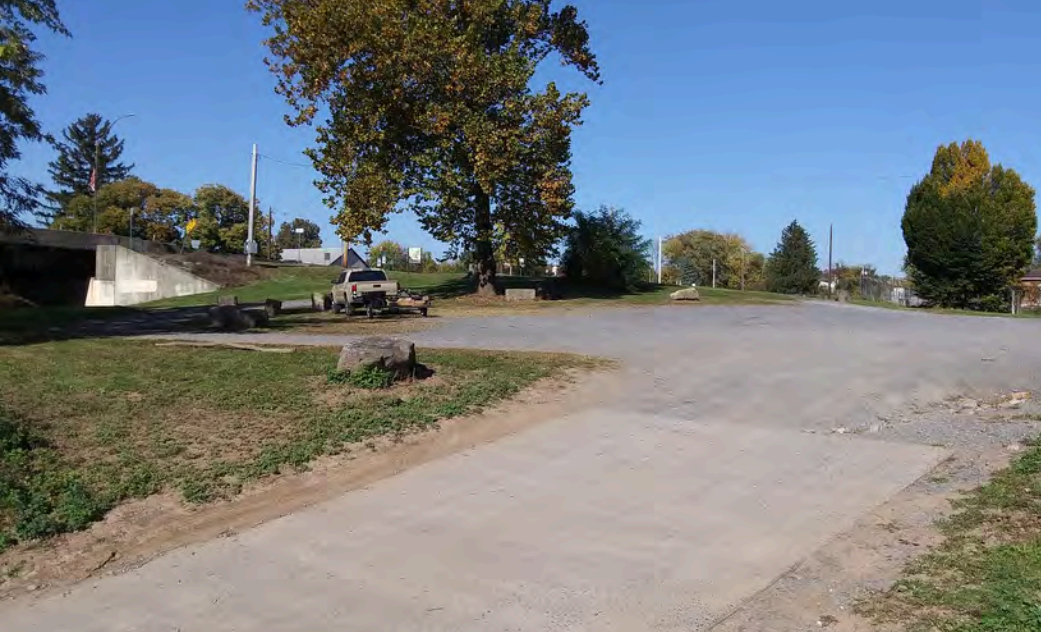
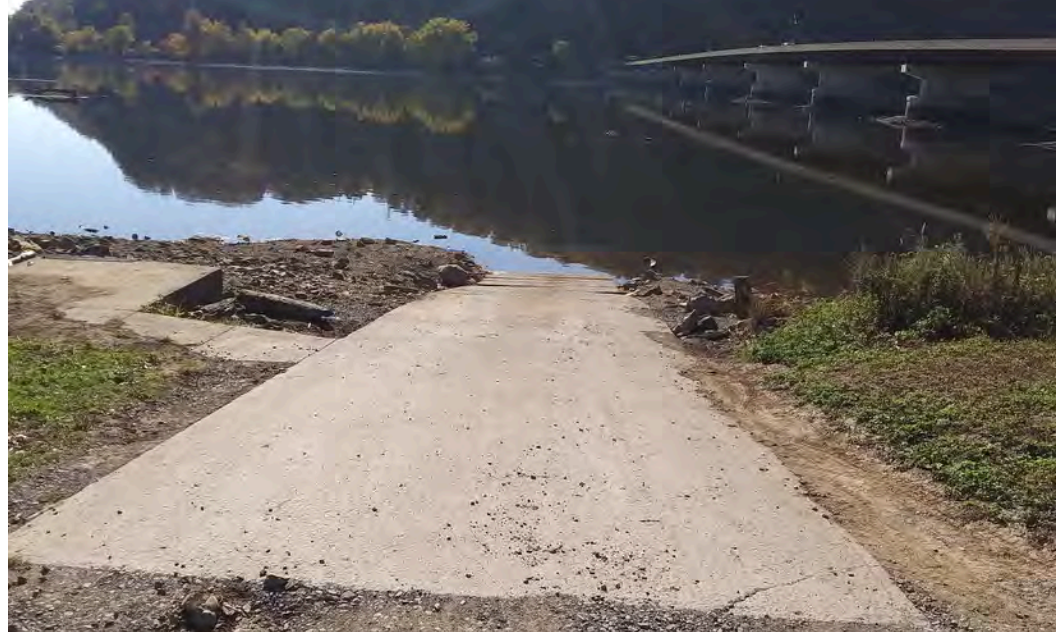
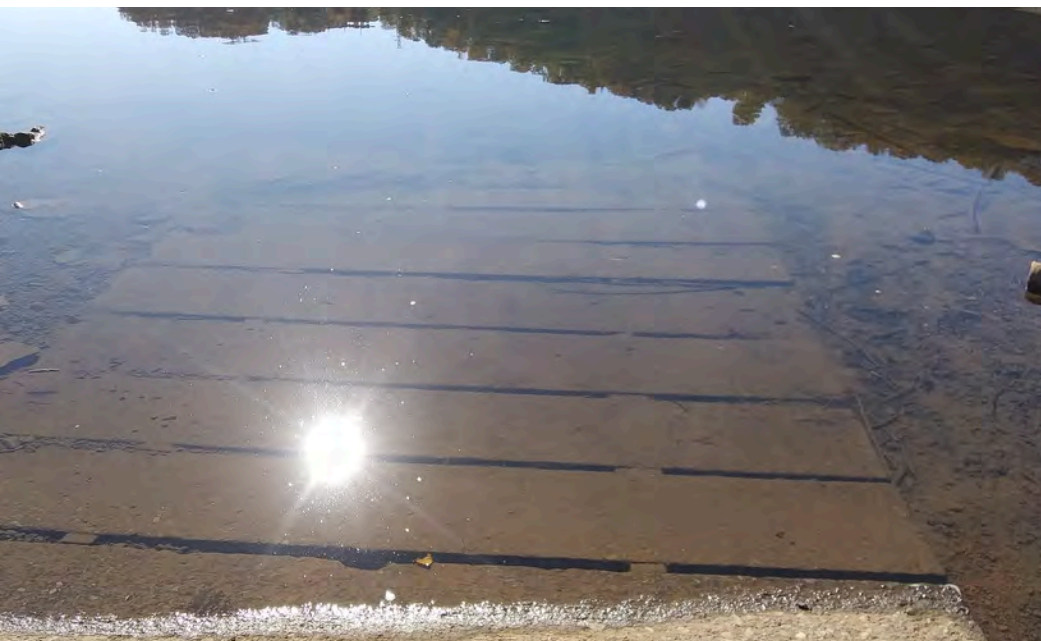
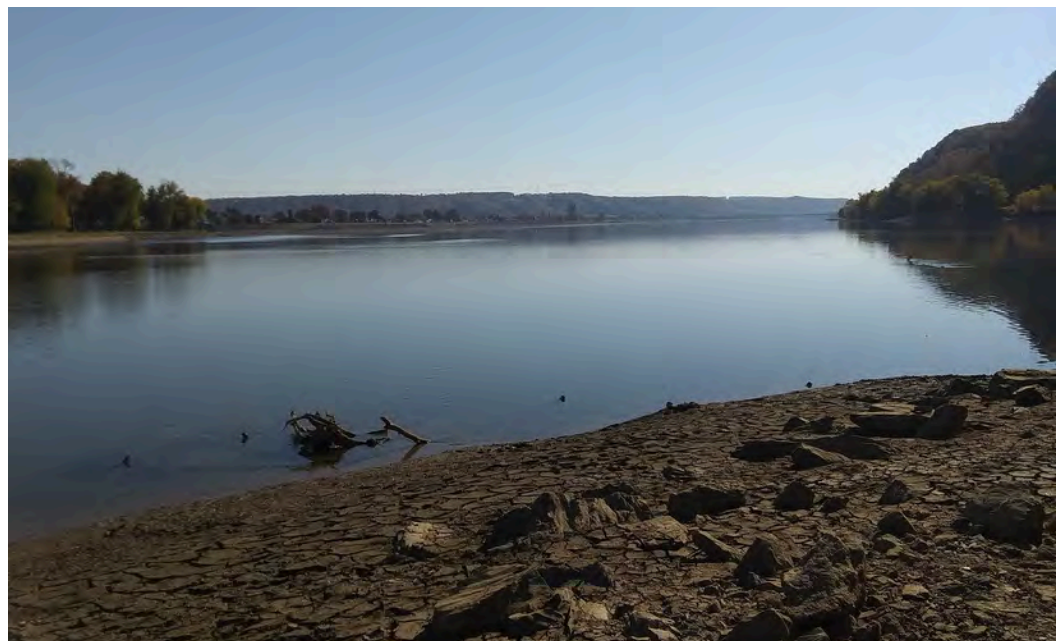
# Northumberland Point Municipal Access

Northumberland Point Municipal Access provides river access for boaters and shoreline users along the Susquehanna River. The site includes a large, non-delineated parking area with mixed dirt and stone surfaces, a concrete boat ramp, and seasonal dock infrastructure. While located near an urban area and adjacent park amenities, the access site itself is minimally developed and lacks defined infrastructure to support accessible use.

The primary barrier at the site is the absence of ADA-compliant parking. The existing lot is unorganized, with no designated spaces, striping, or accessible features, and consists of loose gravel and dirt surfaces that do not meet ADA requirements. Without defined circulation or accessible accommodations, users with mobility limitations may have difficulty safely navigating the site from arrival.

No accessible route connects parking to the launch or nearby amenities. Users must traverse uneven dirt and gravel surfaces over a short distance to reach the ramp, and informal paths provide the only connection to restroom facilities and other park features located approximately 500 feet away. These conditions do not meet standards for firm, stable, and continuous accessible routes and limit independent use.

The launch consists of a concrete ramp with a moderate slope and a relatively narrow width. Seasonal dock infrastructure is not consistently available, and water entry conditions include shallow, slow-moving water with exposed rocks and uneven substrate. Debris and unstable ground conditions near the ramp further reduce usability. These factors create challenges for individuals requiring stable footing or assisted entry.

Key improvement priorities include establishing ADA-compliant parking, developing a continuous accessible route connecting the launch to parking and nearby amenities, and improving ramp and site surface conditions. Additional opportunities include introducing accessible seating, enhancing site organization, and improving wayfinding signage.

| PRIORITY | IMPROVEMENT | DESCRIPTION / NOTES |
|---|---|---|
| <b>Early Implementation Opportunities</b> | Surface Stabilization | Grade and compact existing parking and pathway areas to improve stability and reduce loose materials. |

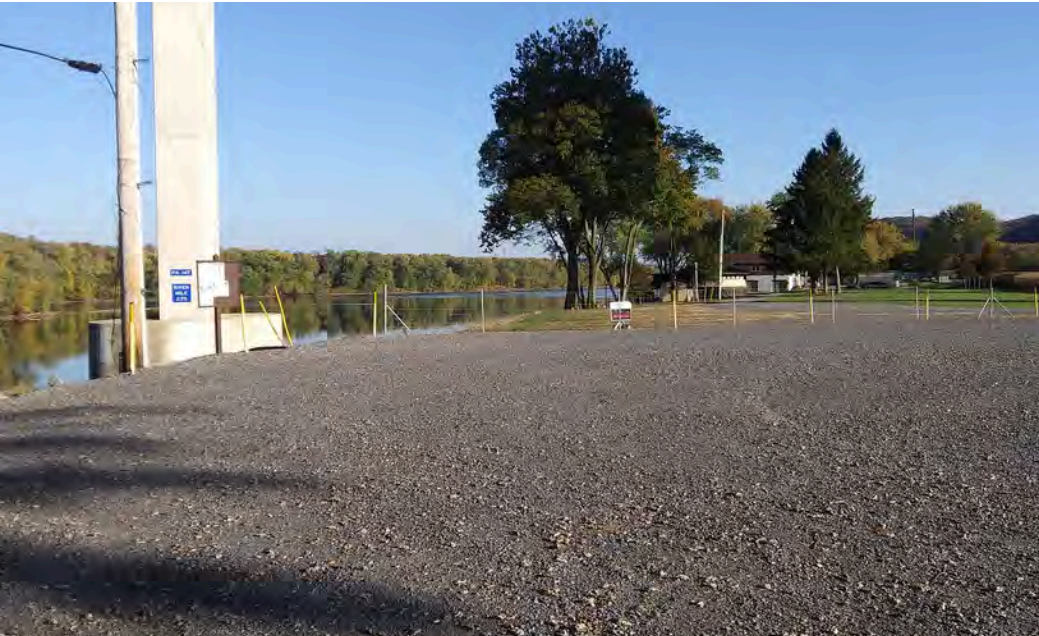
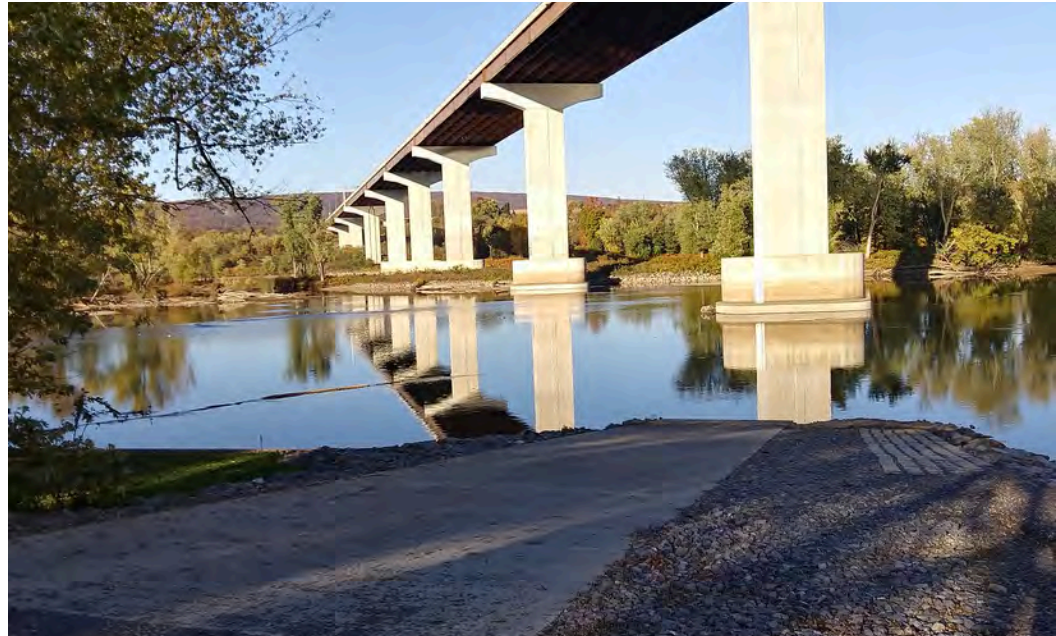
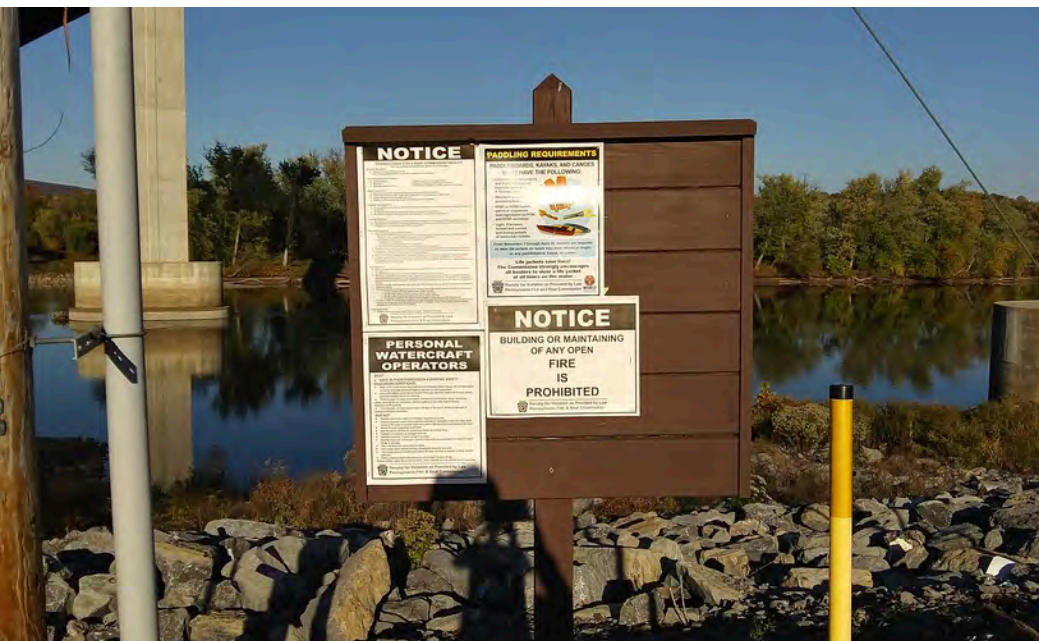
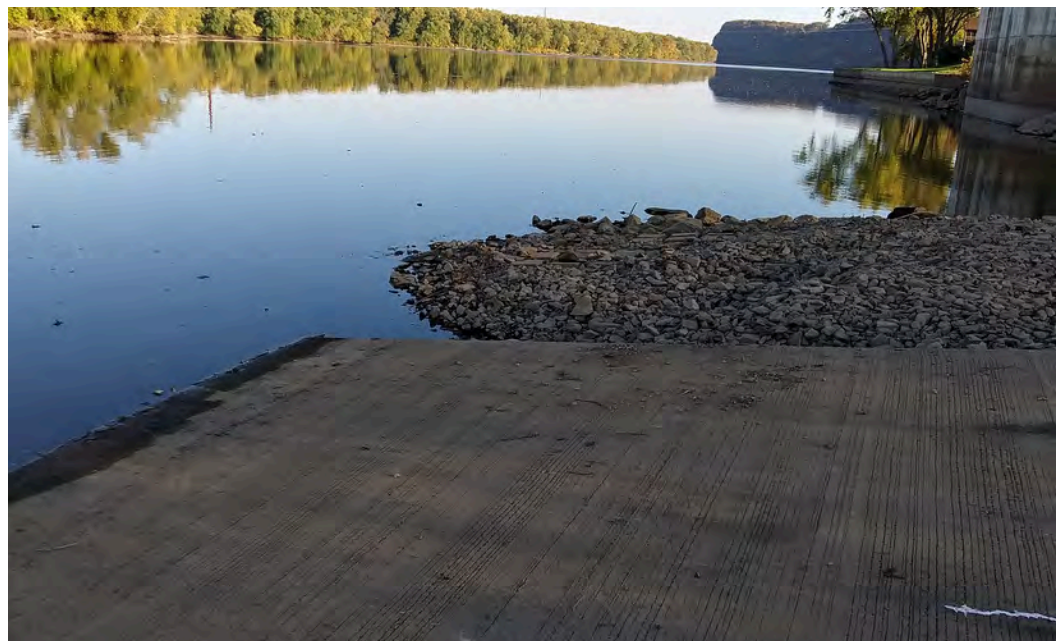
# Winfield Fish and Boat Commission Access or CSVT Bridge Access

The primary barrier at the site is the absence of ADA-compliant parking. The existing lot is non-delineated, with no designated spaces, striping, or signage, and consists of loose crushed stone that does not meet requirements for firm and stable surfaces. This condition limits safe navigation and independent use for individuals with mobility limitations.

The launch consists of a concrete ramp with a moderate slope and designated widths for different vessel types. No dock or boarding structure is present. Shoreline conditions include shallow, slow-moving water with large rocks and broken concrete, further limiting stable entry. These factors reduce the ability of users with mobility impairments to independently access the water.

Key improvement priorities include establishing ADA-compliant parking, developing a firm and continuous accessible route to the launch, and improving surface conditions at critical transition points. Additional opportunities include introducing basic amenities and enhancing wayfinding signage.

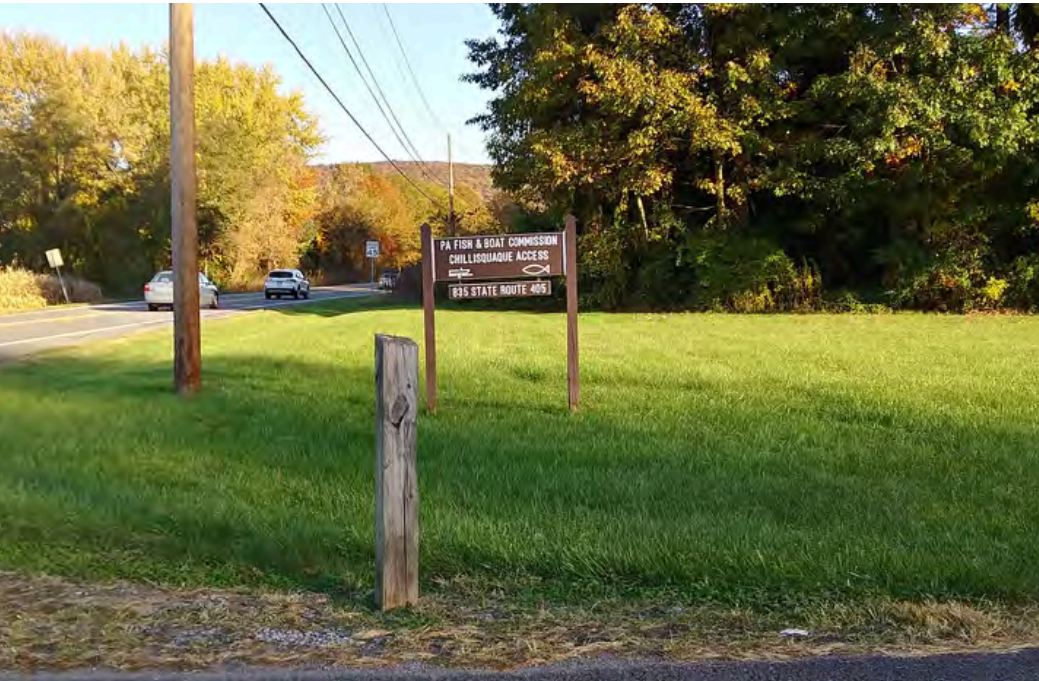
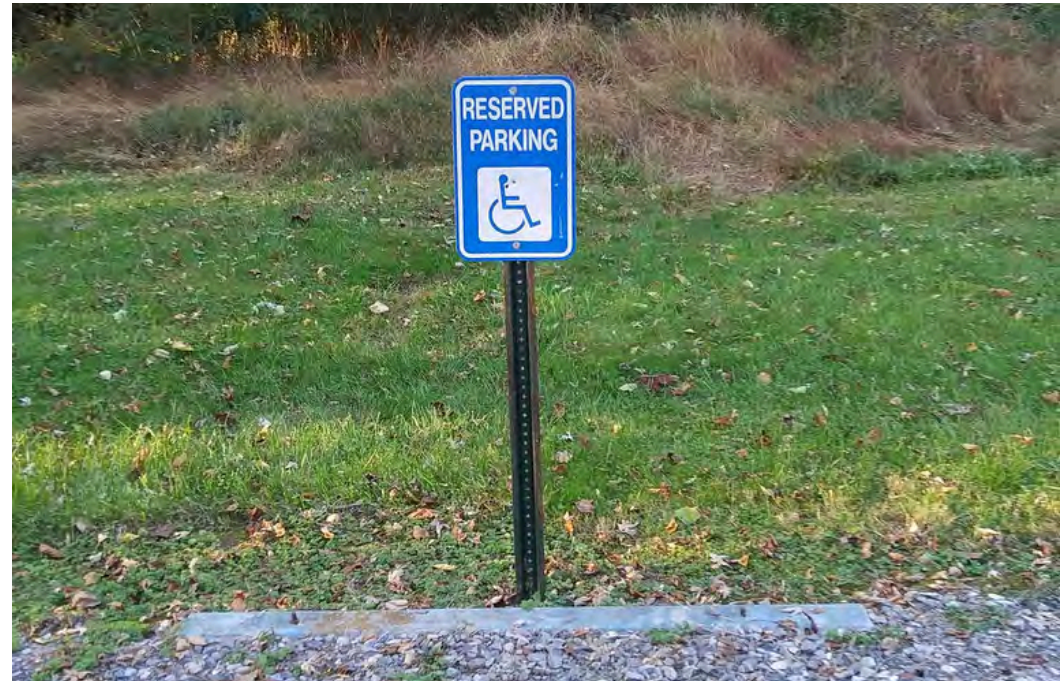
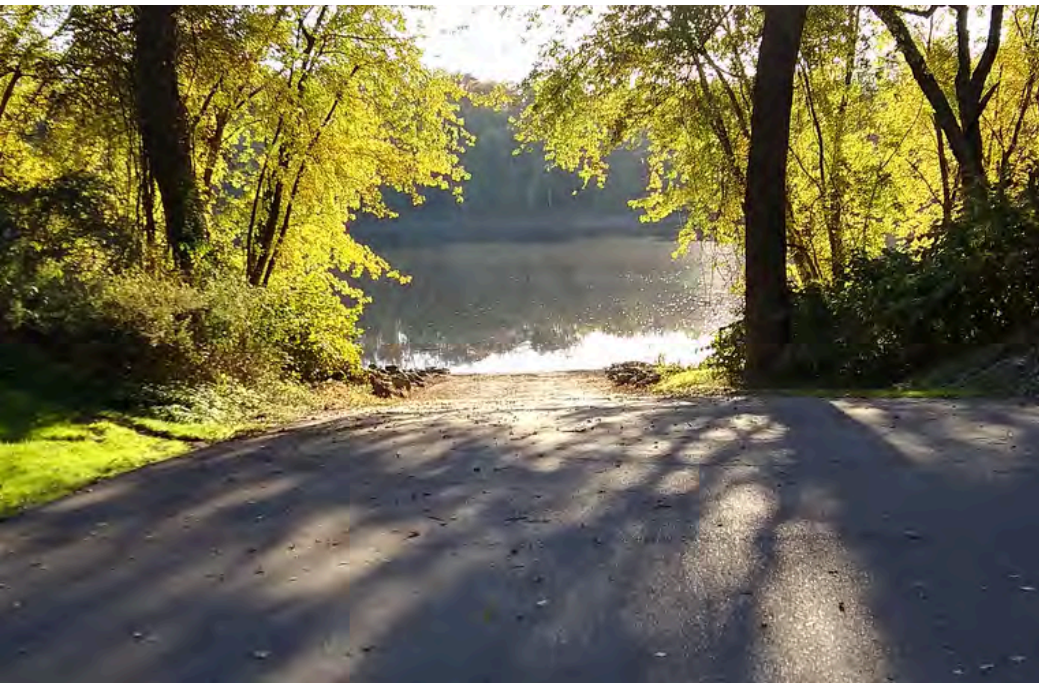
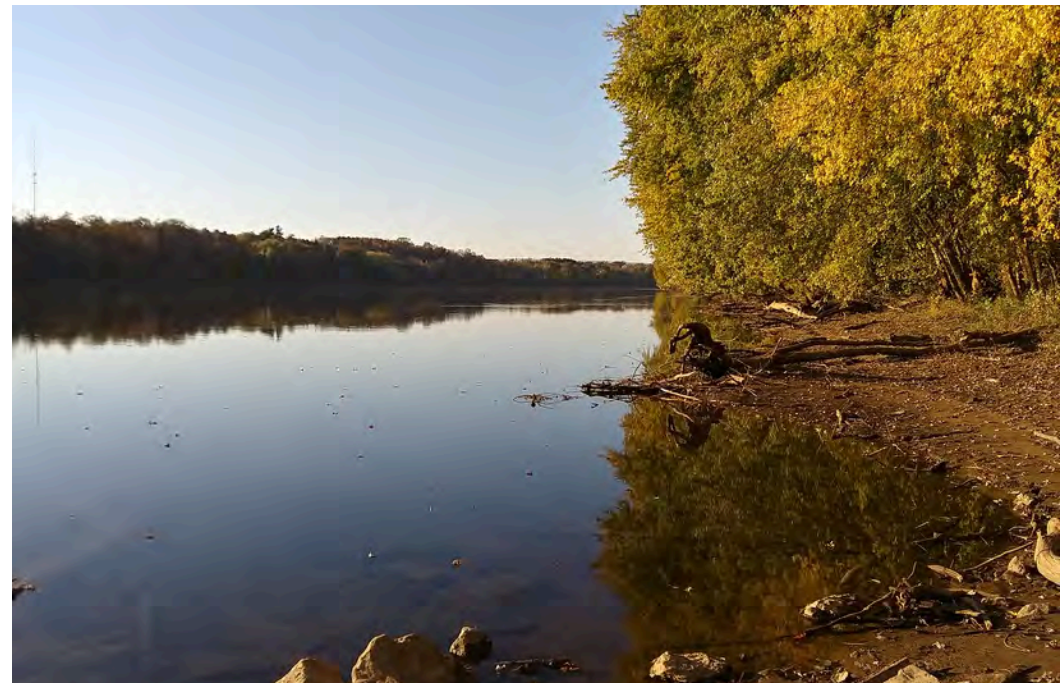
# PFBC Chillisquaque Launch

Accessible parking is provided at the site; however, the designated space is located on a loose crushed stone surface, which does not meet ADA requirements for firmness and stability. In addition, signage associated with the space is mounted below the required height standards. These conditions reduce the effectiveness of the accessible space and create challenges for safe and independent use. Despite these limitations, the site benefits from a paved connection between the parking area and the launch, which offers a generally stable and continuous route over a moderate distance.

The boat ramp is wide, smooth, and in good condition, supporting a range of boating

activities. However, the slope and the absence of a dock or other boarding infrastructure limits independent water access for users with mobility impairments. Shoreline conditions consist of shallow, slow-moving water and a vegetated dirt and silt edge, which may present additional stability challenges.

Key barriers at the site include the placement of accessible parking on an unstable surface, non-compliant signage, limited boarding accessibility, and the absence of amenities. Addressing these issues—particularly through improvements to parking conditions, signage, and basic site features—would significantly enhance overall usability. With targeted upgrades, the site has strong potential to provide more inclusive access while maintaining its current function and character.

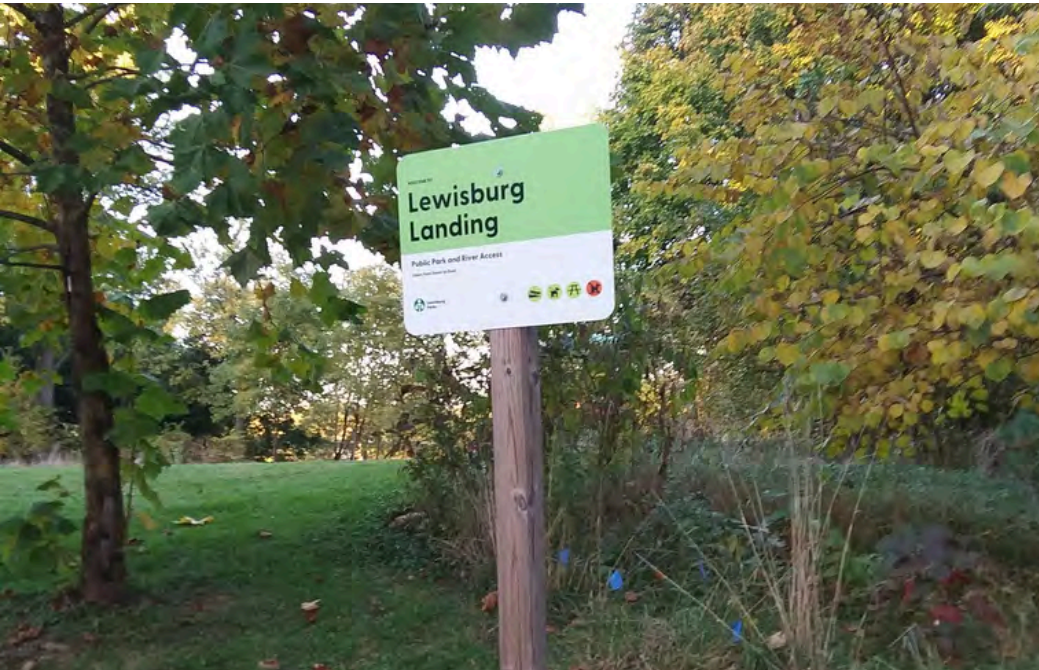
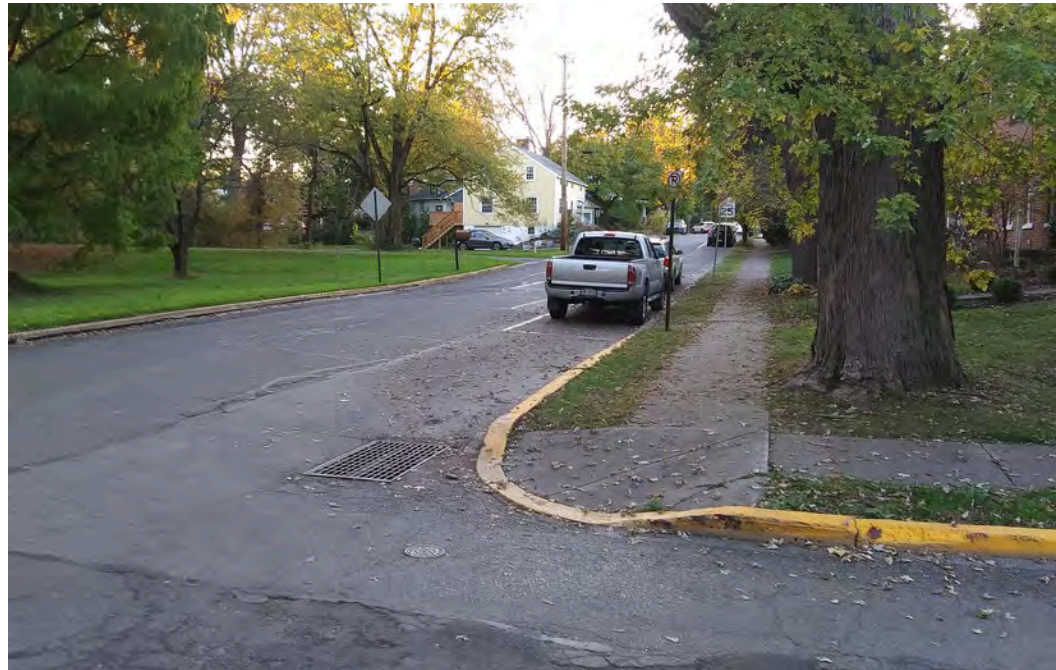
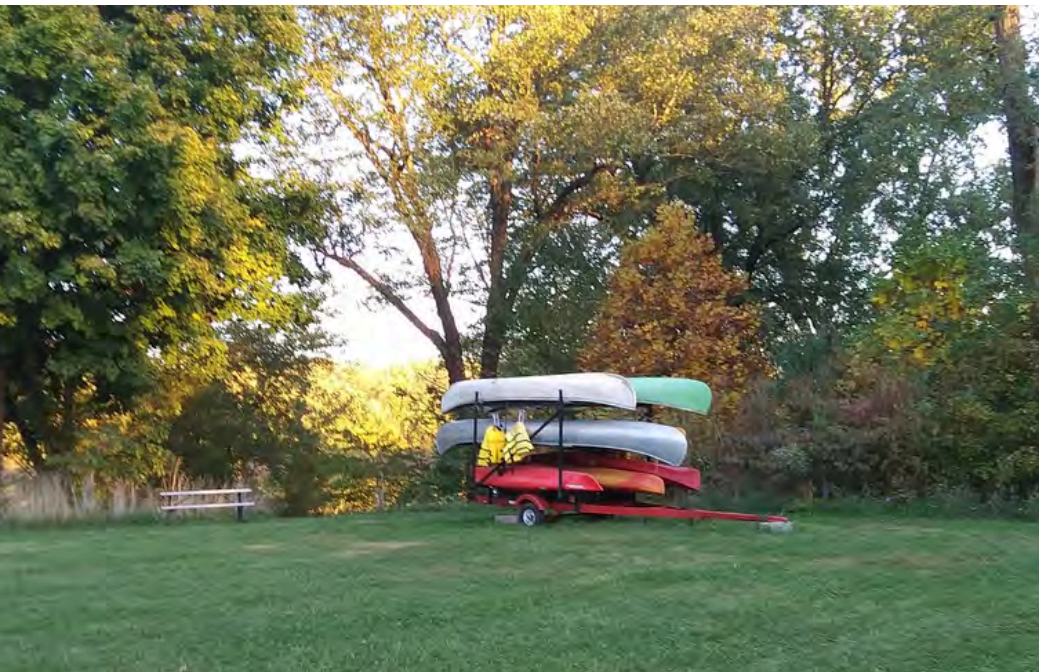
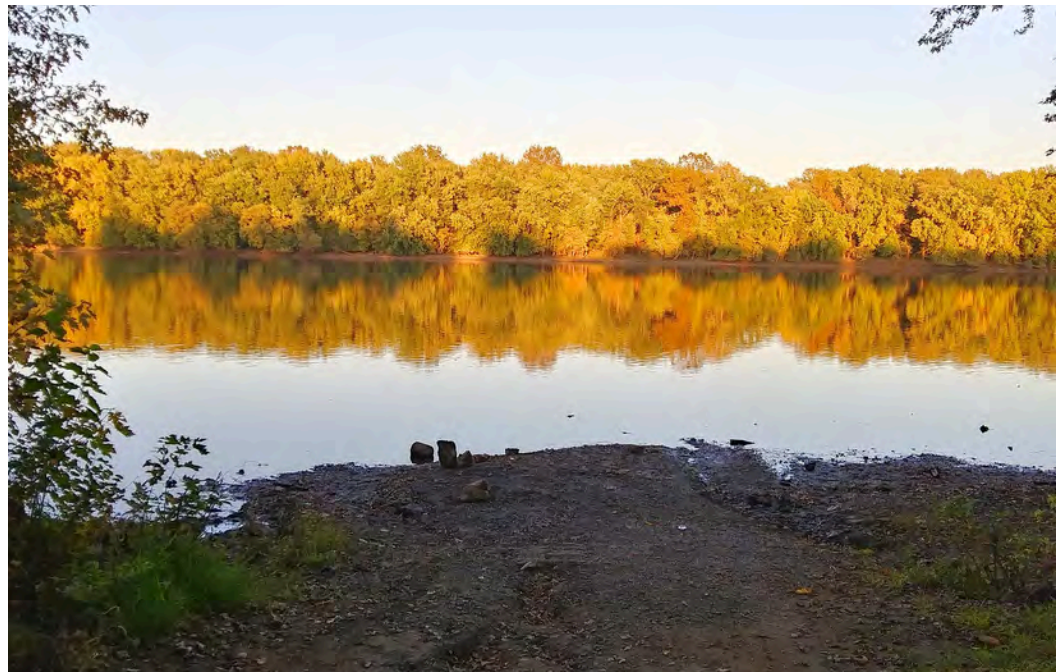
# Lewisburg Landing

Key improvement priorities include establishing a designated accessible parking space, creating a firm and stable accessible route to the launch, and adding basic wayfinding signage. Additional opportunities include improving connections to the adjacent park amenities and evaluating future accessible launch features.

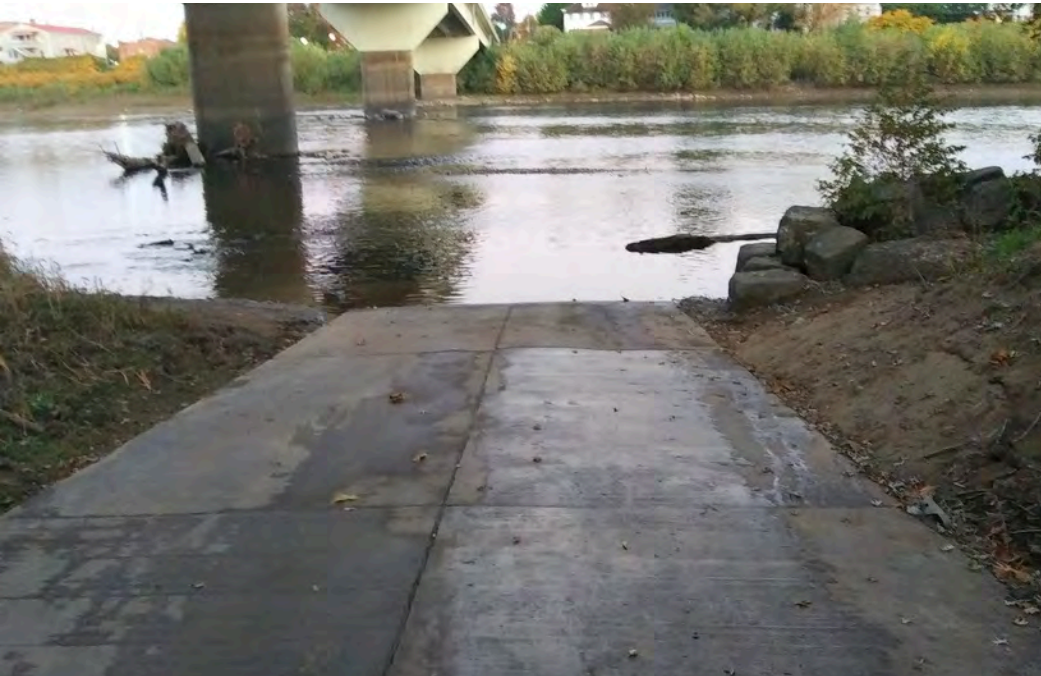
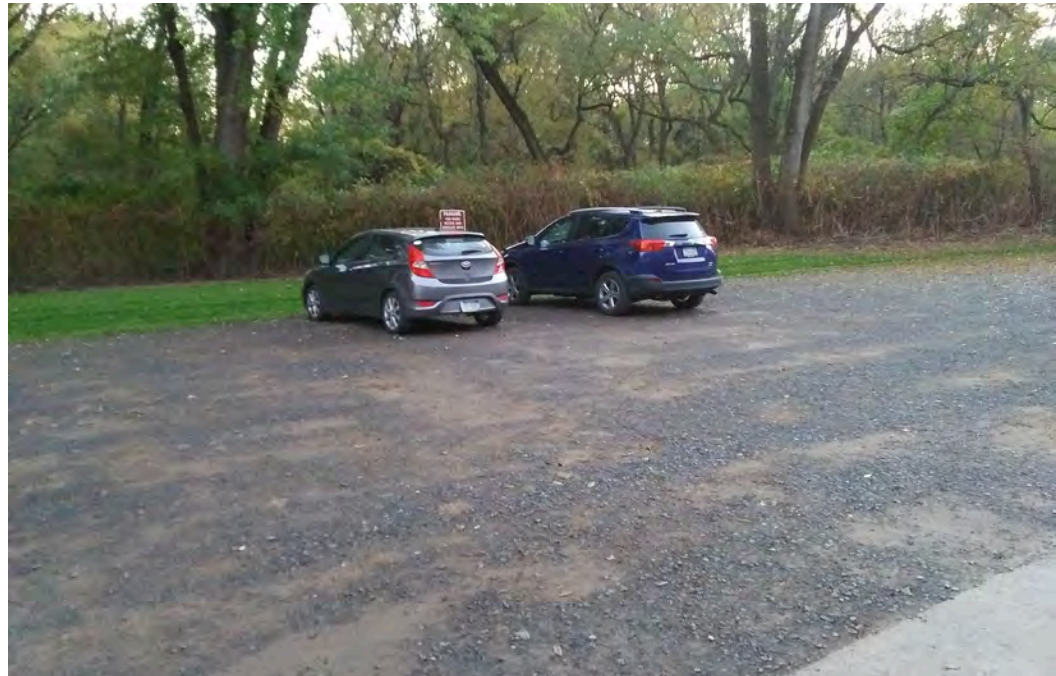
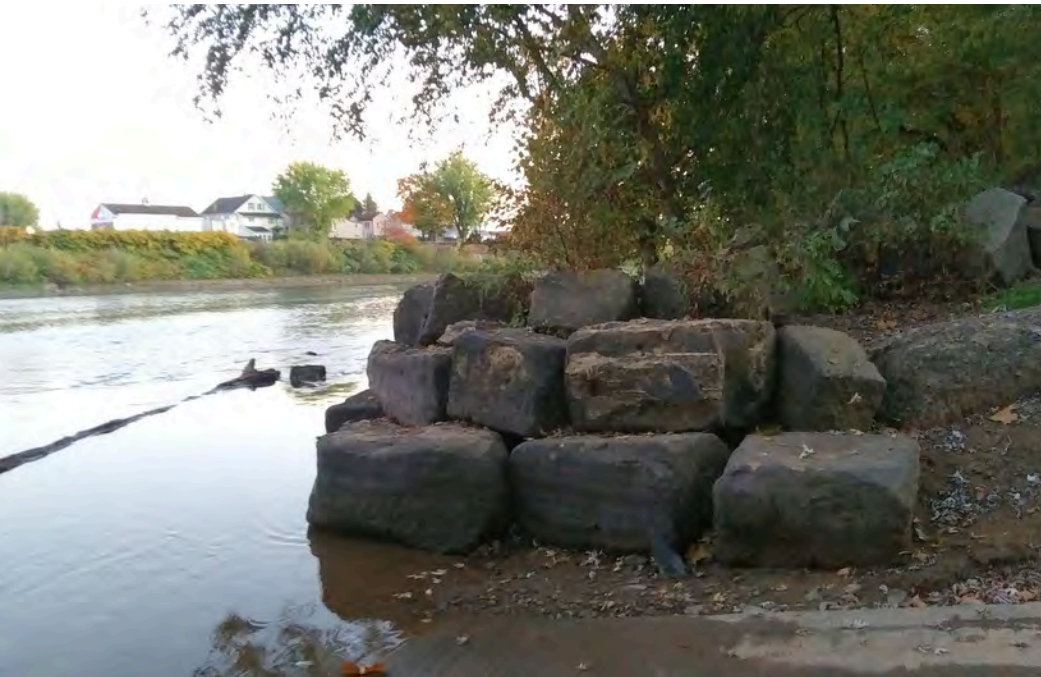
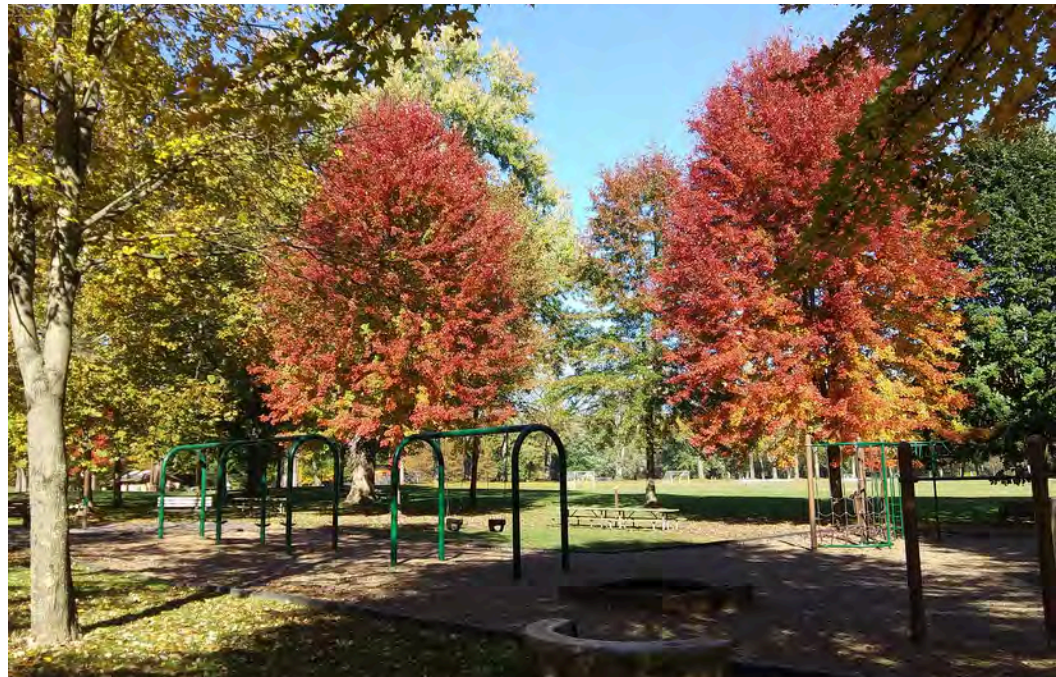
# Milton State Park Boat Launch

The primary barrier for users is the absence of ADA-accessible parking at the water access site. While an ADA-accessible space exists near the central restroom facilities, it does not meet the requirements for a van-accessible stall with marked access aisles and is located approximately 700 feet from the launch. With no accessible route connecting the two locations, users must use roadways or uneven terrain to access the site. The surface lot at the water access is loose packed gravel, and parking spots are not defined, with no accessible parking stalls.

The launch ramp from the surface lot to the water's edge is a consistent slope that is relatively steep. The facility lacks accessible boarding infrastructure such as docks, transfer platforms, or adaptive launch systems. Water entry conditions are shallow and silty, with rocks, debris, and vegetation further limiting usability for individuals requiring stable footing or assisted entry.

Key improvement priorities include establishing ADA-compliant parking at the water access site and creating a firm and stable accessible route connecting parking, launch ramp, bathrooms, and other site elements.

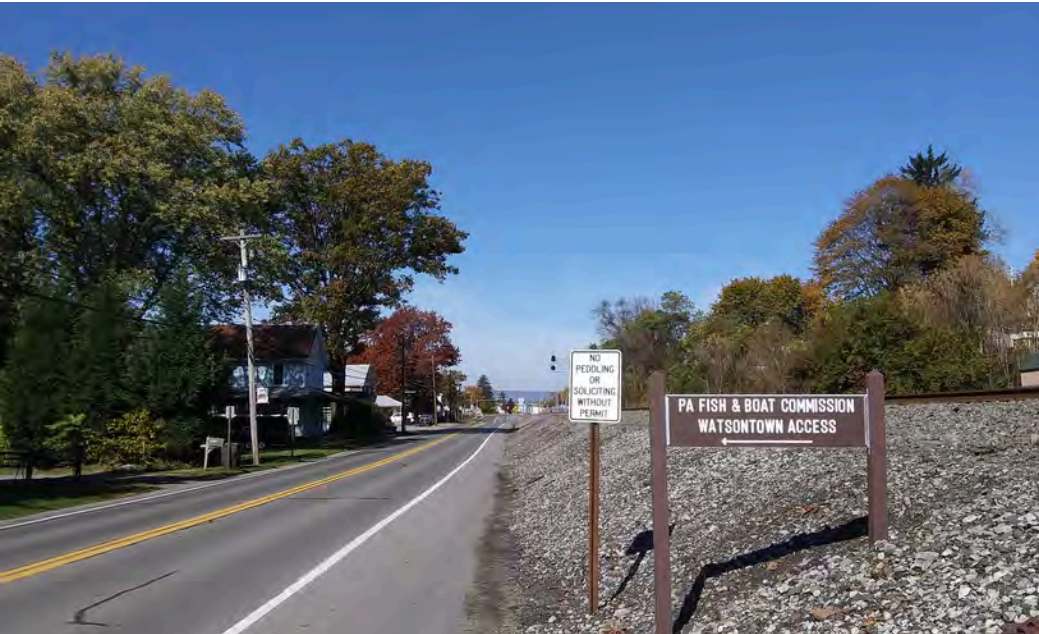
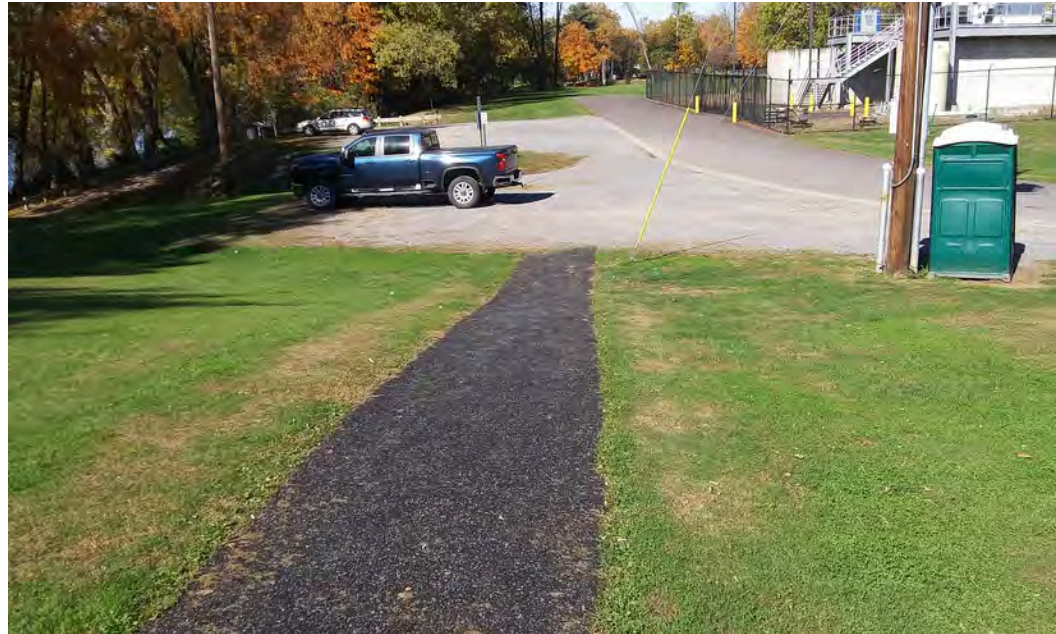
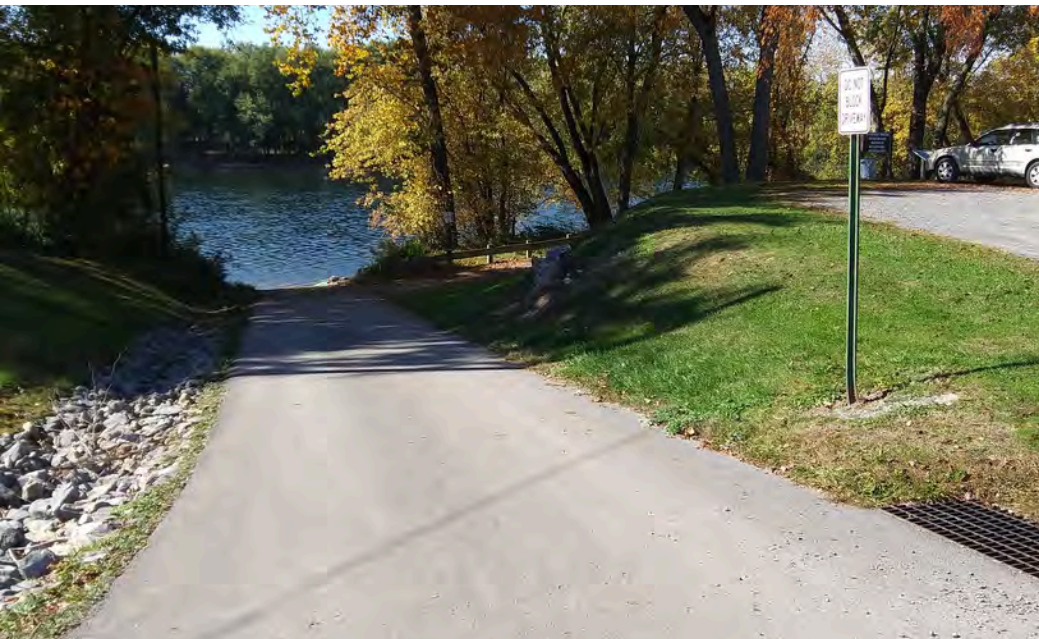
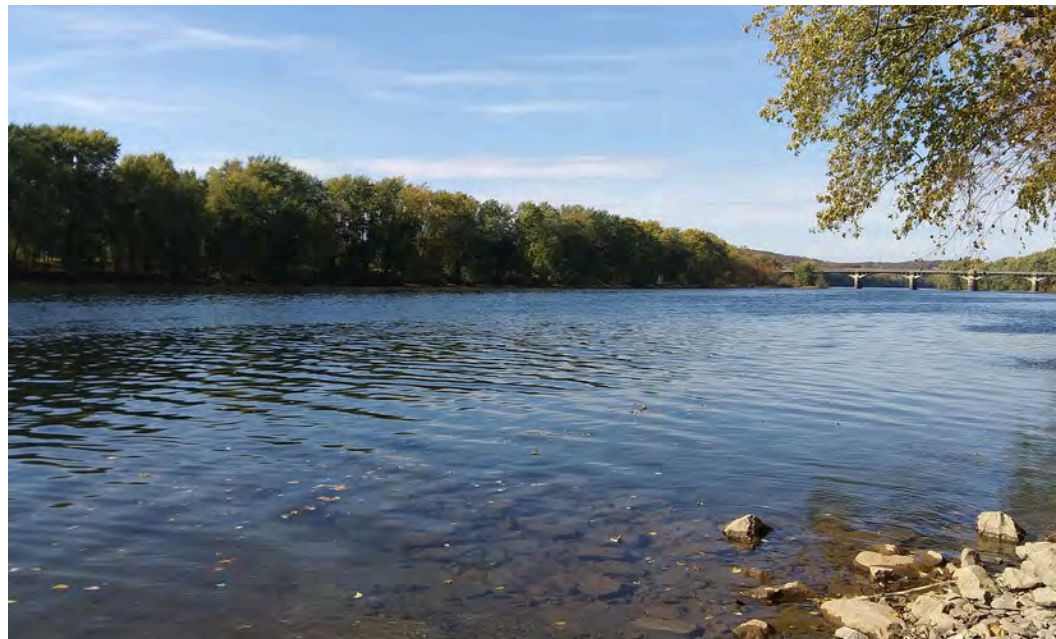
# Watsonstown PFBC Access & Boat Ramp

Accessibility is primarily limited by the absence of designated ADA parking and a continuous accessible route. The parking area is not lined and is surfaced with loose stone, with no accessible spaces or signage provided. Although a paved roadway connects to the ramp, users must navigate mixed and uneven surfaces without a clearly defined pedestrian path. Travel distances to the launch and restroom are relatively short to moderate; however, surface instability and abrasions reduce usability for individuals with mobility limitations.

The boat ramp is structurally sound and provides a stable launch surface, but its length and slope may present challenges for independent use. The absence of a dock or other boarding infrastructure further limits accessible water entry. Shoreline conditions consist of rocky terrain with mild
