PHASE I

# Lower West Branch Susquehanna River ADA and Universal Accessibility Access Study

A PROJECT OF THE SUSQUEHANNA GREENWAY PARTNERSHIP

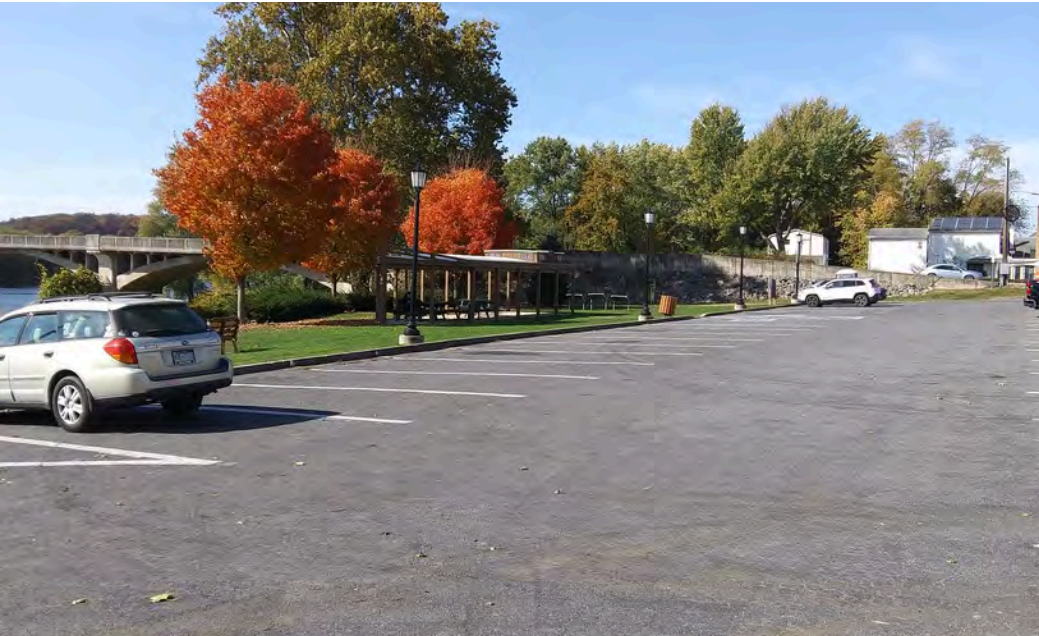
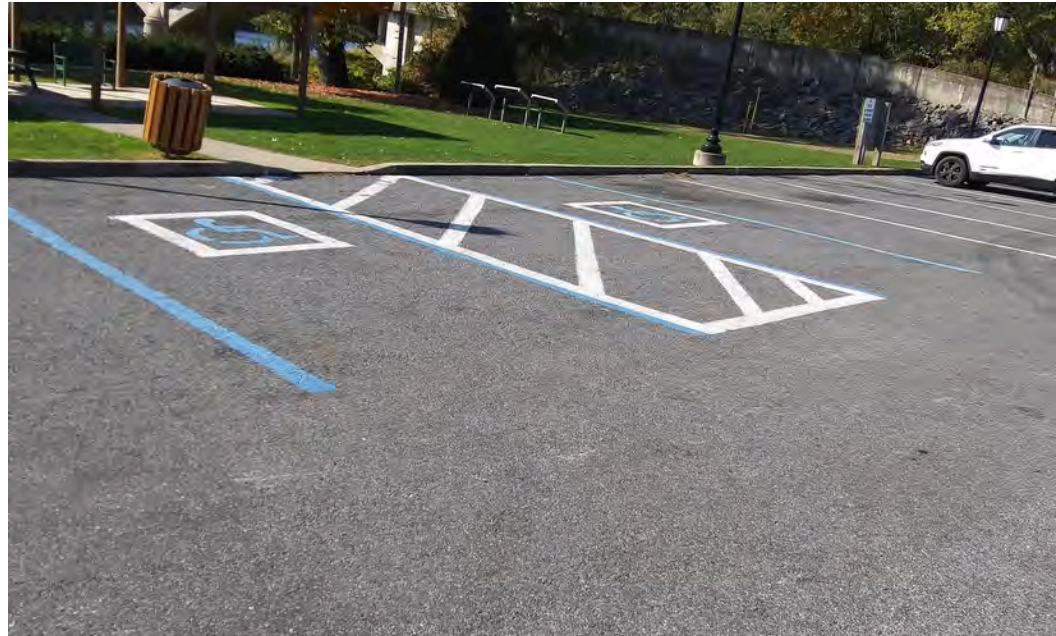
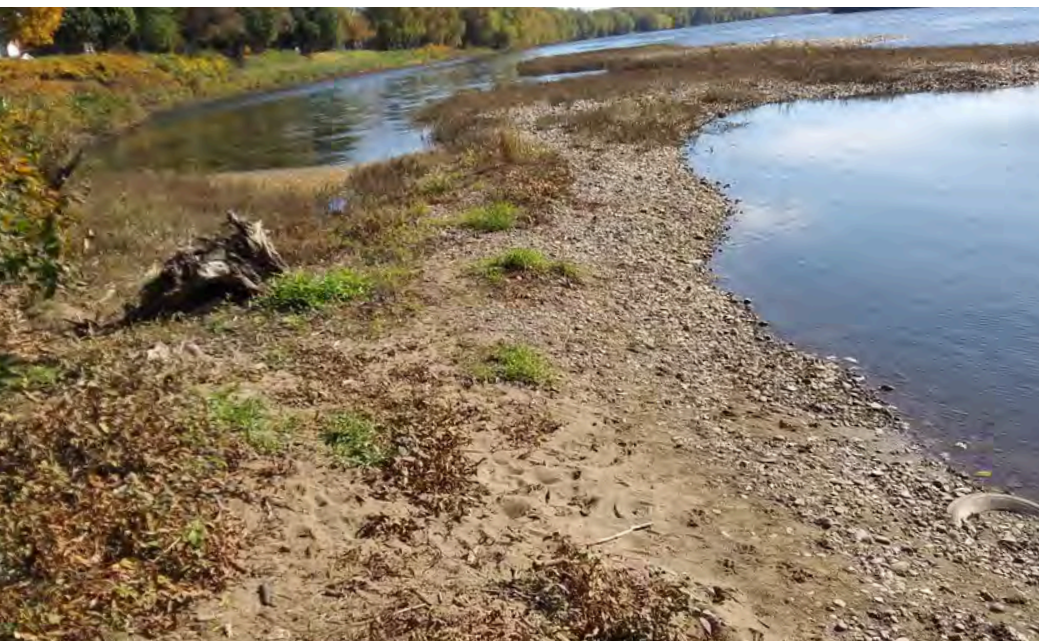
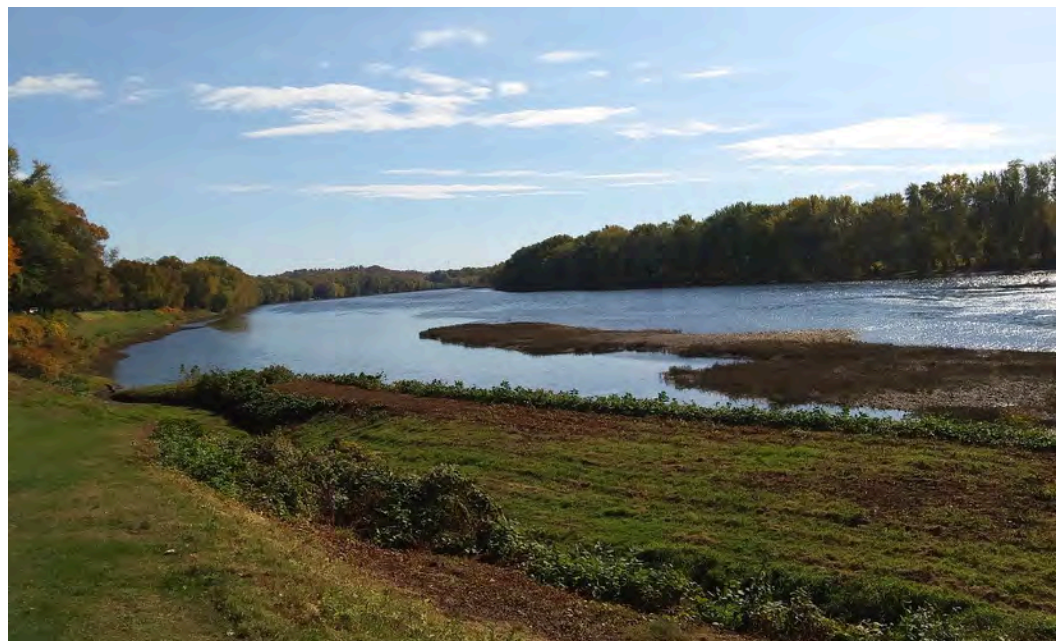
# **Watsonstown Park Boat Launch or Watsonstown Borough Access**

Despite these strengths, the site's function as a water access point is limited. While accessible parking is present, required parking signage is missing and a vertical lip at the transition to the accessible route creates a barrier. Circulation throughout the site is partially supported by paved surfaces; however, there is no clearly defined or protected accessible route connecting parking to the water access area, and users may need to travel within vehicular spaces to reach the shoreline.

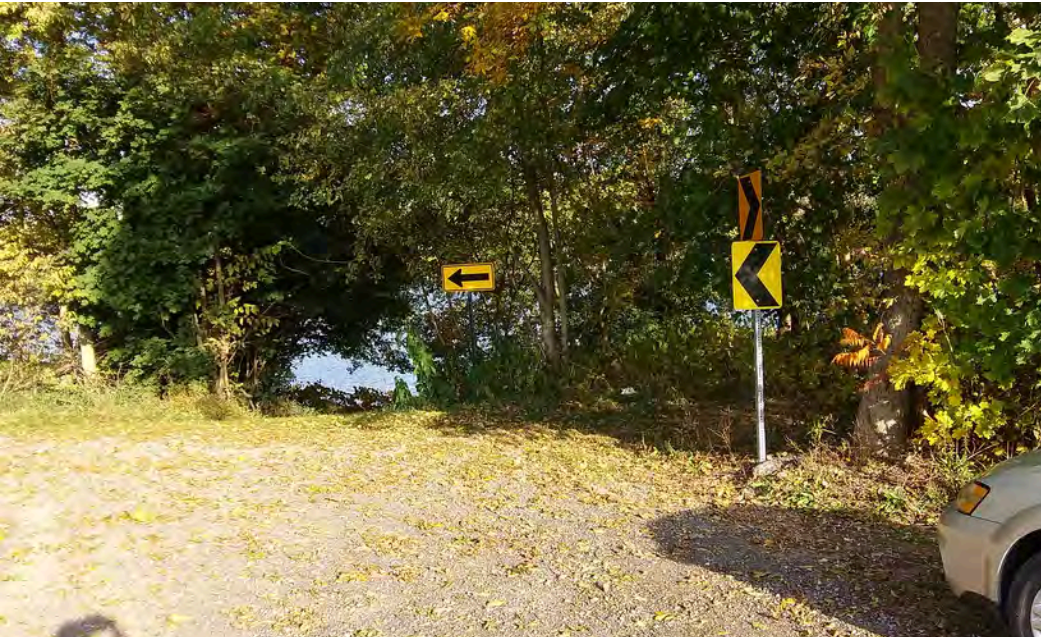
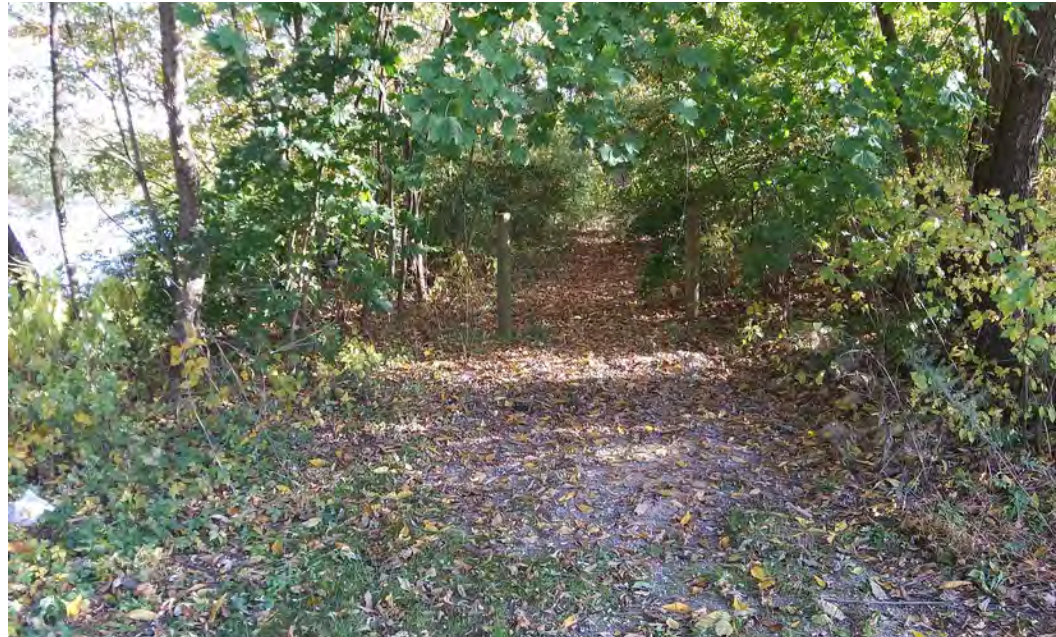
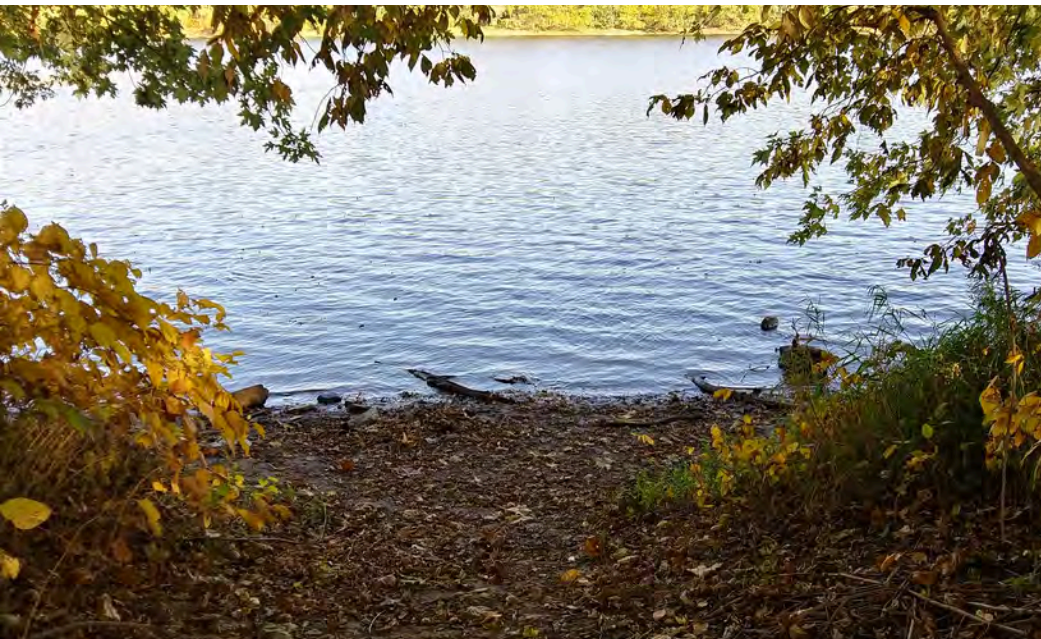
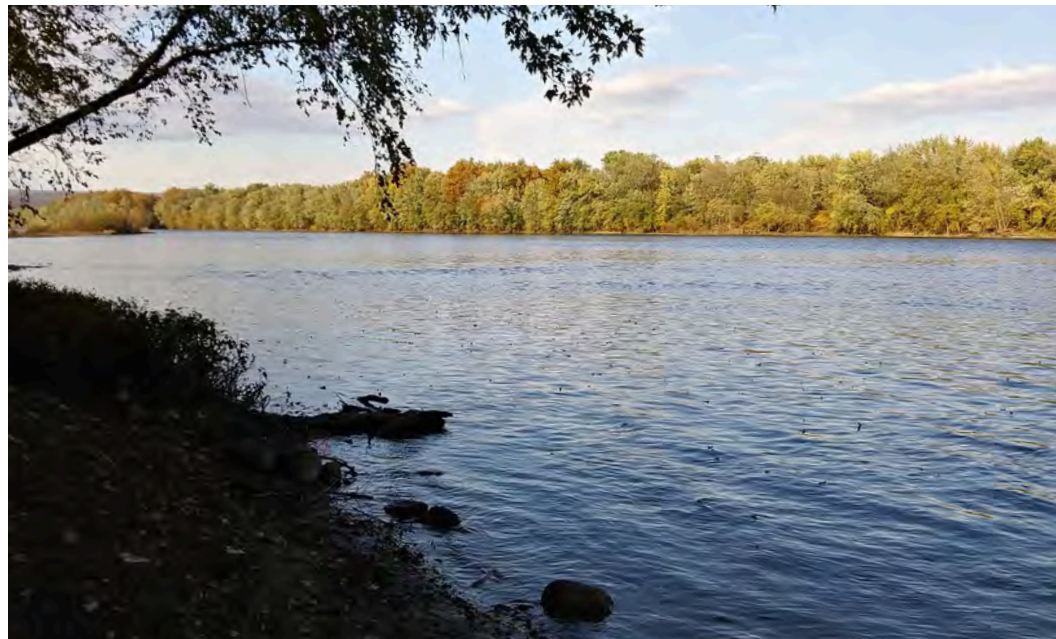
# Great Stream Commons Access

Accessibility at the site is extremely limited. There are no designated or ADA-compliant parking spaces, and users rely on an informal roadside pull-off with unstable surface conditions. No accessible route connects parking to the river, requiring travel across uneven terrain that is not firm, stable, or slip-resistant. These conditions create a fundamental barrier to site entry and circulation for individuals with mobility impairments.

Water access is similarly constrained by the absence of a formal launch structure. The existing entry consists of a steep, narrow, and deteriorated slope with a surface of dirt and residual materials. The shoreline is rocky, muddy, and uneven, with vegetation and debris present, including broken glass. These conditions do not meet accessibility guidelines and present both usability and safety concerns, limiting independent access to the water.

Targeted improvements focused on establishing defined parking, creating a stable and continuous accessible route, and stabilizing the launch area would provide meaningful initial progress. With comprehensive and coordinated upgrades, the site has strong potential to evolve into a functional and more inclusive access point while maintaining its natural character. In the short term, nearby launches such as the PFBC Montgomery Access upriver and the PFBC Watontown downriver offer more accessible options.

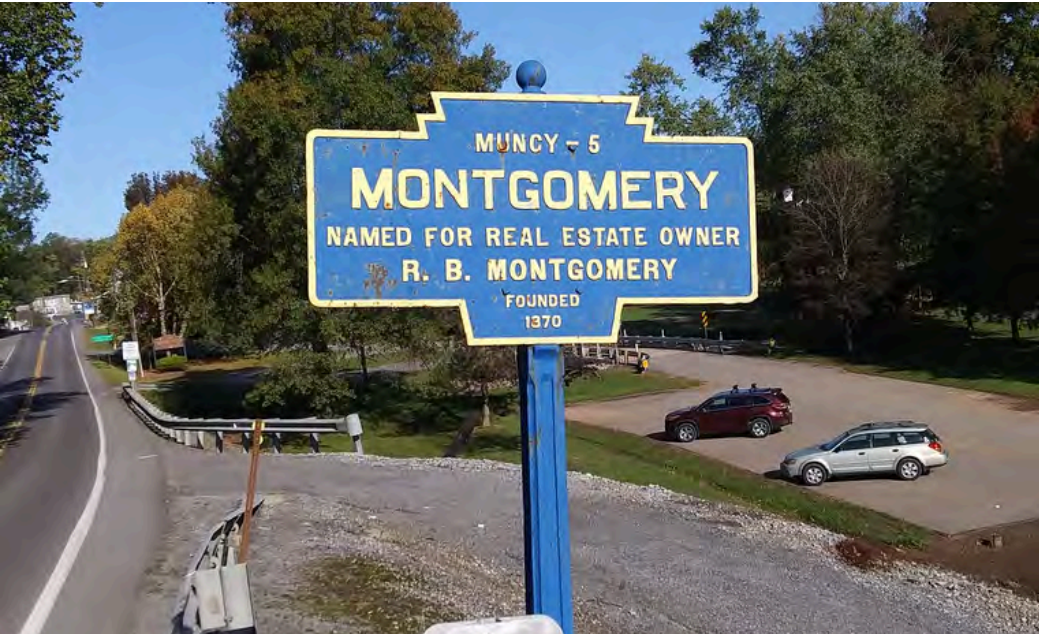
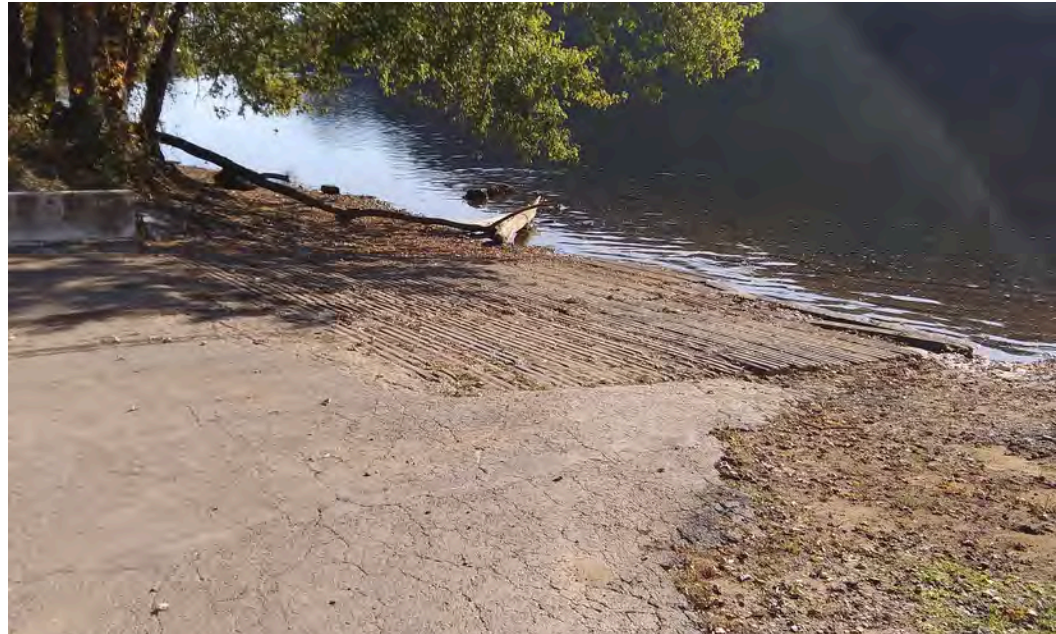
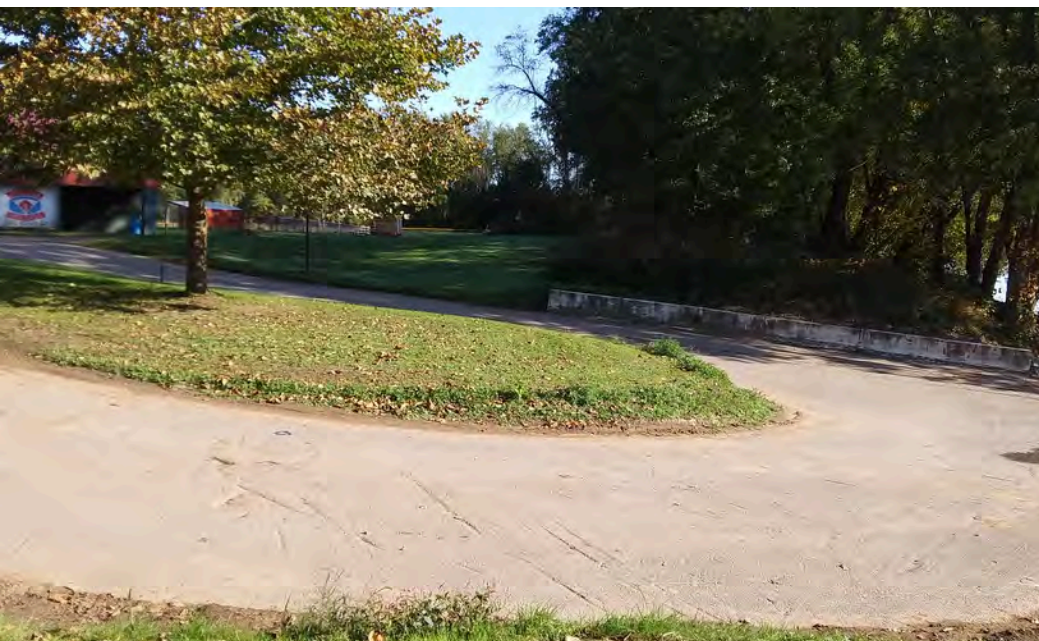
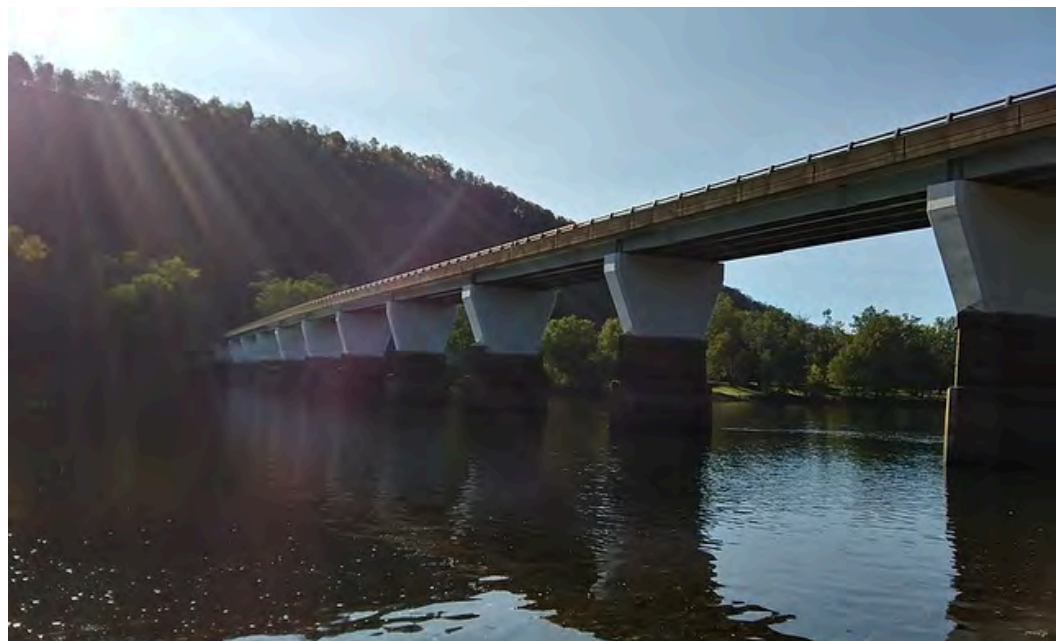
# Montgomery Borough Access or PFBC Montgomery Access

PFBC Montgomery Access is a moderately developed river access site that provides a functional connection to the Susquehanna River within a broader park setting. The site includes a paved parking area, a wide concrete boat ramp, and both seasonal and permanent restroom facilities nearby. Gentle grades and a broad paved roadway support general circulation and create a foundation for accessible use; however, accessibility is limited by the lack of formal designation and incomplete connections between site elements.

The boat ramp is structurally sound and notably wide, supporting a range of users. However, it is a medium slope, and the absence of boarding infrastructure limits independent water access. Shoreline conditions, consisting of rocky and vegetated surfaces, may further reduce stability for users entering the water.

Wayfinding and signage are present but primarily informational, with no clear identification of accessible parking, routes, or site features. As a result, users may have difficulty locating accessible elements or understanding circulation patterns within the site.

Overall, PFBC Montgomery Access offers a well-maintained and functional access point with several characteristics that could support accessible use. However, the absence of designated accessible parking, incomplete route connectivity, and lack of boarding infrastructure limit full accessibility. Focused improvements to parking designation, route definition, and connections to amenities would significantly enhance usability. With incremental upgrades, the site has strong potential to provide more inclusive access while maintaining its existing role and character.

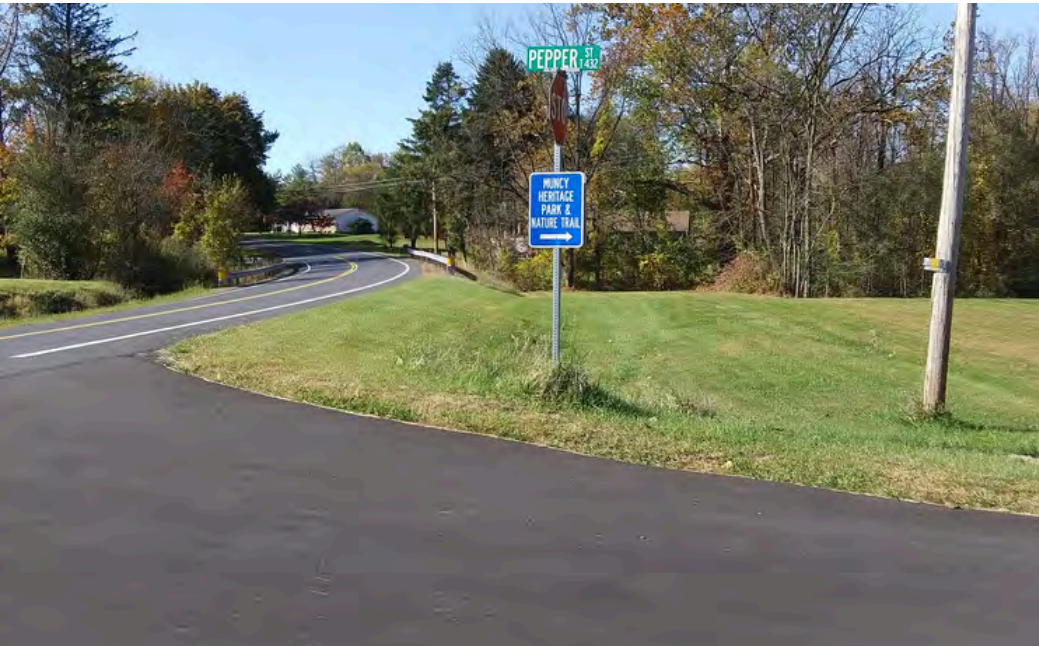
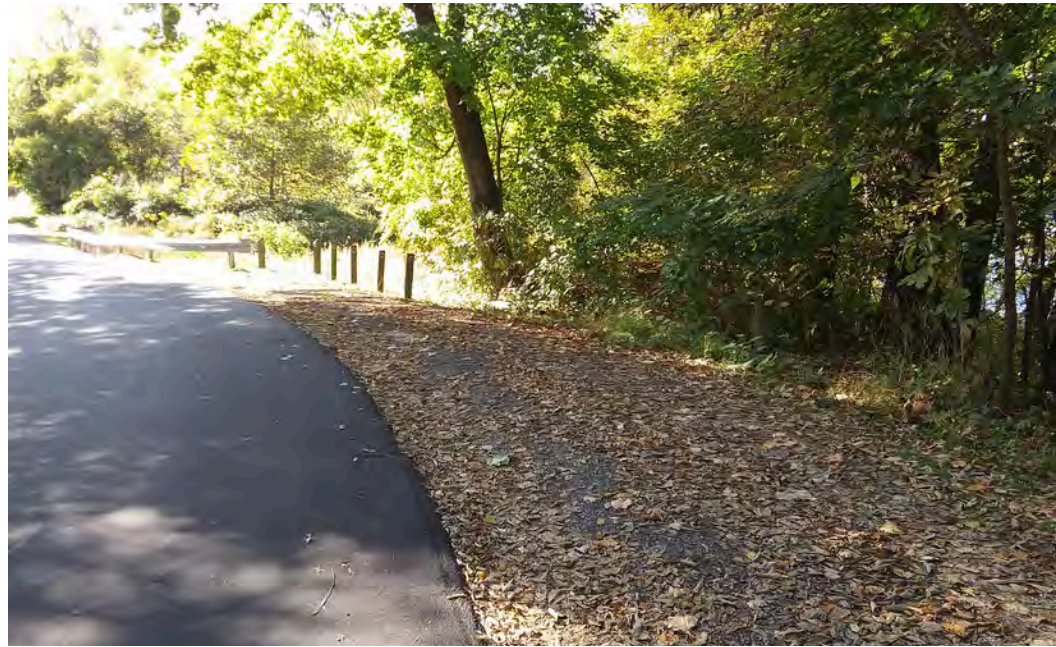
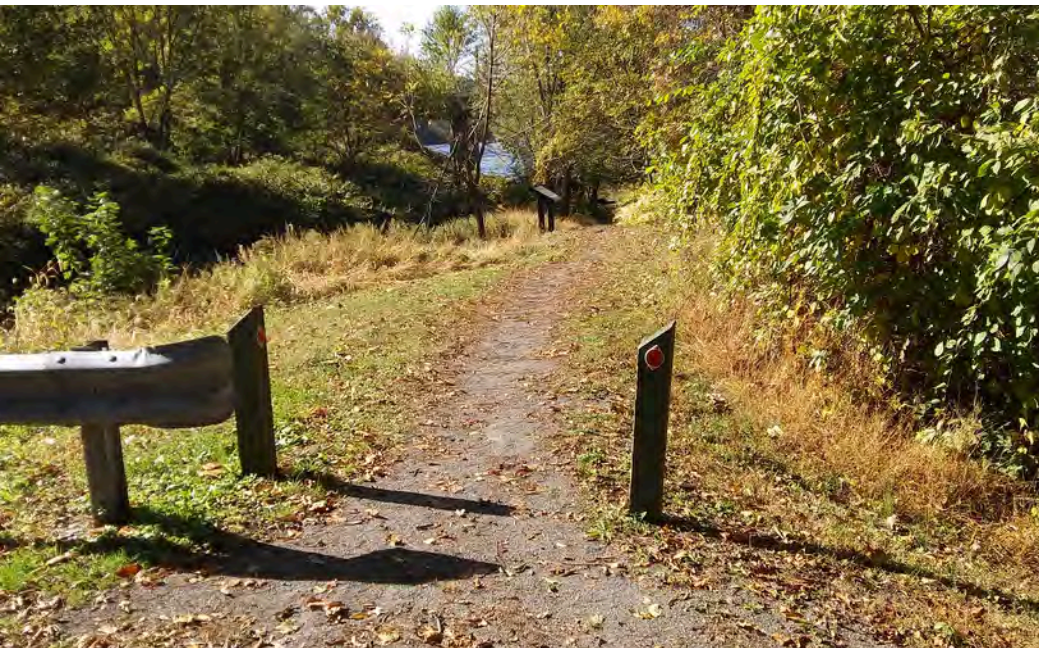
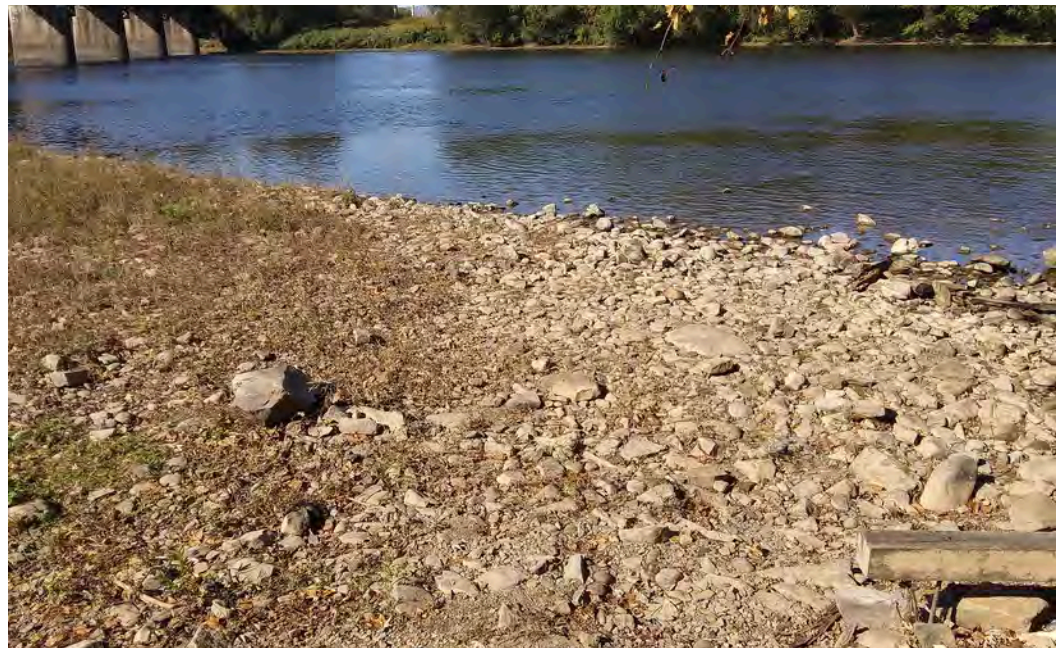
# Muncy Heritage Park River Access & Canoe Launch

Muncy Heritage Park Access functions as an informal shoreline access point within a historic park setting along the Susquehanna River. The site consists of a roadside pull-off and a short but steep descent to the riverbank via steps and mixed natural surfaces. While the surrounding park includes some amenities, these features are separated from the access point and are not connected by an accessible route. As a result, the site operates more as a passive viewing and shoreline area than a developed water access facility.

Accessibility at the site is extremely limited. There is no designated or ADA-compliant parking at the access point, and the primary route to the river relies entirely on steps and uneven terrain with no alternative accessible path. These conditions prevent independent access for individuals with mobility impairments and do not meet ADA standards for accessible routes. The distance and separation between the access point and the main park's parking area further reduce usability.

Water entry is informal and constrained by natural conditions. The shoreline consists of rocky, uneven terrain with shallow water, light vegetation, and exposed stones, particularly near nearby bridge structures. The absence of a defined launch or stabilized surface significantly limits the site's suitability for watercraft use and reinforces its function as a shoreline access point rather than a launch facility.

Amenities at the access point are minimal, with no restroom facilities or supporting infrastructure directly available. Although the adjacent park contains some features, the lack of accessible connections prevents these from effectively supporting use of the river access area. Wayfinding is also limited, with no signage identifying the access point or providing guidance on site conditions or accessible features. This lack of information further reduces usability and awareness for potential users.

Overall, Muncy Heritage Park Access provides a basic, informal connection to the river but lacks the infrastructure necessary to support accessible use. Significant barriers—including the absence of accessible parking, reliance on steps, and unstable shoreline conditions—limit functionality.

| PRIORITY | IMPROVEMENT | DESCRIPTION / NOTES |
|---|---|---|
| | Install railing on route to shoreline | Construct a railing to allow for better access along path to shoreline while maintaining the rustic nature of the site |
| | Stabilize shoreline access area | Improve grading and surface conditions at the river edge to enhance safety and usability. |
| | Install temporary signage | Add interim signage to identify the access point and communicate site conditions. |

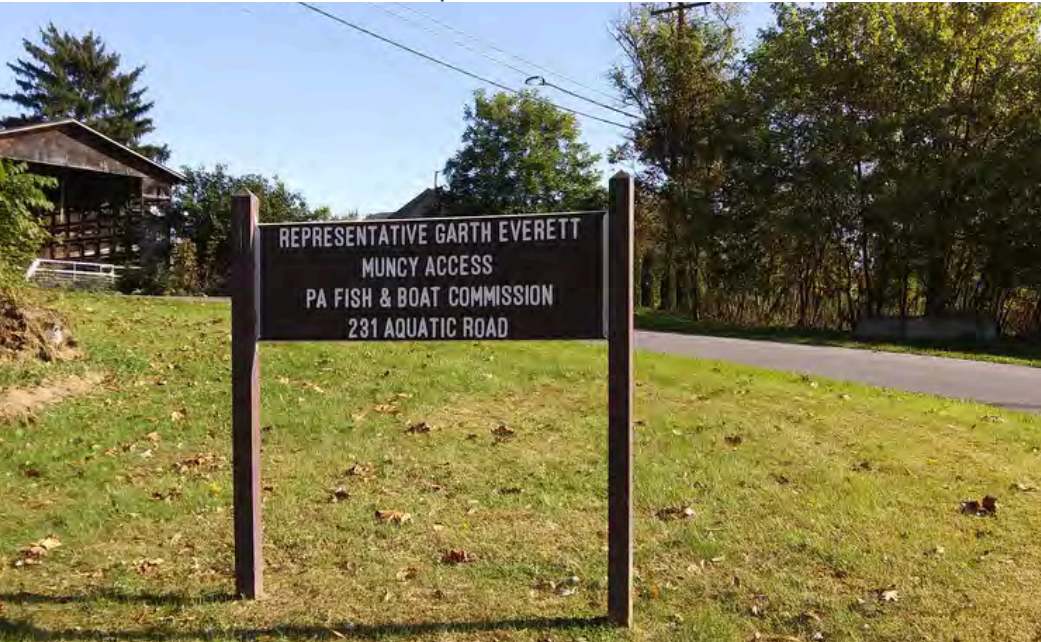
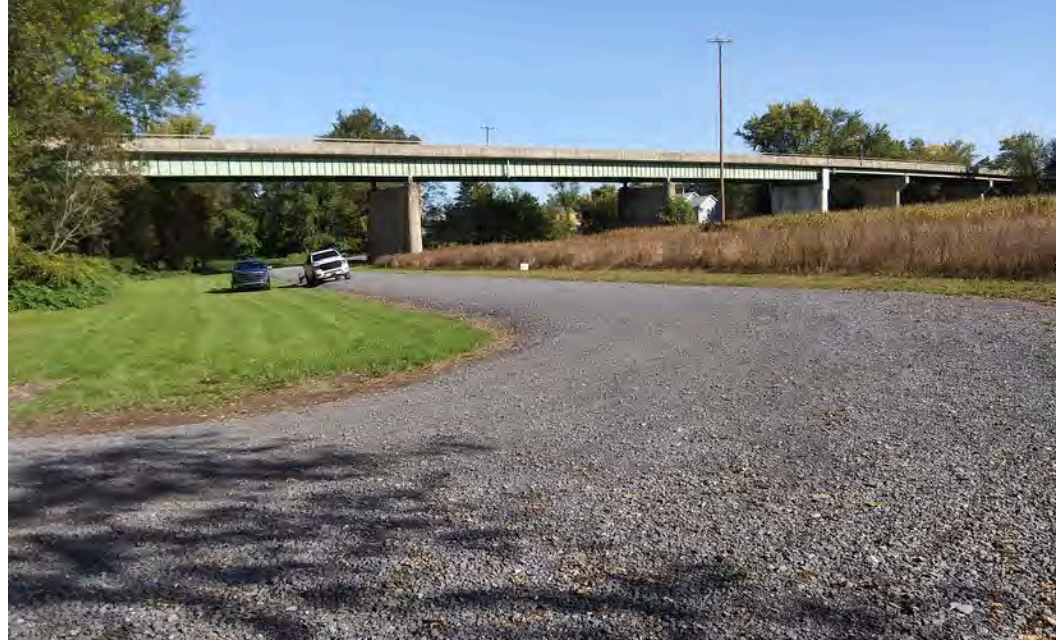
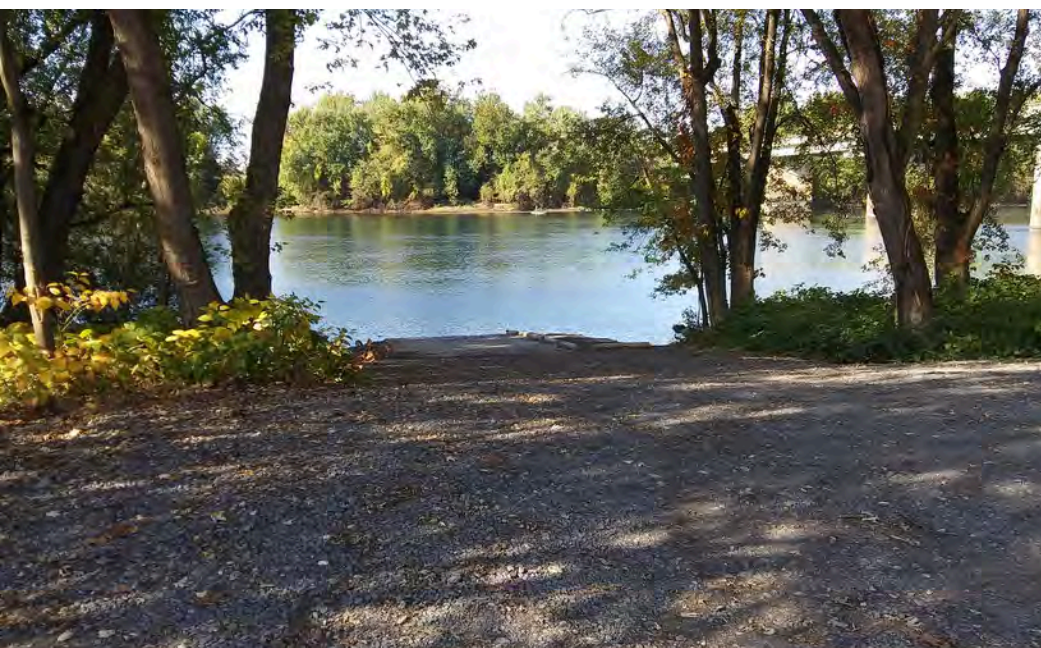
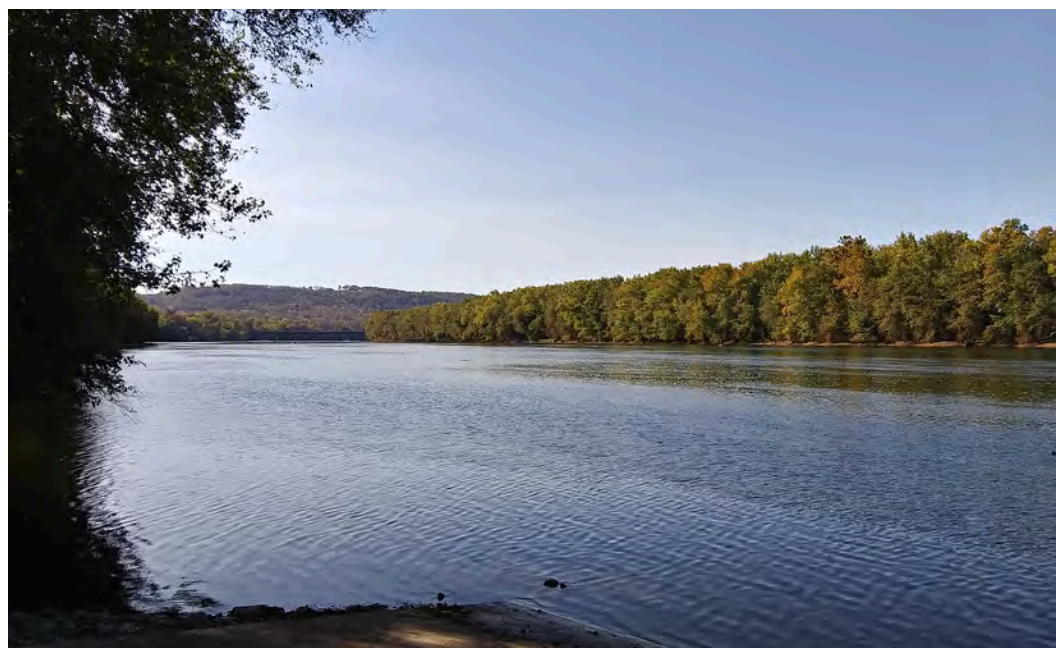
# PFBC Muncy - Representative Garth Everett Boat Launch

PFBC Muncy Access is a river access site characterized by a split configuration between an older, closed launch and a newer, active ramp located approximately 600 feet away. While the newer ramp provides improved and reliable water access, site infrastructure has not been updated to reflect this transition. As a result, parking, circulation, and accessibility features remain oriented toward the former launch area, creating a disconnected and inefficient site layout.

Circulation between site elements is a primary limitation. The route from the paved parking area to the active ramp exceeds 600 feet and follows a washboard gravel roadway with no defined pedestrian path. Surfaces are uneven and unstable, and there is no protected or continuous accessible route. These conditions significantly restrict safe movement and limit usability for individuals with mobility impairments.

The active launch consists of a wide concrete ramp with a moderately steep slope and favorable water conditions, including shallow, slow-moving flow and an open shoreline. While the ramp supports general boating use, the absence of boarding infrastructure such as a dock or transfer system limits independent access. The continued presence of the closed ramp, without clear indication of its status, contributes to confusion and detracts from overall site clarity.

Overall, PFBC Muncy Access functions as a usable launch location but is constrained by the disconnect between its active facilities and supporting infrastructure. Key barriers include non-compliant and poorly located accessible parking, lack of a defined accessible route to the new ramp, and insufficient wayfinding.

| PRIORITY | IMPROVEMENT | DESCRIPTION / NOTES |
|---|---|---|
| <b>Medium<br/>(1–3 years)</b> | Stabilize access roadway surfaces | Improve gravel roadway conditions through grading, compaction, or surfacing to enhance usability and safety. |
| | Improve visibility of existing signage | Adjust placement and condition of current signs to enhance readability and awareness. |

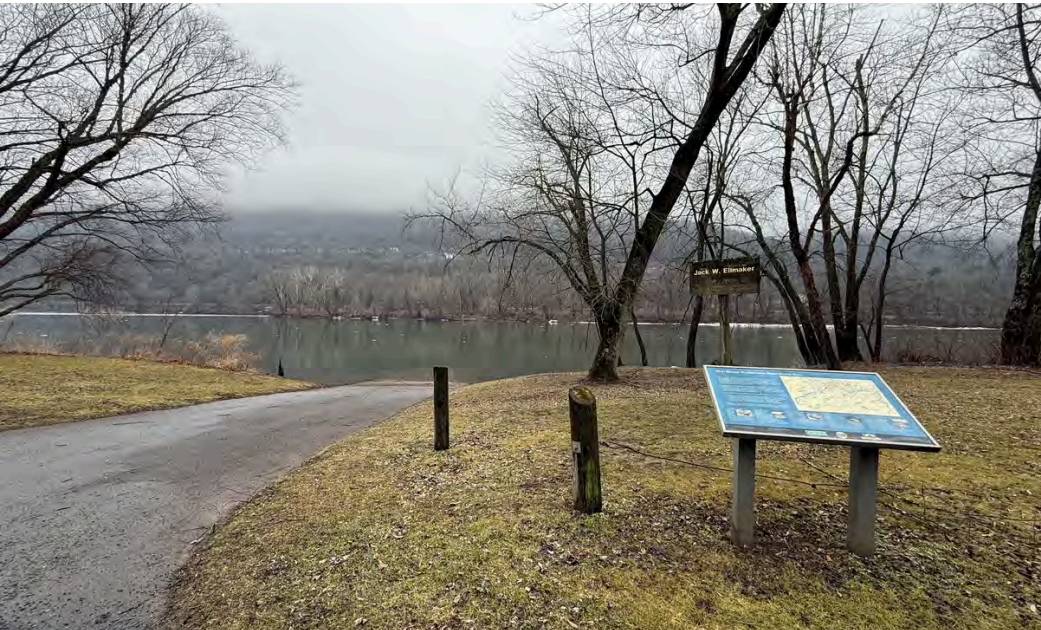
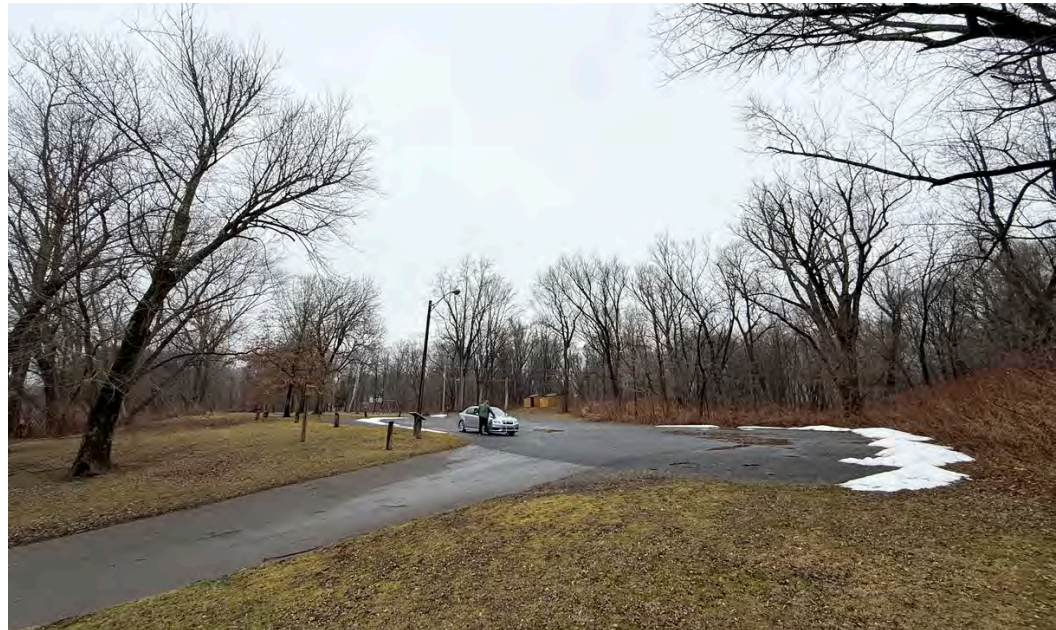
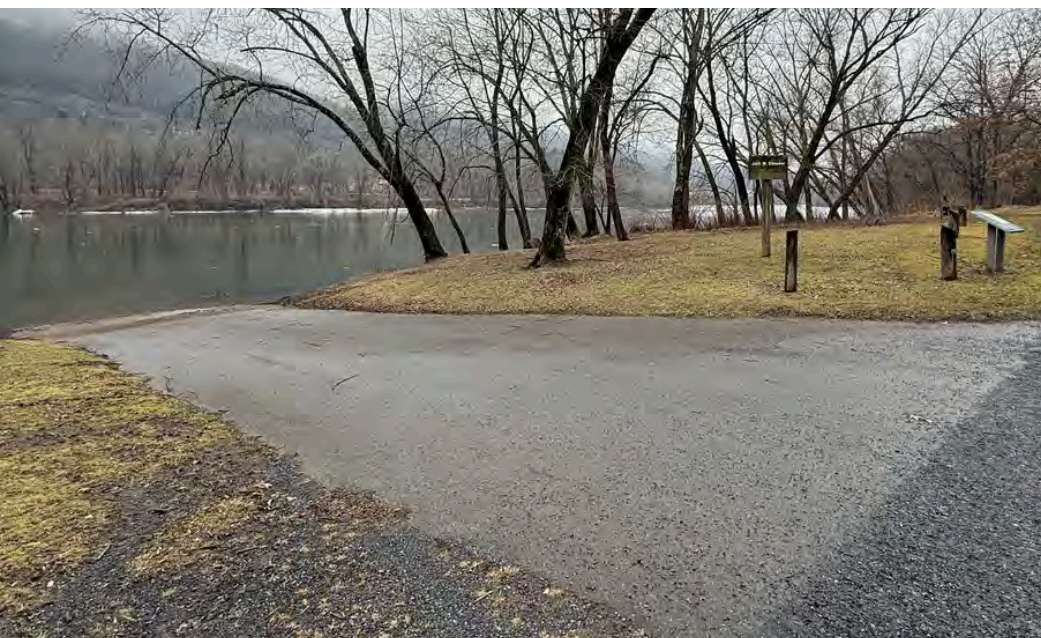
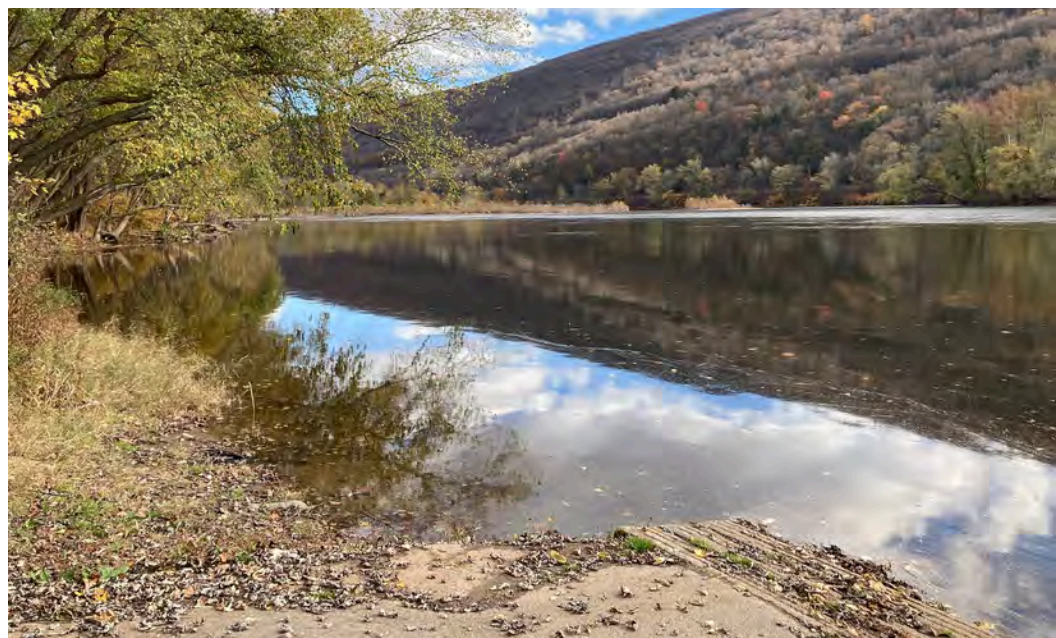
# Mill Street Boat Launch

Montoursville's Mill Street Boat Launch is a municipal river launch that provides basic access to the West Branch Susquehanna River. The site includes a tarmac parking area, a concrete boat ramp, a short, paved route to the water, and limited amenities. The distance from the parking area to the ramp is approximately 34 feet, and the paved surface provides generally favorable conditions for mobility.

However, the site currently lacks several key accessibility features. No ADA-designated parking spaces, access aisles, striping, or signage are present, which represents the most significant compliance gap. While the paved route to the ramp is short and potentially accessible, the absence of compliant parking prevents a fully accessible path of travel. Additionally, the launch area does not include a dock, boarding pier, or adaptive kayak/canoe launch system, making independent watercraft entry difficult for users with mobility impairments.

Amenities are minimal and include picnic tables without accessible pathways and a non-ADA-compliant restroom, including the lack of an accessible path to the door. Overall, Mill Street Boat Launch currently offers limited ADA accessibility. With the addition of compliant parking infrastructure and potential dock or adaptive launch improvements, the site has strong potential to improve accessibility due to its compact layout and paved surfaces.

| PRIORITY | IMPROVEMENT | DESCRIPTION / NOTES |
|---|---|---|
| | Upgrade restroom facilities | Replace or retrofit portable/pit restrooms to meet ADA standards; address lack of accessible path |
| | Stabilize shoreline edge near ramp | Improve the transition area between pavement and shoreline to reduce uneven or rocky conditions. |
| | Improve pavement-to-shoreline edge condition | Conduct minor grading or stabilization where pavement meets the shoreline to improve safety and usability. |

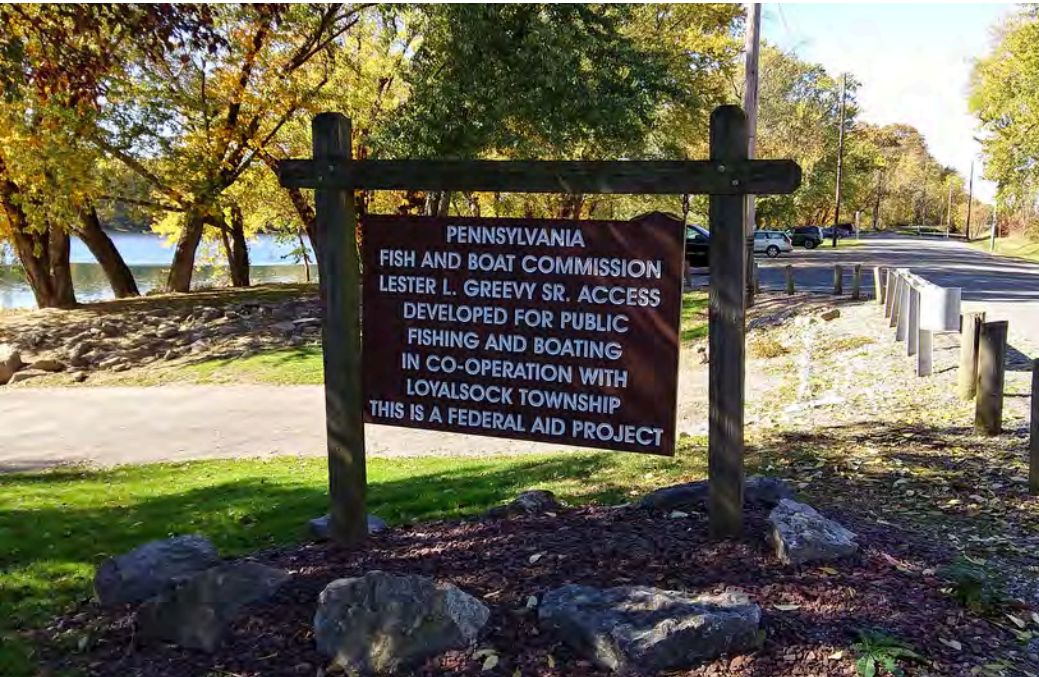
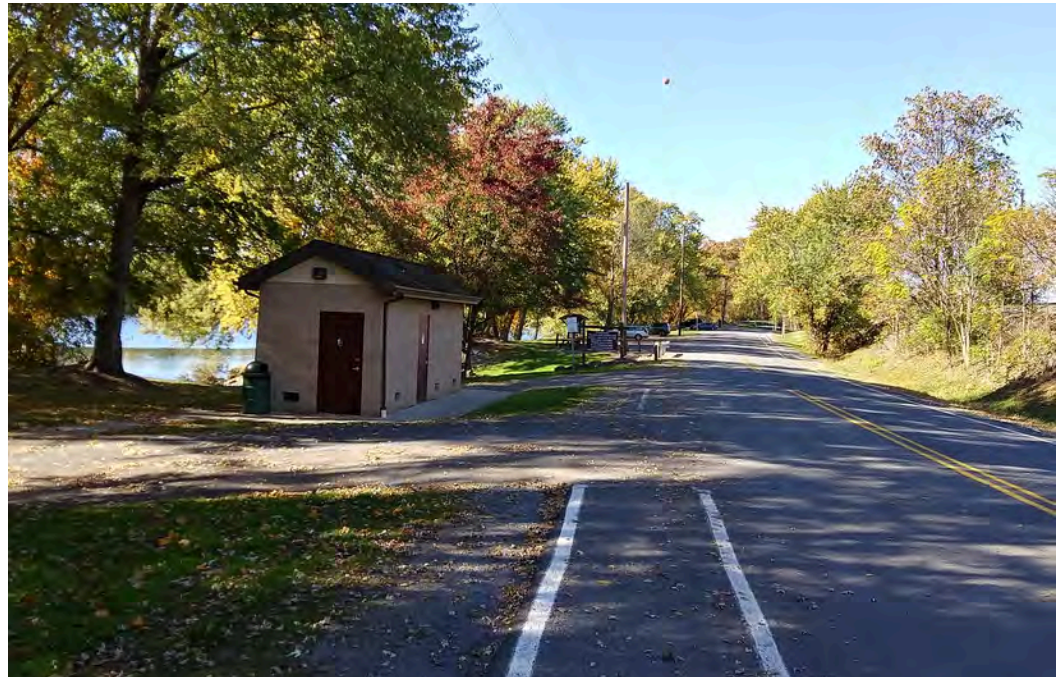
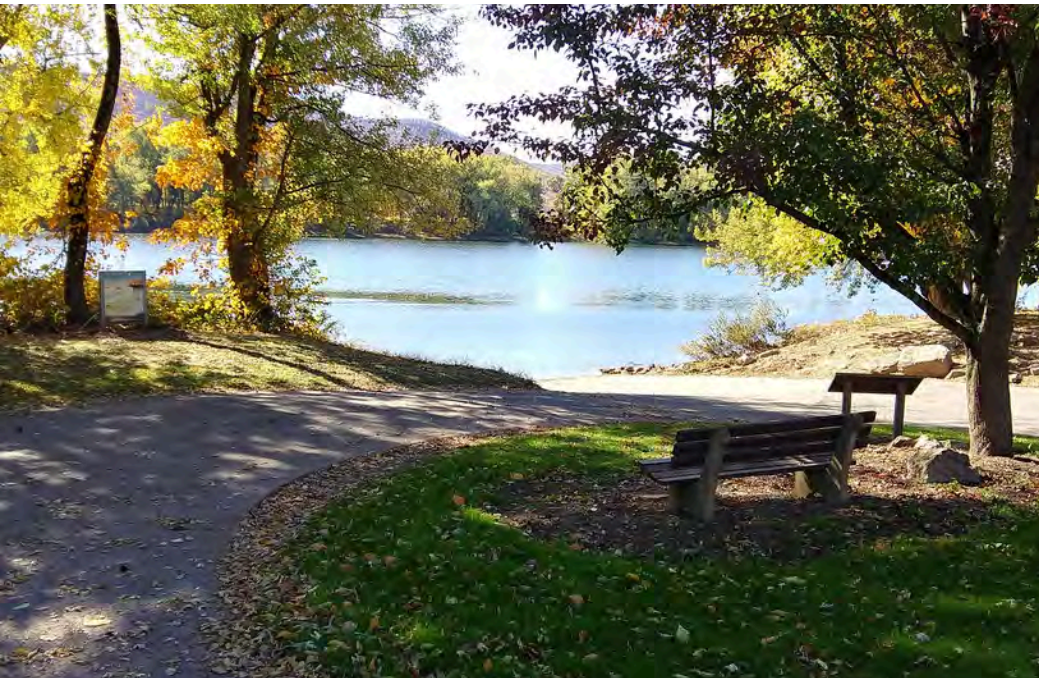
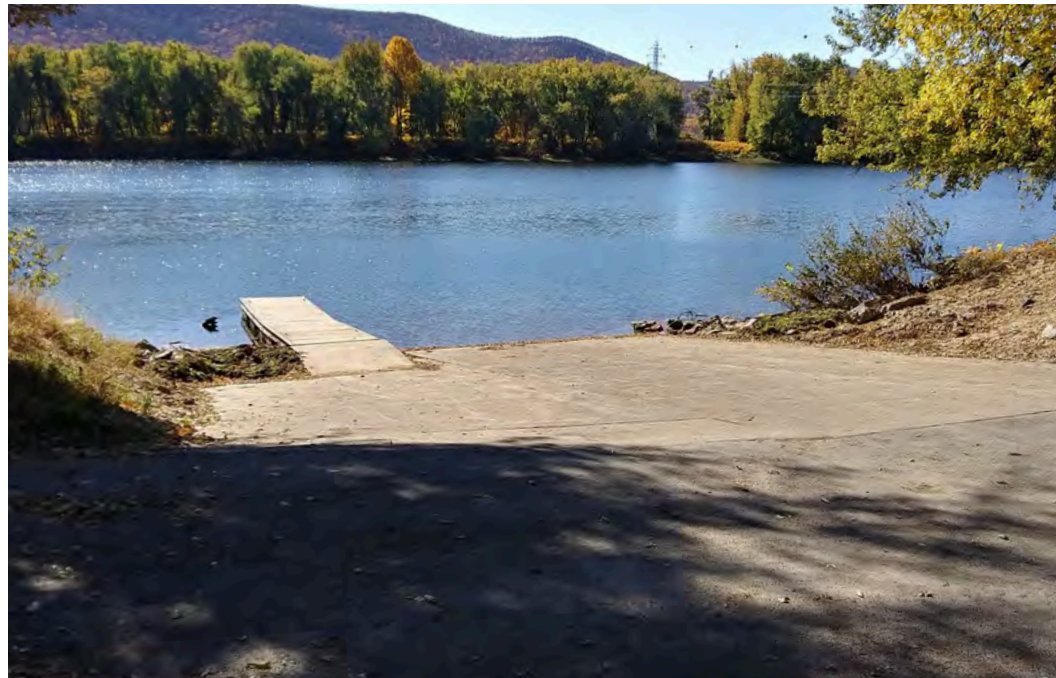
# Greevy Boat Launch

Greevy Boat Launch is a moderately developed river access. The site includes a mixed-surface parking area, separate motorized and non-motorized concrete boat ramps, a floating dock with gangway, and a restroom facility.

No adaptive canoe/kayak launch system is present, and shoreline conditions include sand, debris, and mud.

Key barriers include incomplete ADA parking, limited dock safety features, lack of adaptive launch infrastructure, and inaccessible amenities.

Overall, Greevy Boat Launch is best characterized as moderately ADA-accessible, with targeted improvements needed to support more independent and inclusive use.

| PRIORITY | IMPROVEMENT | DESCRIPTION / NOTES |
|---|---|---|
| | Routine maintenance | Remove debris and improve surface conditions at launch area |
