PHASE I

# Lower West Branch Susquehanna River ADA and Universal Accessibility Access Study

A PROJECT OF THE SUSQUEHANNA GREENWAY PARTNERSHIP

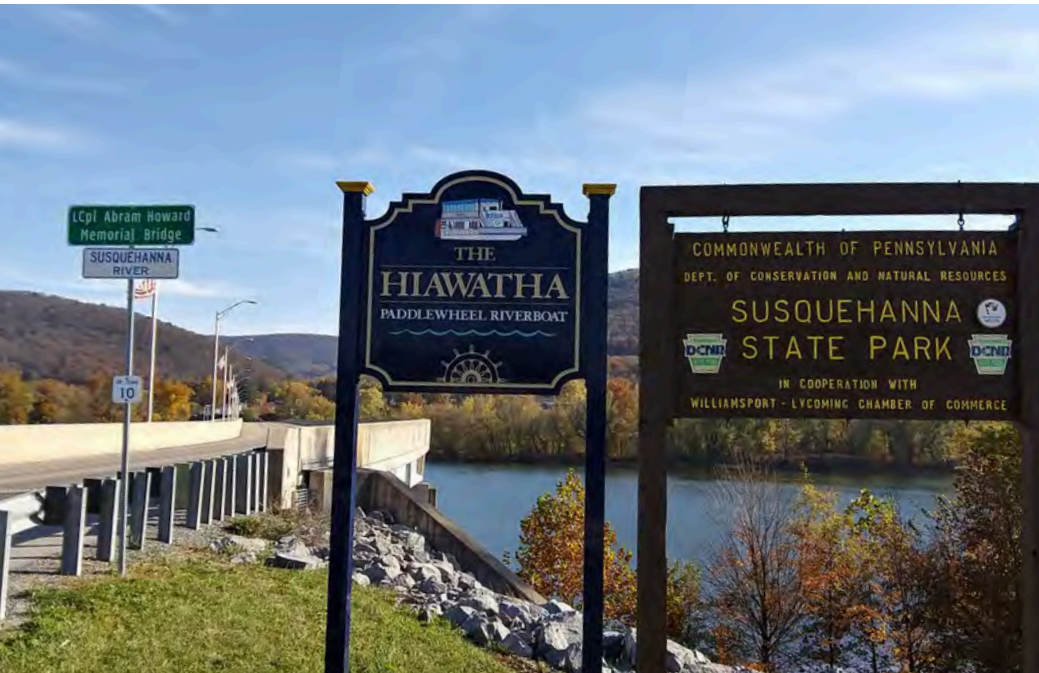
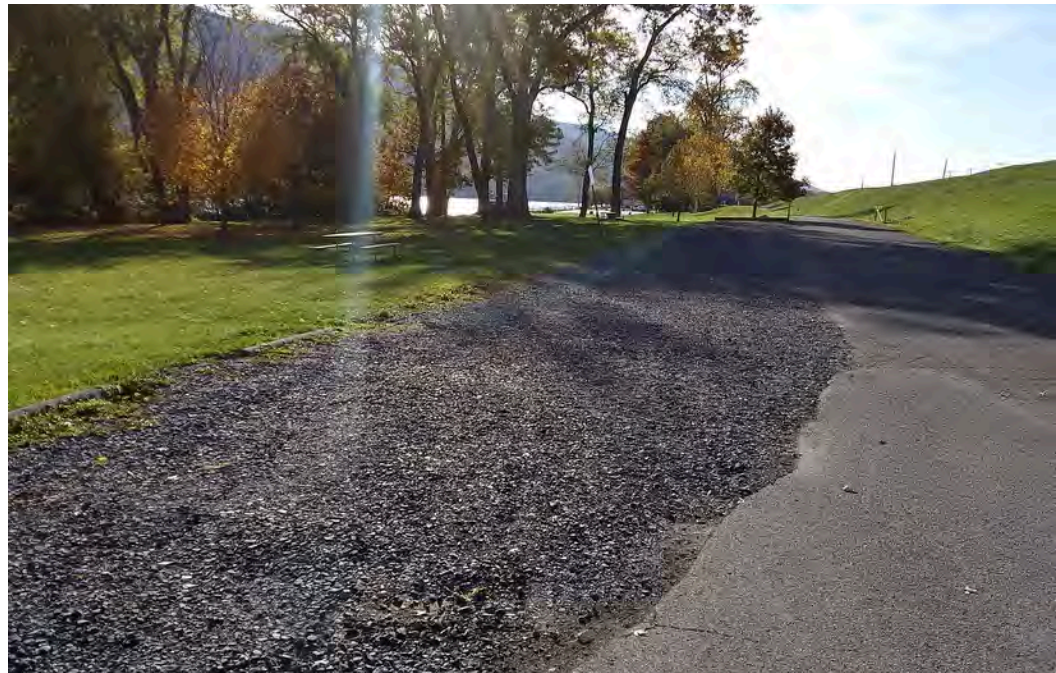
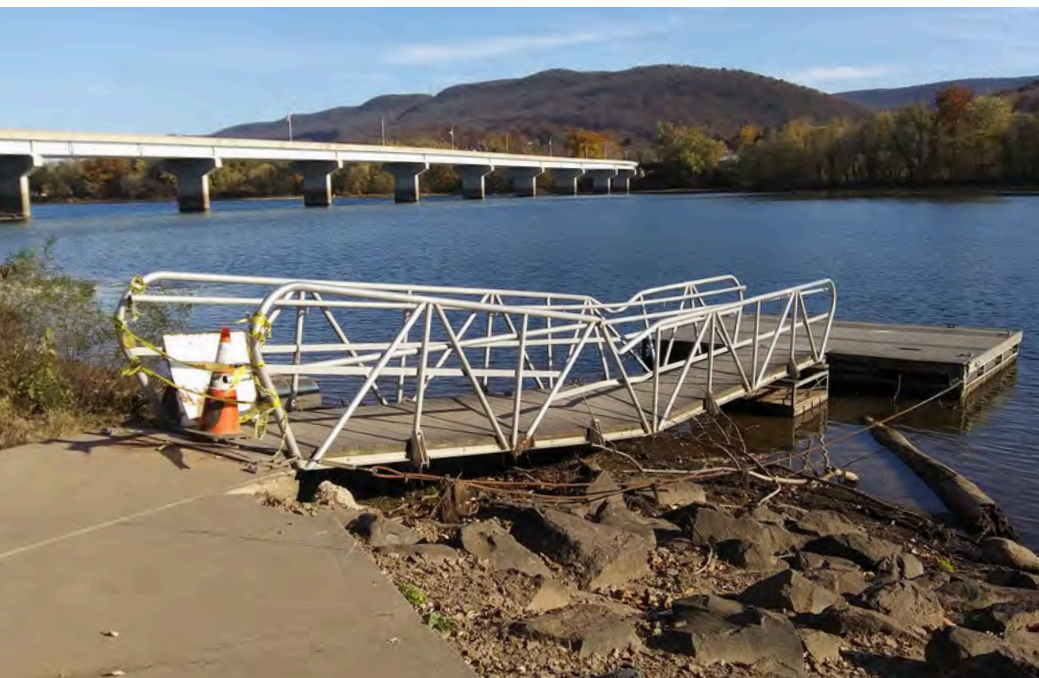
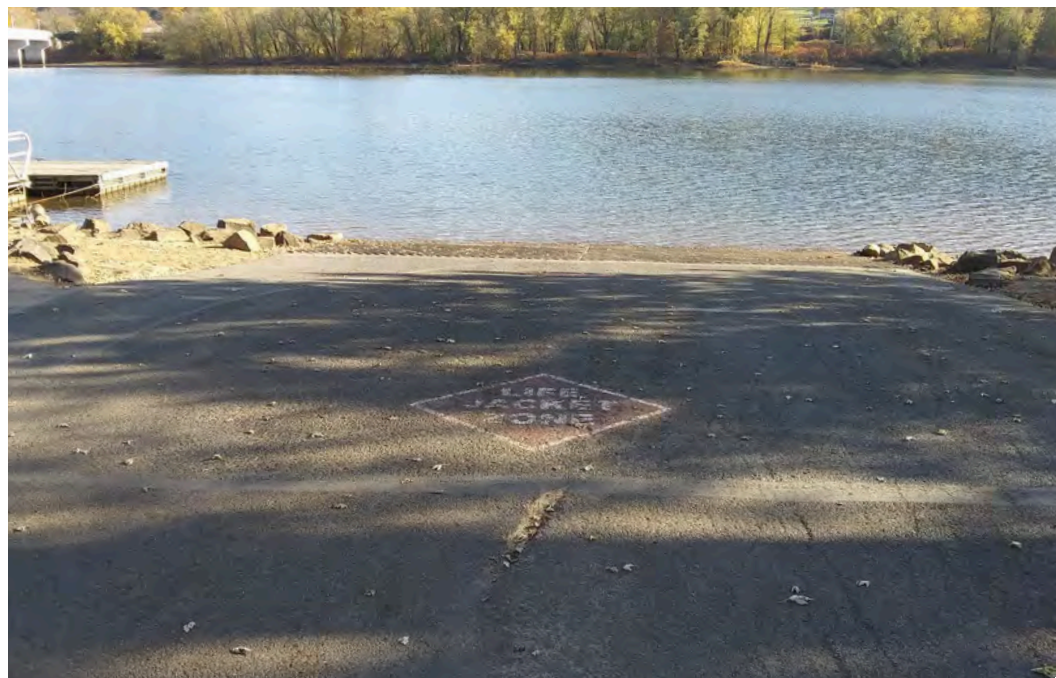
# Susquehanna State Park

Susquehanna State Park Access is a high-capacity facility that includes a paved parking lot with 20 spaces (including 2 ADA-designated spaces), an adjacent stone overflow lot with approximately 22 additional spaces, a passenger loading zone, a concrete boat ramp, floating dock with gangway, and extensive paved circulation routes. Restroom and pavilion amenities are located at the nearby Hiawatha Riverboat dock and are connected via internal park routes, though not directly adjacent to the canoe/kayak launch.

The site has a strong foundation for accessibility. Paved routes from parking to the launch are firm, stable, and within acceptable slope limits, supporting independent mobility. The dock and gangway system further enhance access to the water under normal conditions, with appropriate slopes, handrails, and transition elements.

At the launch, the boat ramp is wide but steep, and flood damage to the dock at the time of assessment limited usability. Additionally, no adaptive canoe/kayak launch system is provided, restricting independent water access.

Key barriers include excessive parking slopes, faded ADA markings, lack of van-accessible parking, limited adaptive launch infrastructure, flood-related dock limitations, and the separation of restrooms and amenities from the launch area.

Overall, Susquehanna State Park Access can be considered moderately to substantially ADA-accessible. With targeted improvements—particularly to parking compliance, dock usability, and accessible launch features—the site has strong potential to provide a more inclusive and independently accessible recreational experience.

| PRIORITY | IMPROVEMENT | DESCRIPTION / NOTES |
|---|---|---|
| | Repair flood-damaged dock infrastructure | Restore full usability of dock and gangway to support safe and accessible water entry. |
| | Provide interim shoreline stabilization near launch | Address minor edge conditions to improve safety and usability. |
| | Conduct routine maintenance checks | Regularly inspect slopes, surfaces, and infrastructure to prevent further degradation. |

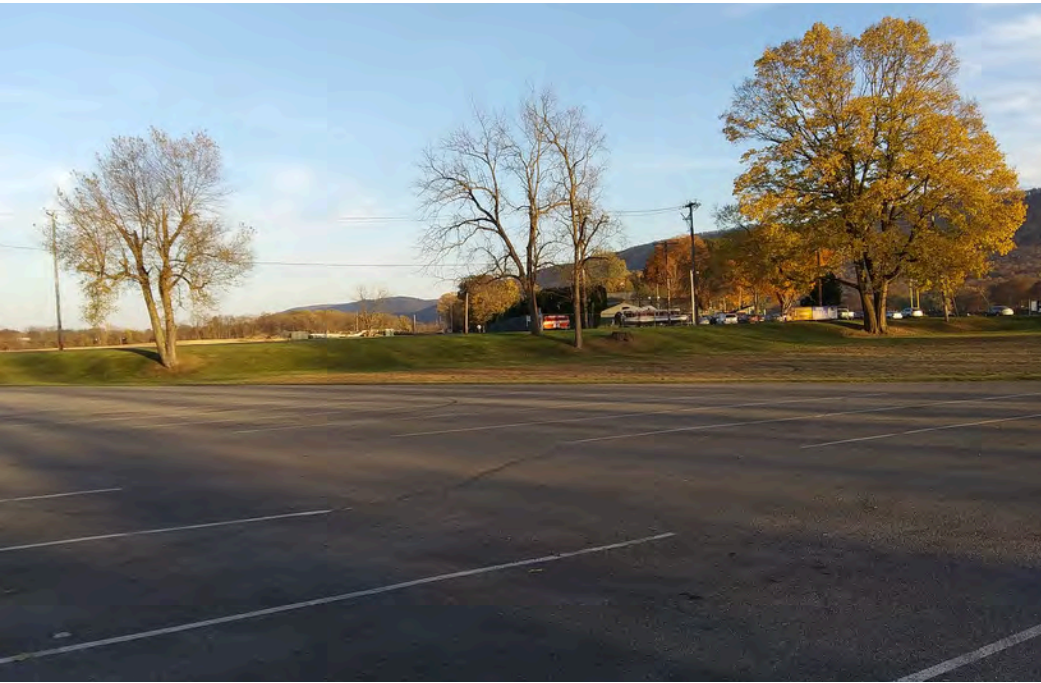
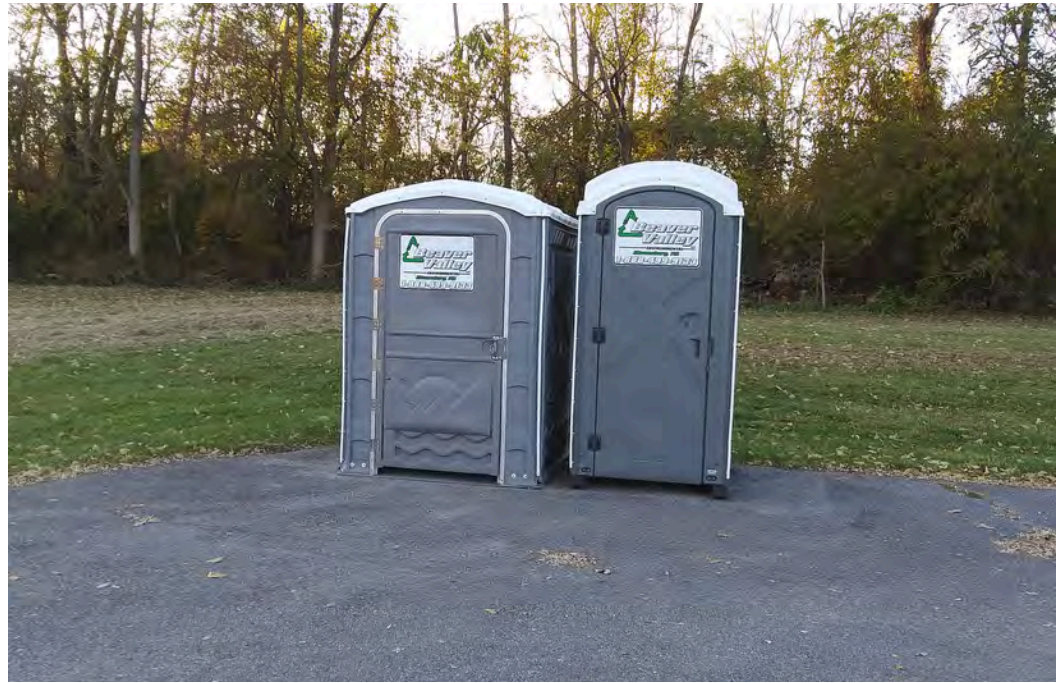
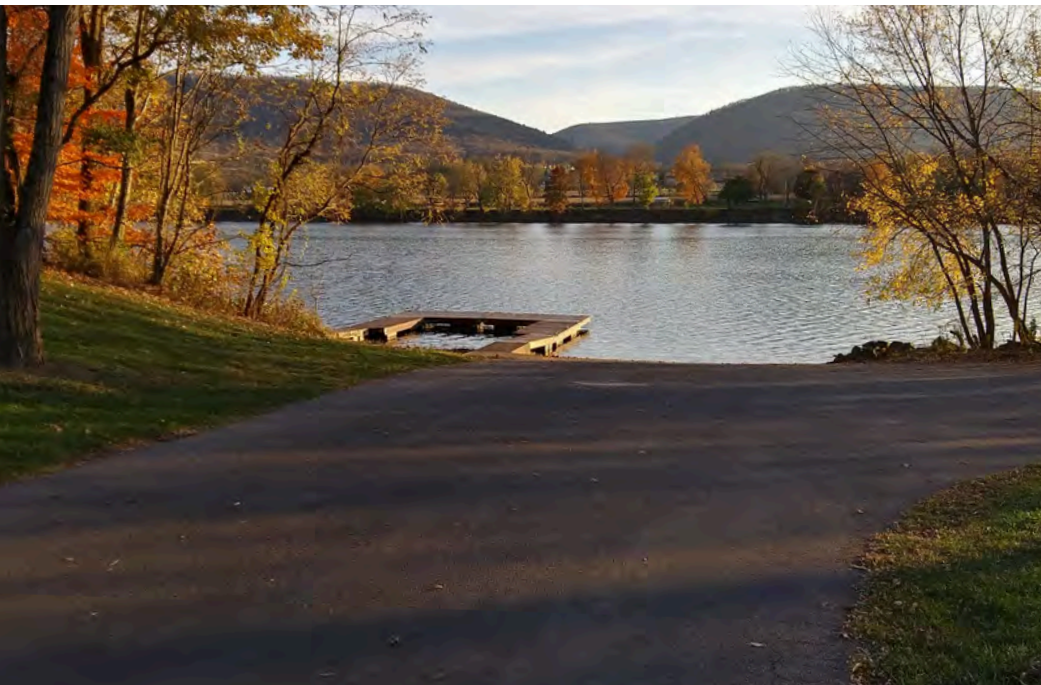
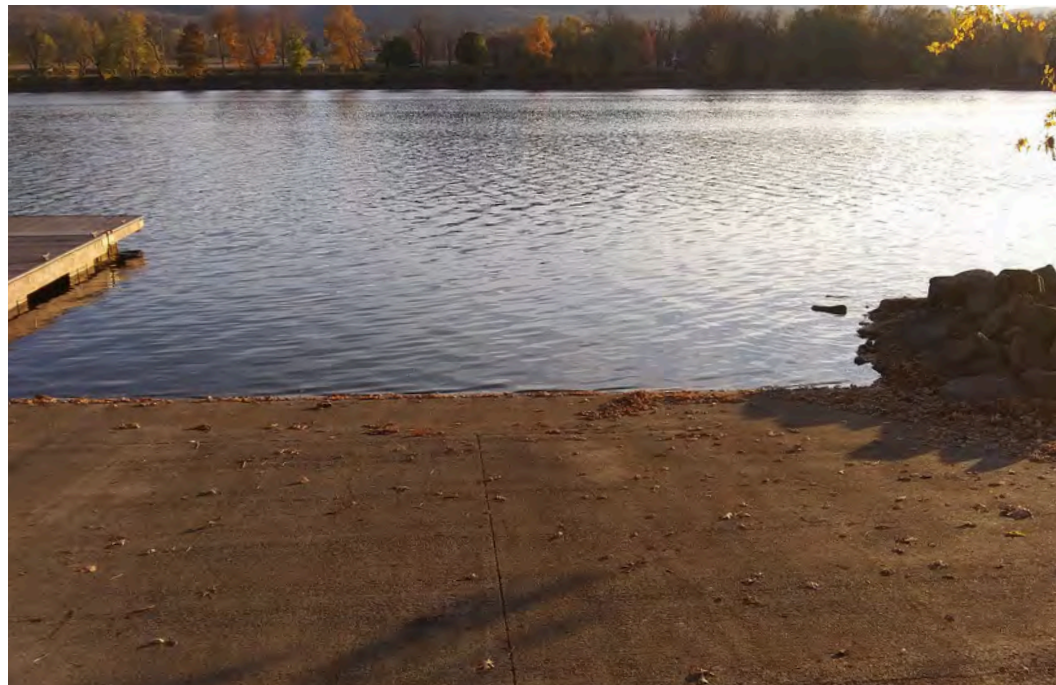
# Linden PFBC Access and Boat Ramp

PFBC Linden Access is a developed river access site that includes a paved parking lot with 47 spaces (including 2 ADA-designated spaces), a passenger loading zone, a concrete boat ramp, floating dock with gangway, and a seasonal portable restroom. It functions as a high-capacity, utilitarian launch with solid infrastructure but limited accessibility features.

At the water, the ramp and dock system provide a functional access point. The gangway slope is within acceptable limits, and the dock allows for maneuvering. However, key limitations include the absence of handrails on the gangway, a transition plate that exceeds ideal slope and lacks a landing, no adaptive canoe/kayak launch system, and debris at the water's edge that may impact safety and usability.

Parking accessibility is incomplete, as ADA spaces lack proper signage and a van-accessible designation. Restroom access is also limited, with only a seasonal portable unit that does not appear ADA-compliant and no defined accessible route.

Overall, PFBC Linden Access can be considered moderately ADA-accessible. Targeted improvements—particularly to water access infrastructure, parking signage, and restroom accommodations—would significantly enhance accessibility and support more inclusive use.

| PRIORITY | IMPROVEMENT | DESCRIPTION / NOTES |
|---|---|---|
| | Upgrade restroom to ADA-compliant unit | Replace or retrofit portable restroom to meet ADA standards |
| | Routine maintenance program | Address debris, surface conditions, and minor hazards regularly |

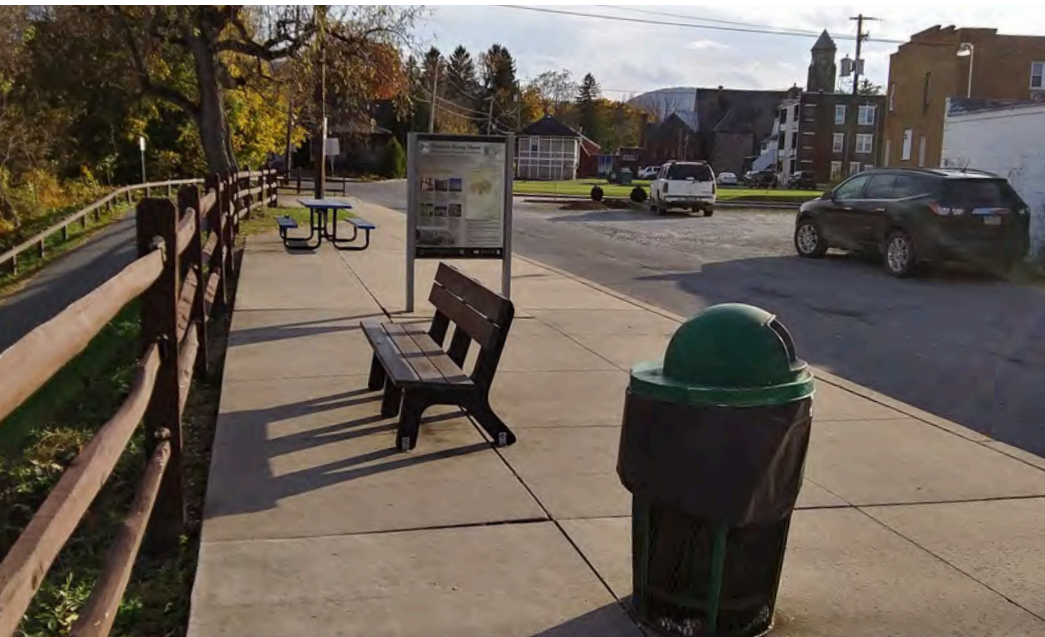
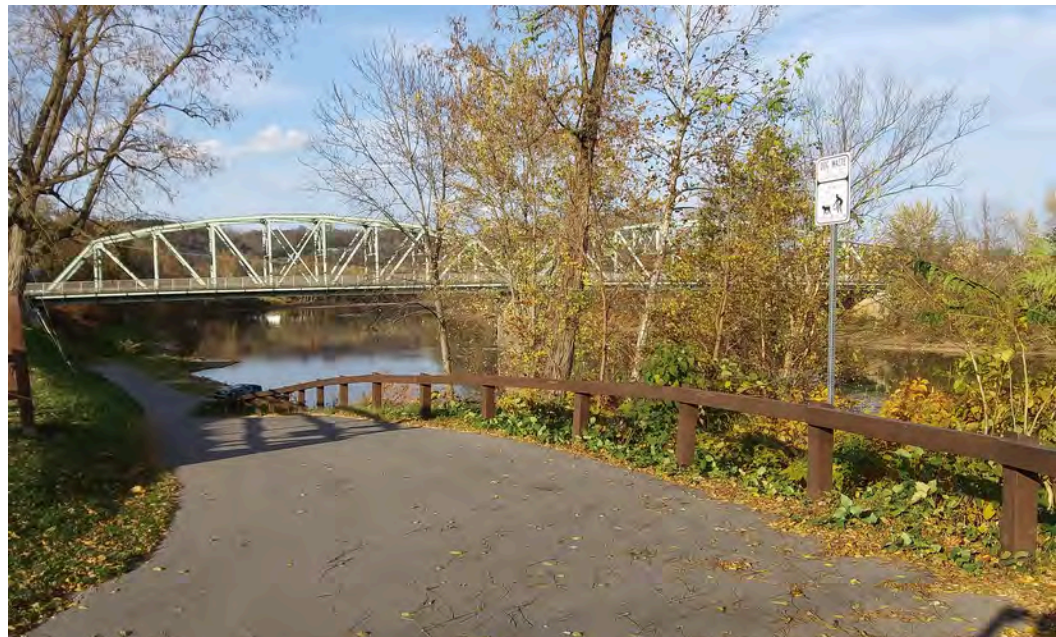
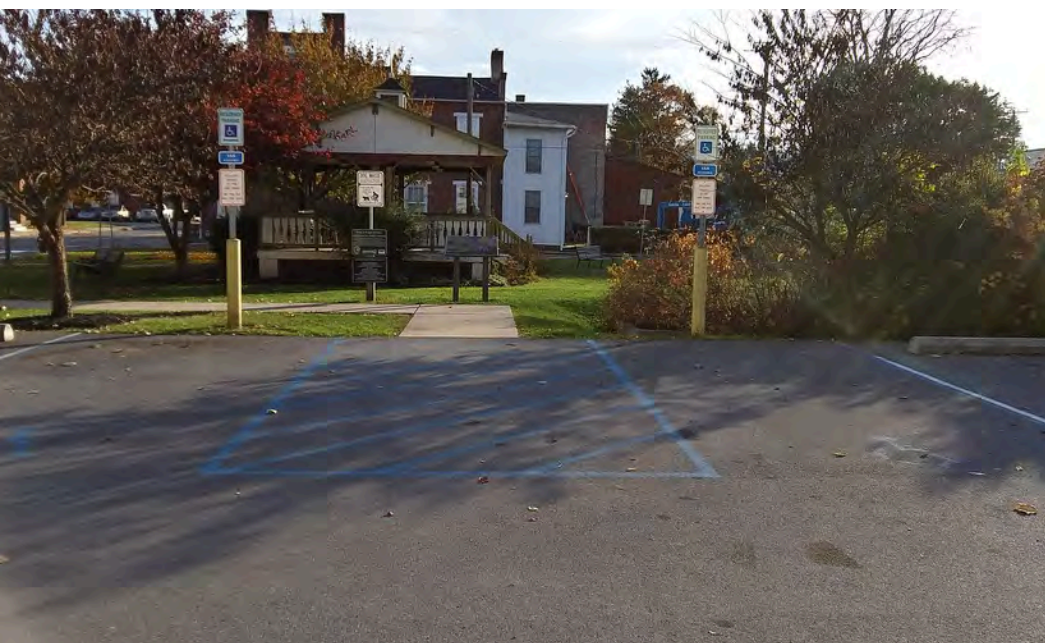
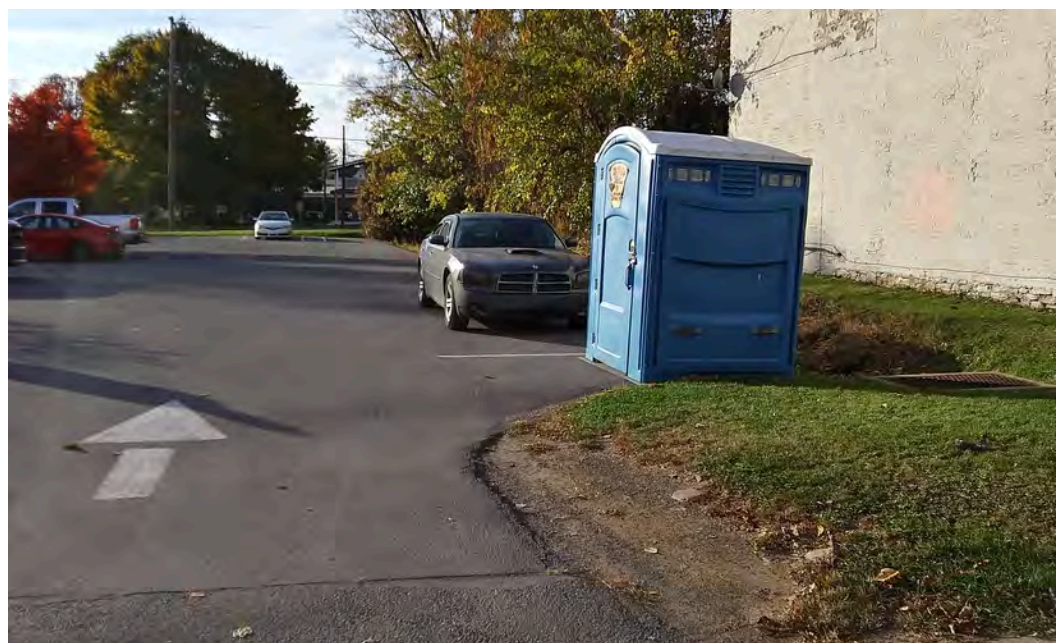
# Jersey Shore Public River Access

Jersey Shore Public River Access is a moderately developed municipal river access featuring a paved launch area, concrete boat ramp, floating dock, and multiple parking areas. While the site includes several accessibility elements, its layout and infrastructure create notable challenges for consistent and independent use.

Key barriers include the distribution and location of ADA parking, lack of accessible restroom access, steep ramp conditions, and absence of adaptive launch infrastructure.

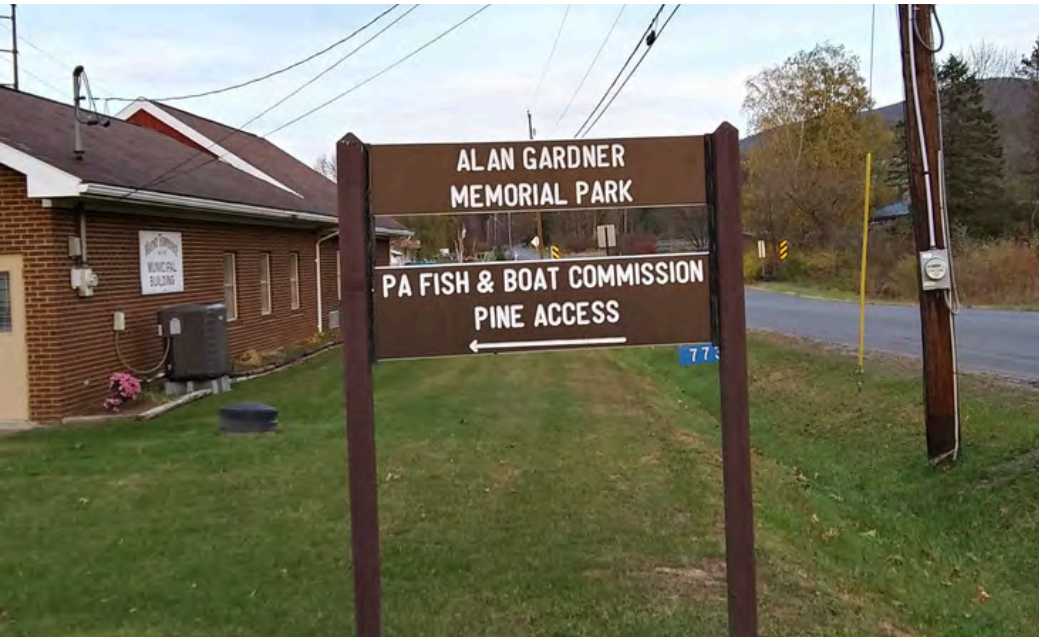
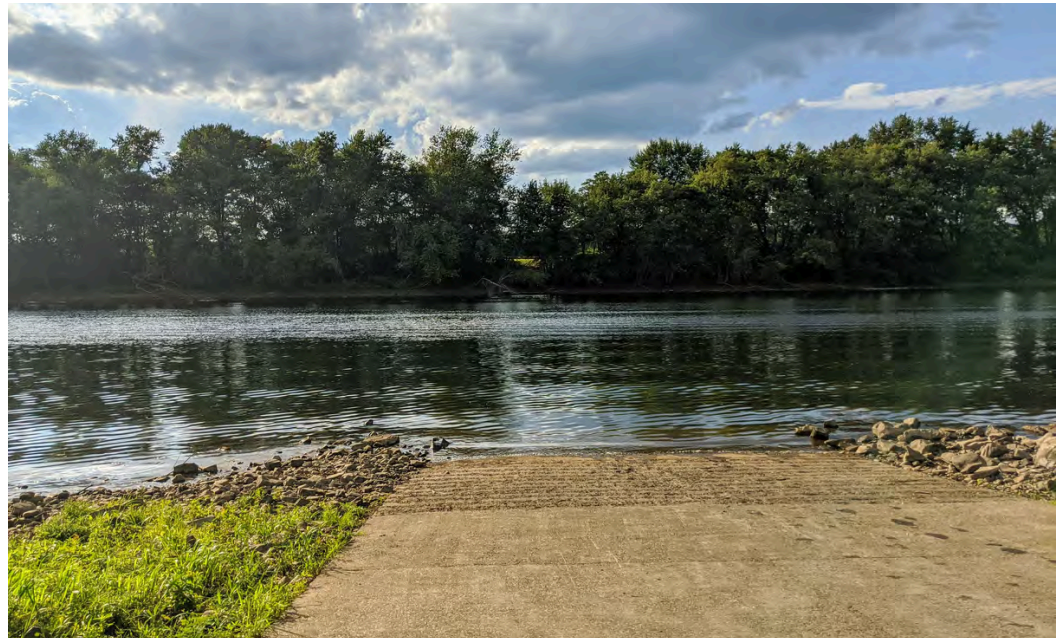
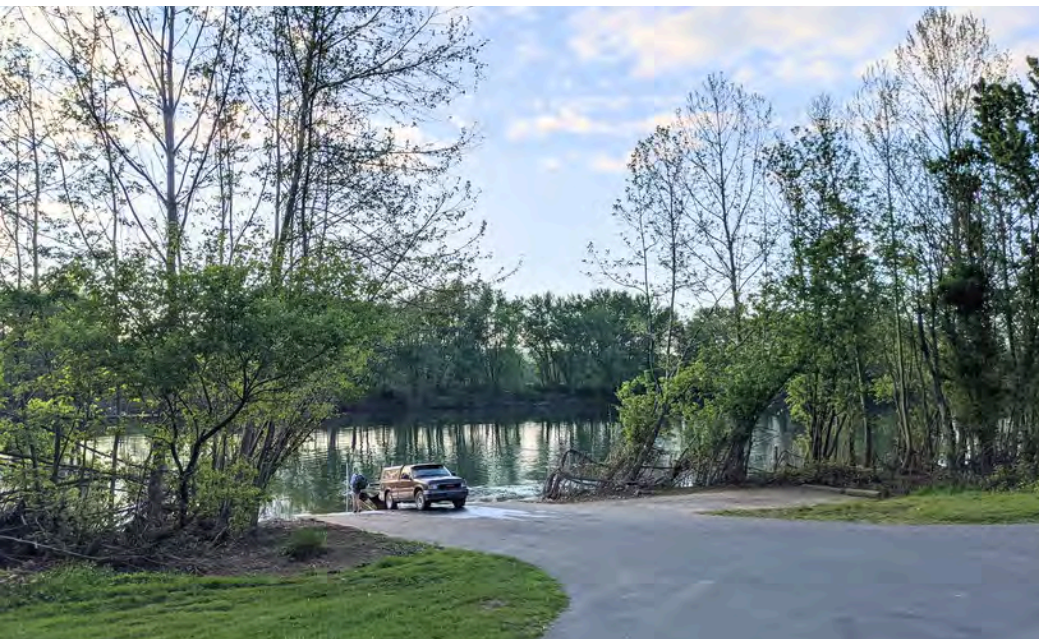
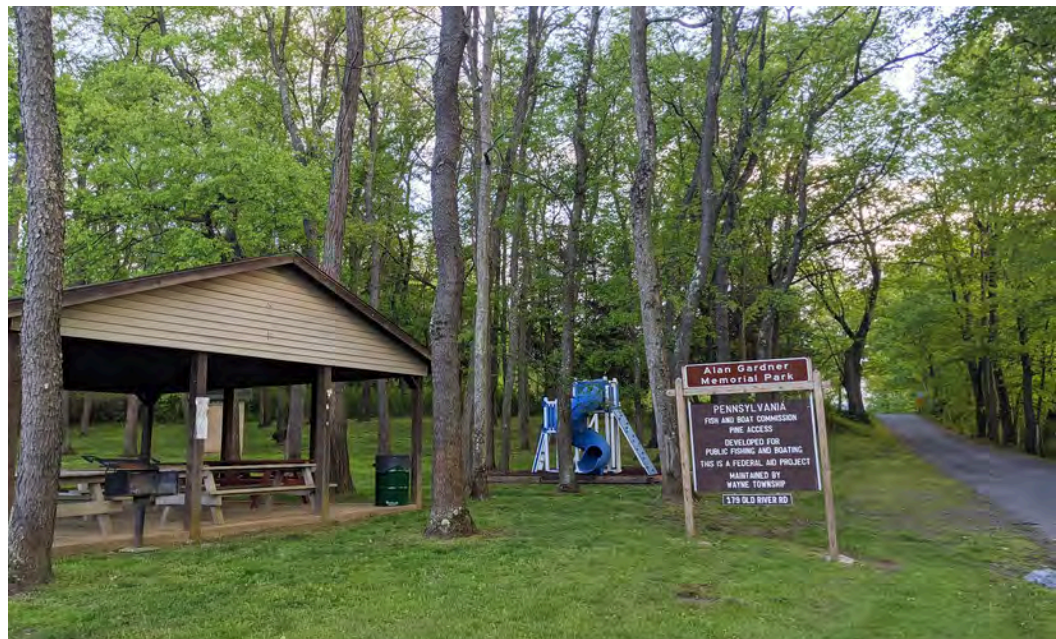
# PFBC Pine Creek Access

PFBC Pine Creek Access is a moderately developed river access. The site includes a paved parking area, concrete boat ramp, pavilion with picnic tables, and seasonal restroom facilities. While some accessible features are present, overall accessibility is limited by poor connectivity and non-compliant amenities.

Key barriers include limited accessible parking features, non-compliant restroom access, lack of accessible routes to amenities, and absence of adaptive water access infrastructure.

| PRIORITY | IMPROVEMENT | DESCRIPTION / NOTES |
|---|---|---|
| | Upgrade restroom facilities | Replace or retrofit portable/pit restrooms to meet ADA standards; address steep entrance slope and lack of accessible path. |
| | Address surface barriers | Repair cracks, remove upheavals (>1”), and improve transitions between pavement and grass. |

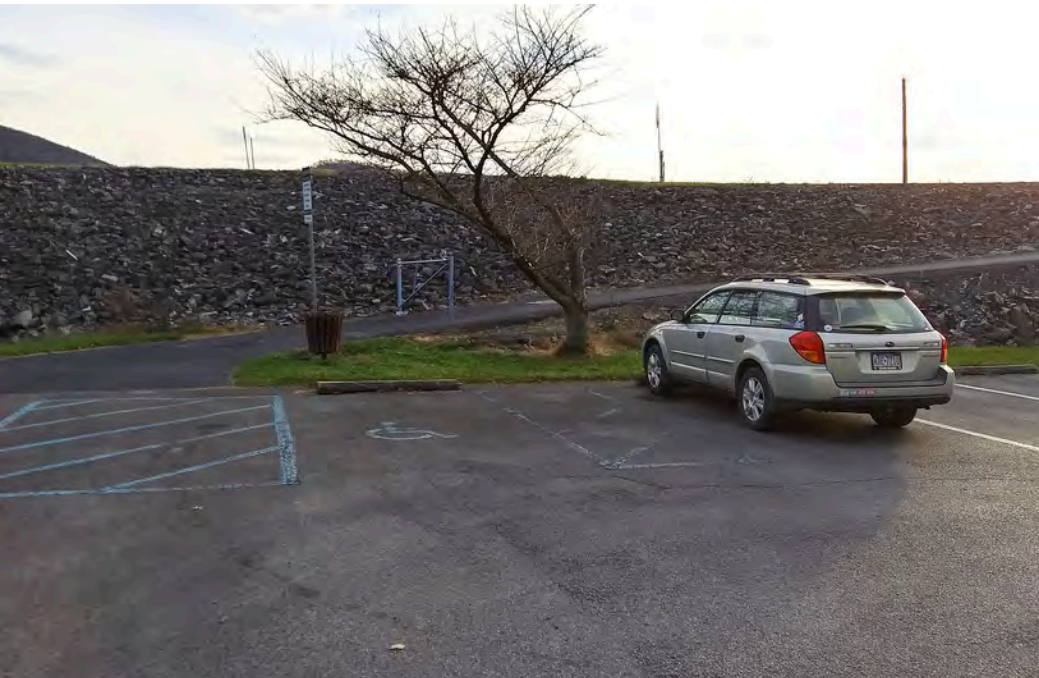
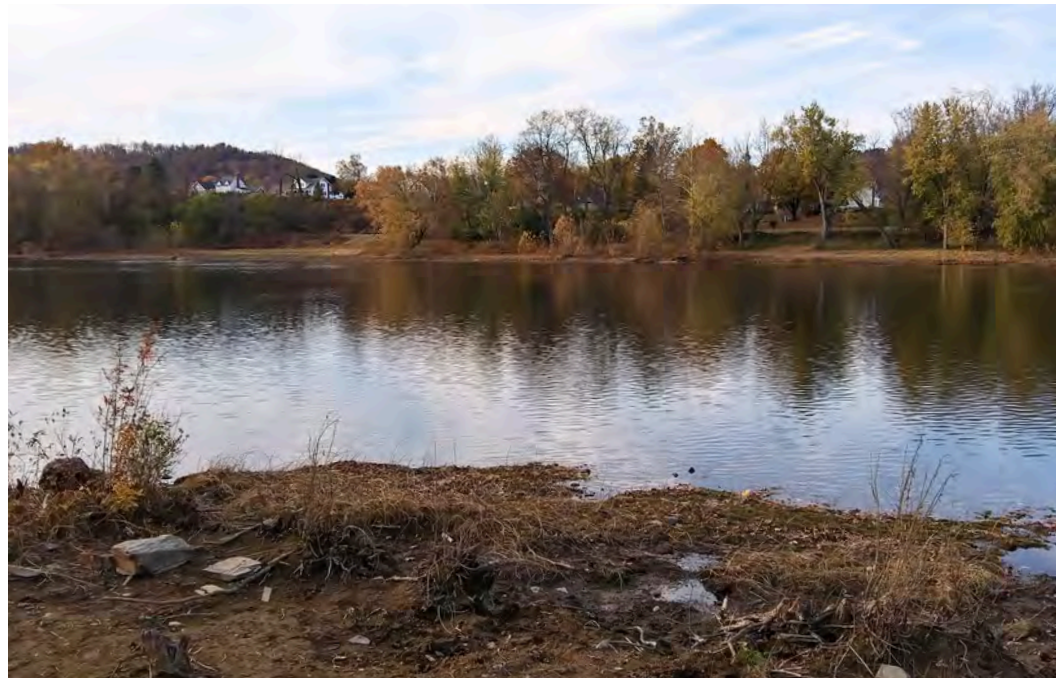
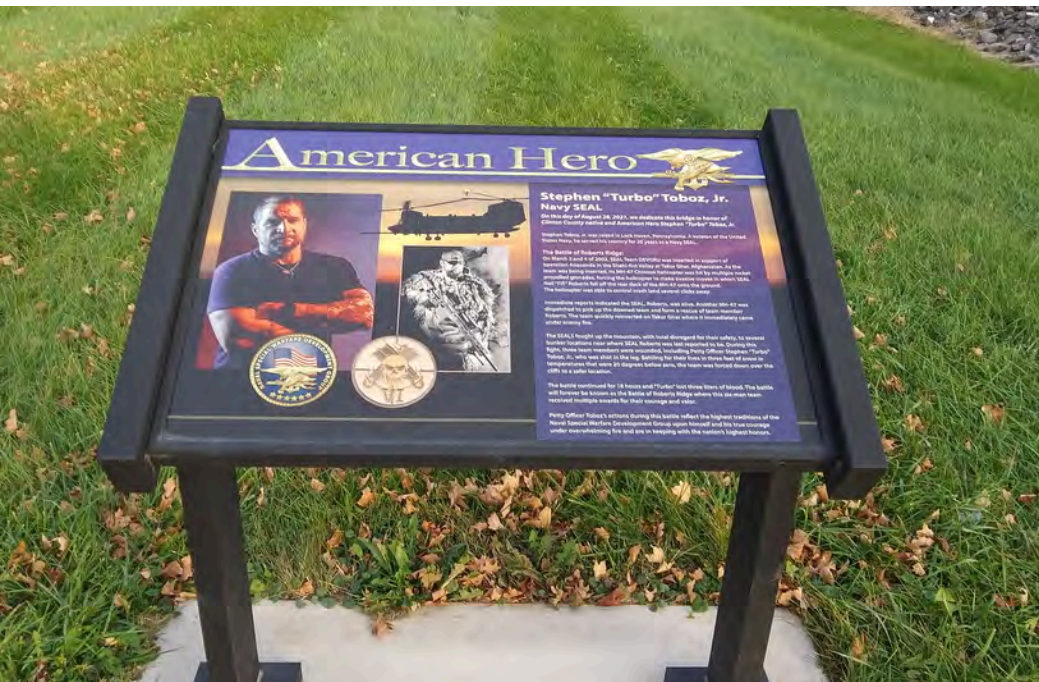
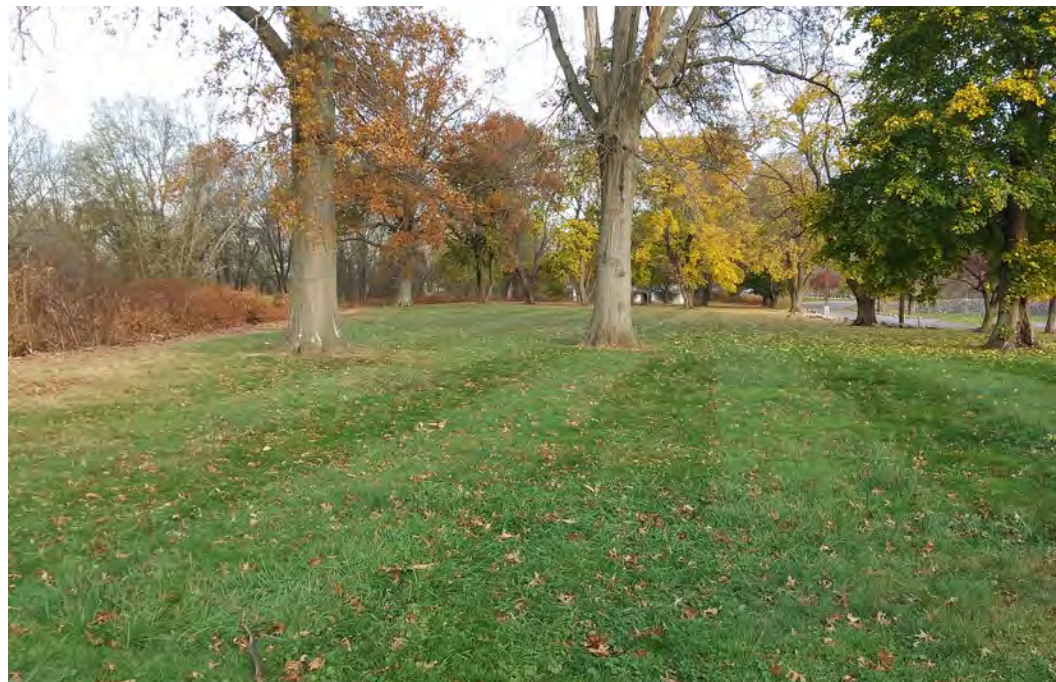
# Lock Haven Memorial Park

Lock Haven Memorial Park Access is a minimally developed municipal river access site with limited accessibility infrastructure. The site includes a small, paved parking area (13 spaces) with one ADA-designated space, informal river access, and scattered amenities. There is no formal boat ramp, dock, or restroom facility, and overall site development is low.

Accessible parking meets slope requirements ( $\sim 1.67^\circ$ ) and includes access aisles; however, striping is faded, no ADA signage is present, and there is no van-accessible designation. While the parking space is functional, these deficiencies reduce compliance and visibility.

structure. River access occurs via a muddy, rocky shoreline that is overgrown and covered with debris such as driftwood. These conditions are unstable and hazardous, making independent water entry infeasible.

No restroom facilities are provided, further limiting the usability and duration of site visits. While approximately nine picnic tables are present, only one near the parking area is accessible; the remainder lack ADA-compliant routes. Additional amenities are limited, and there is no signage indicating the location of the river access point or directing users through the site. Overall, Lock Haven Memorial Park Access is best characterized as minimally ADA-accessible.

| PRIORITY | IMPROVEMENT | DESCRIPTION / NOTES |
|---|---|---|
| | Shoreline clearing and stabilization | Remove debris (driftwood, vegetation) and improve immediate water entry conditions for safer access. |

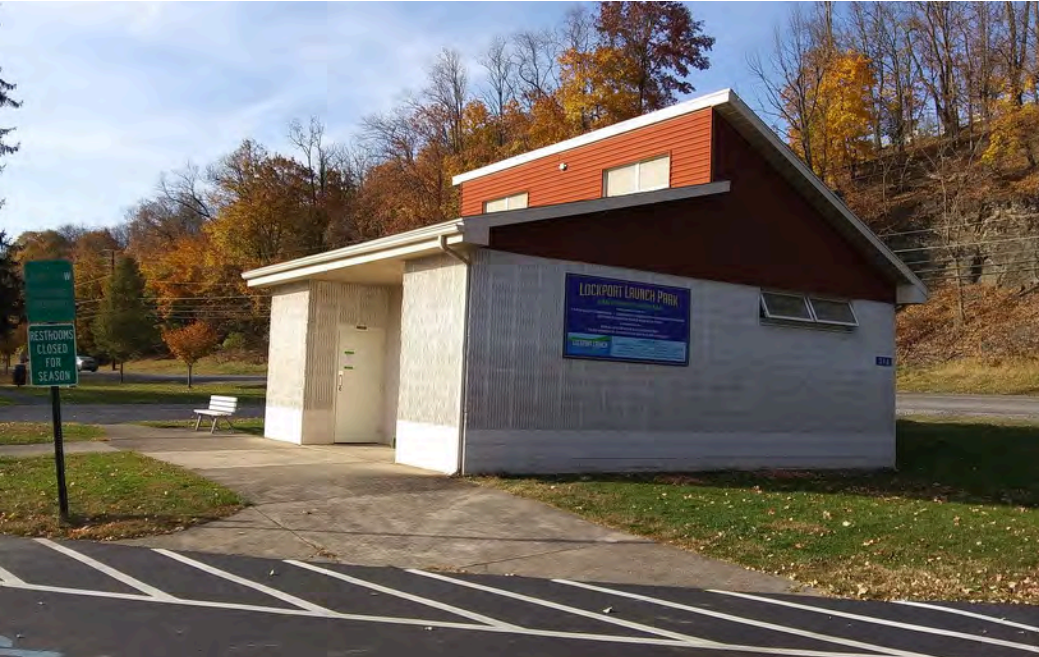
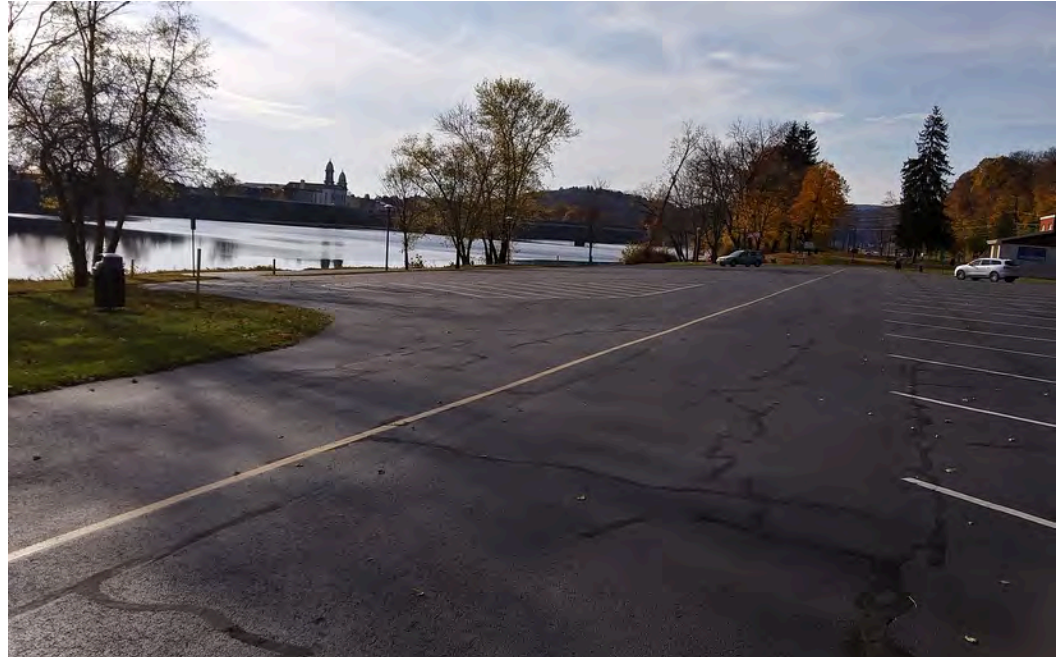
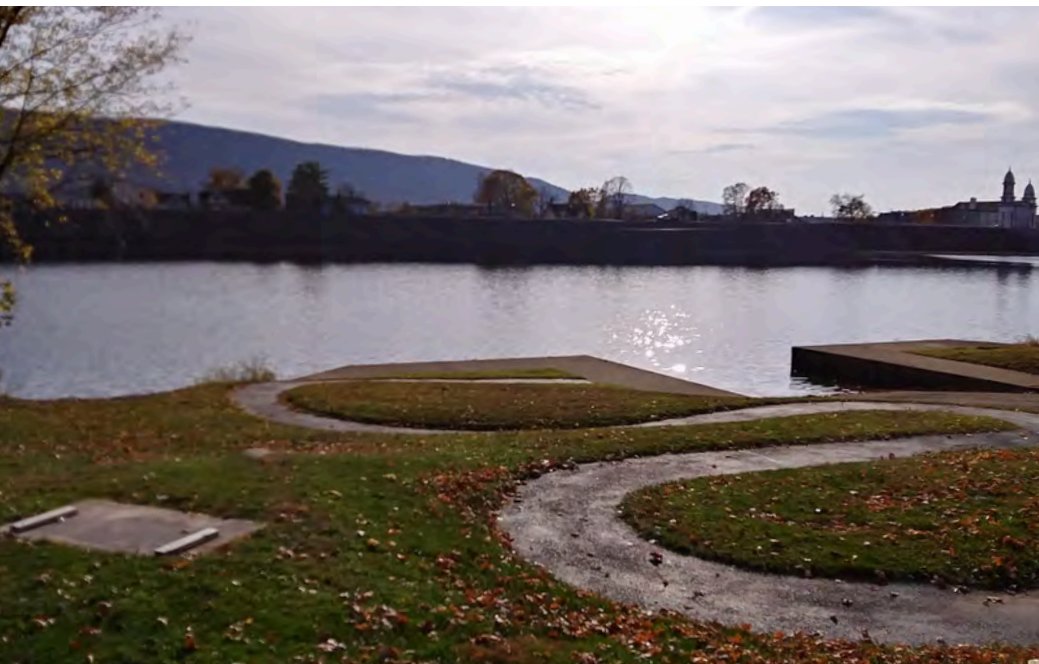
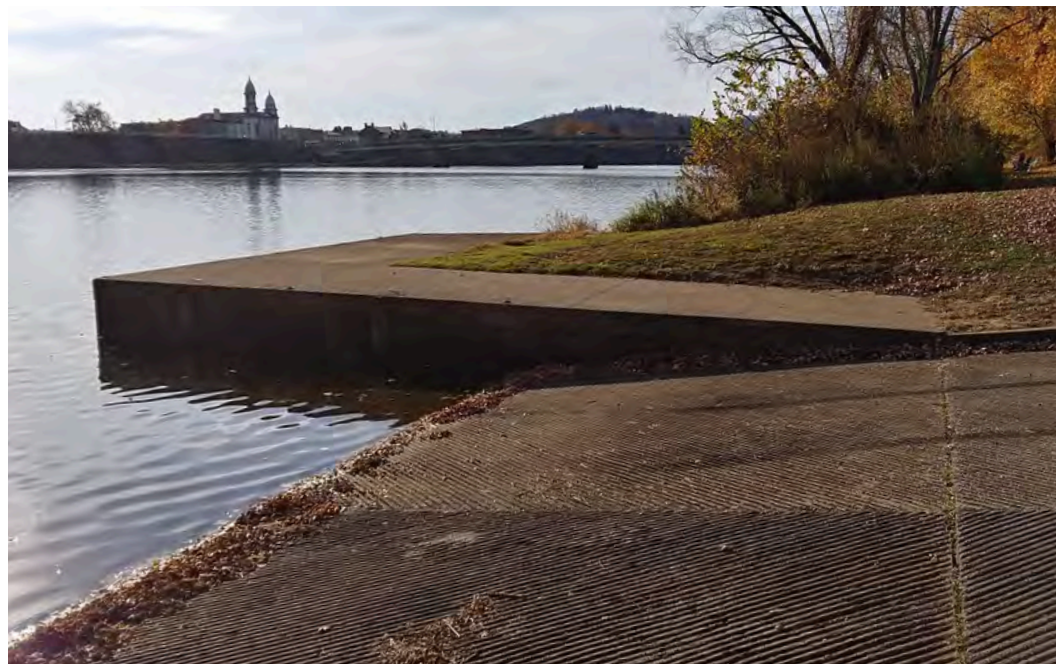
# Woodward Township Access & Boat Ramp - Swissdale or Lockport Recreation Area Access

Lockport Recreation Area Access is a well-developed municipal river access site that provides one of the stronger foundations for accessibility among evaluated locations. The site includes two paved parking areas totaling 56 spaces, a concrete boat ramp, dock, restroom building, and a range of supporting amenities.

Additional amenities include benches, lighting, trash receptacles, and informational signage. While these features support general recreational use, not all are confirmed to meet ADA standards, and wayfinding signage from the roadway is limited.

| PRIORITY | IMPROVEMENT | DESCRIPTION / NOTES |
|---|---|---|
| | Address minor parking slope issues | Regrade or restripe ADA spaces where slopes exceed recommended limits. |
| | Upgrade site furnishings | Evaluate benches, trash cans, and other amenities for ADA compliance and replace as needed. |

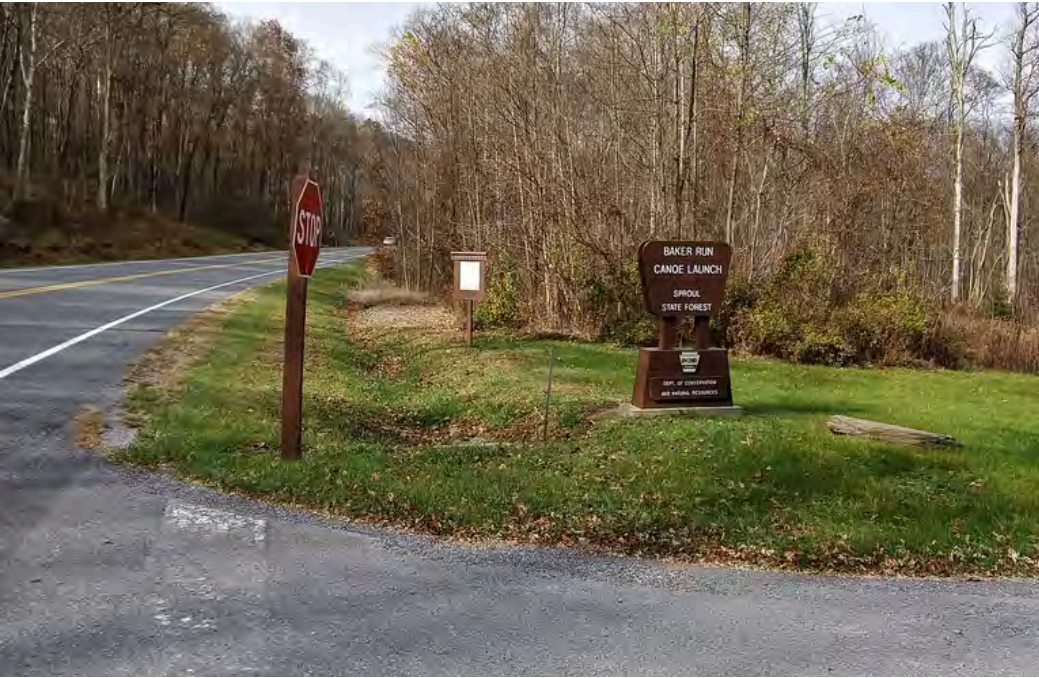
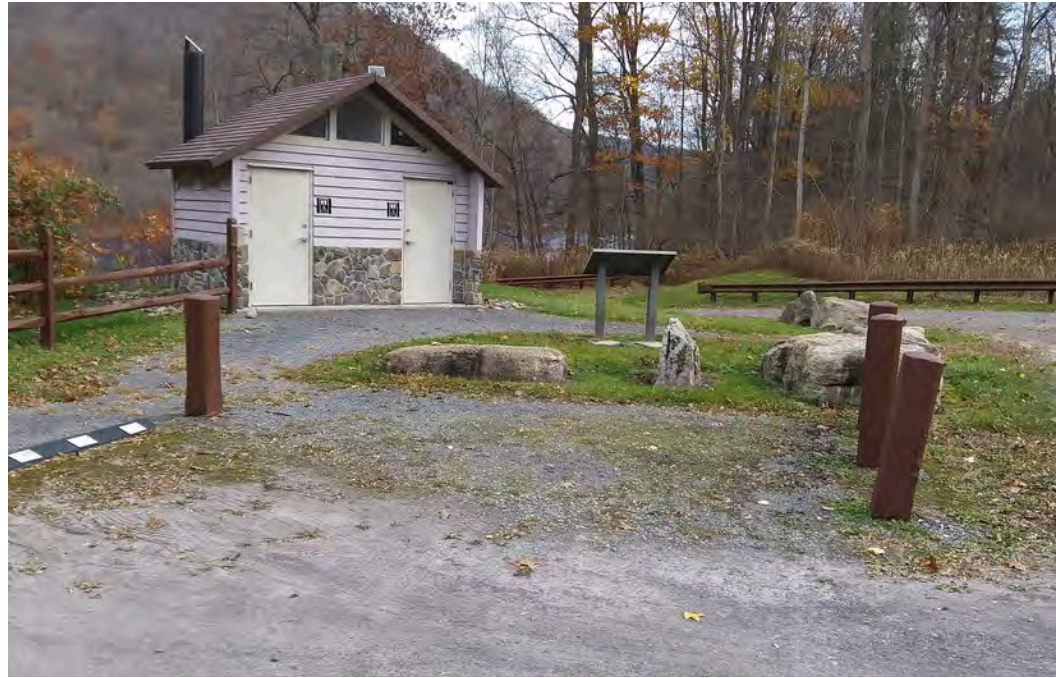
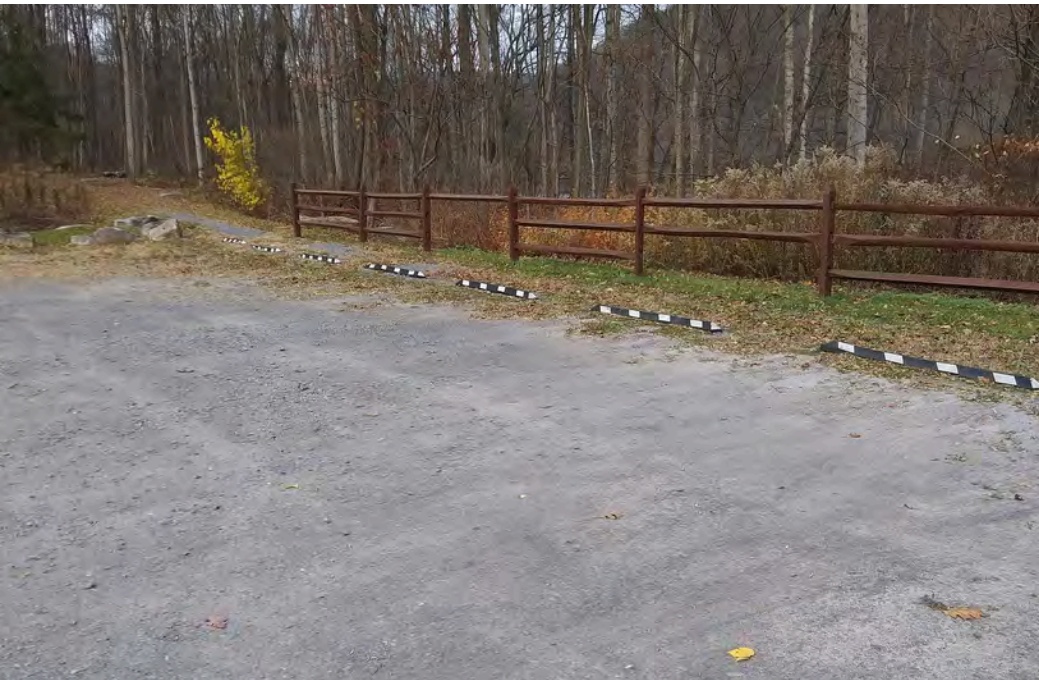
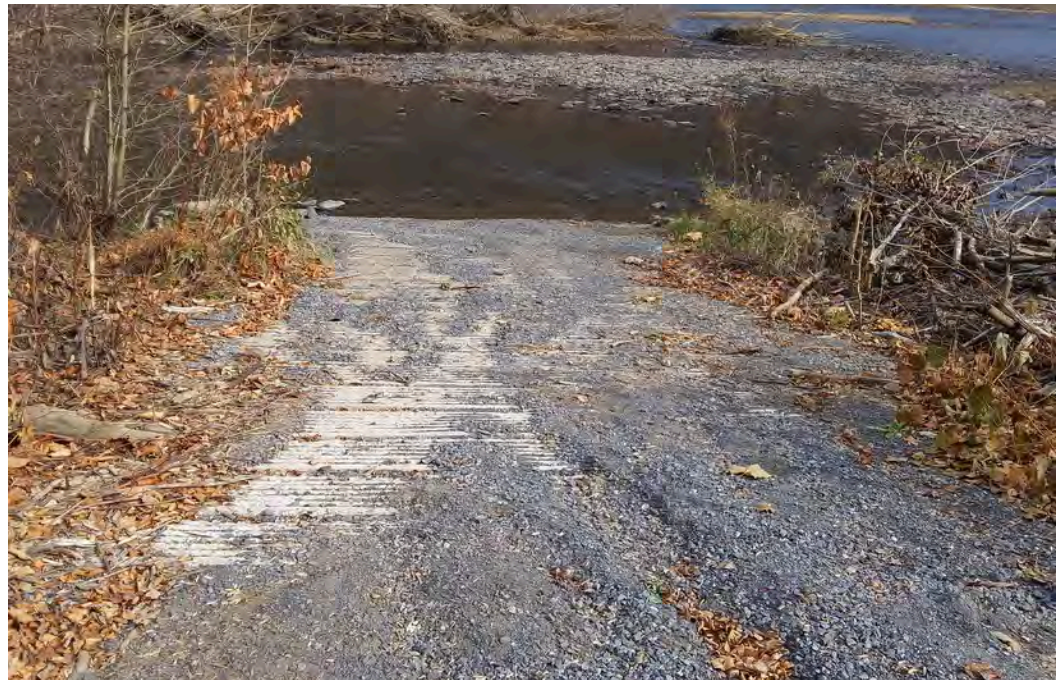
# Baker Run Canoe Access

Baker Run Canoe Launch is a minimally developed river access site characterized by a gravel/stone parking area, informal circulation routes between features, and limited infrastructure. The site includes approximately 8 defined parking spaces (with potential for overflow), a single ADA-designated space, a basic boat ramp, and vault restroom facilities. A small camping area and picnic tables are also present; however, these amenities lack accessible connections. Overall, the site functions as a rustic access point with very limited ADA accessibility.

Accessible parking is technically provided, but it is limited to one space on a gravel/stone surface with a slope slightly exceeding ADA recommendations ( $\sim 2.41^\circ$ ). While signage is present, the lack of a firm, stable, and clearly defined parking layout reduces usability. No passenger loading zone is available, and the informal nature of the lot further complicates access for individuals with mobility impairments.

Water access is one of the most significant barriers at the site. The boat ramp is narrow ( $\sim 10'4''$ ) and transitions into a shallow, rocky riverbed with large exposed stones, accumulated debris, and overgrown vegetation. While the ramp itself is in serviceable condition, the surrounding shoreline is unstable and uneven, making independent water entry difficult or unsafe for users with mobility impairments. No dock or adaptive launch infrastructure is present.

Key barriers at Baker Run include the lack of a stable accessible route to the launch and amenities, poor shoreline and water entry conditions, limited accessible parking infrastructure, and non-compliant access to site features such as picnic tables and the camping area.

| PRIORITY | IMPROVEMENT | DESCRIPTION / NOTES |
|---|---|---|
| | Remove abrupt surface changes along primary path | Address elevation changes greater than 1 inch to improve mobility device navigation and reduce tripping hazards. |
| | Update ADA parking signage | Replace or update signage with the International Symbol of Accessibility to clearly identify the designated accessible space. |
| | Upgrade picnic table to ADA-compliant configuration | Replace the existing picnic table with an ADA-accessible model installed on a firm pad connected to the accessible route. |
