PHASE I

# Lower West Branch Susquehanna River ADA and Universal Accessibility Access Study

A PROJECT OF THE SUSQUEHANNA GREENWAY PARTNERSHIP

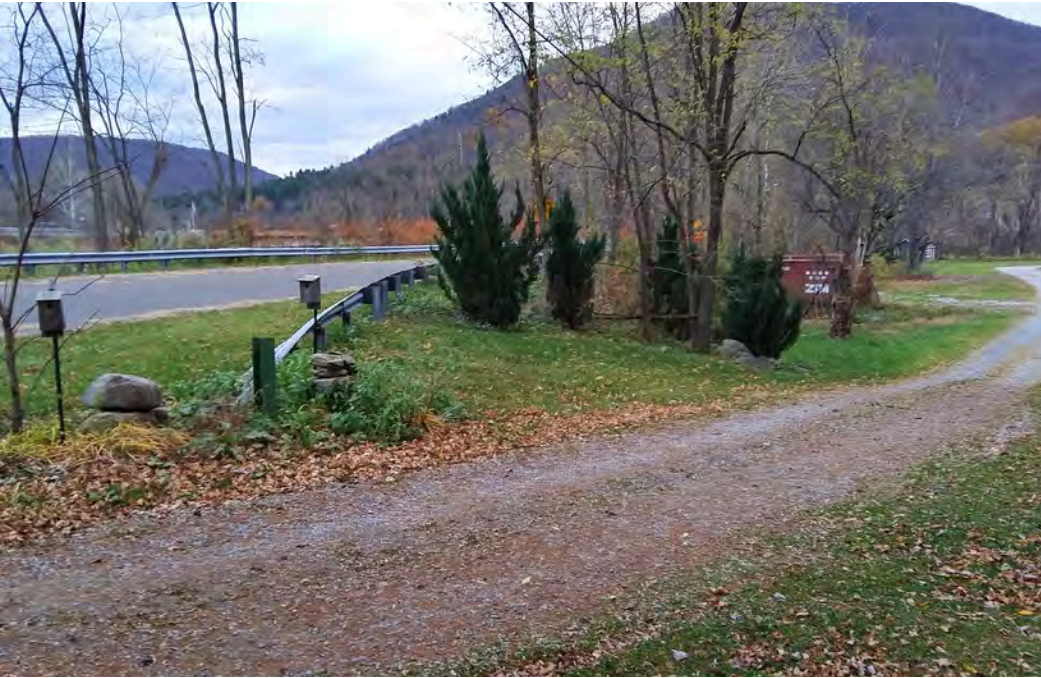
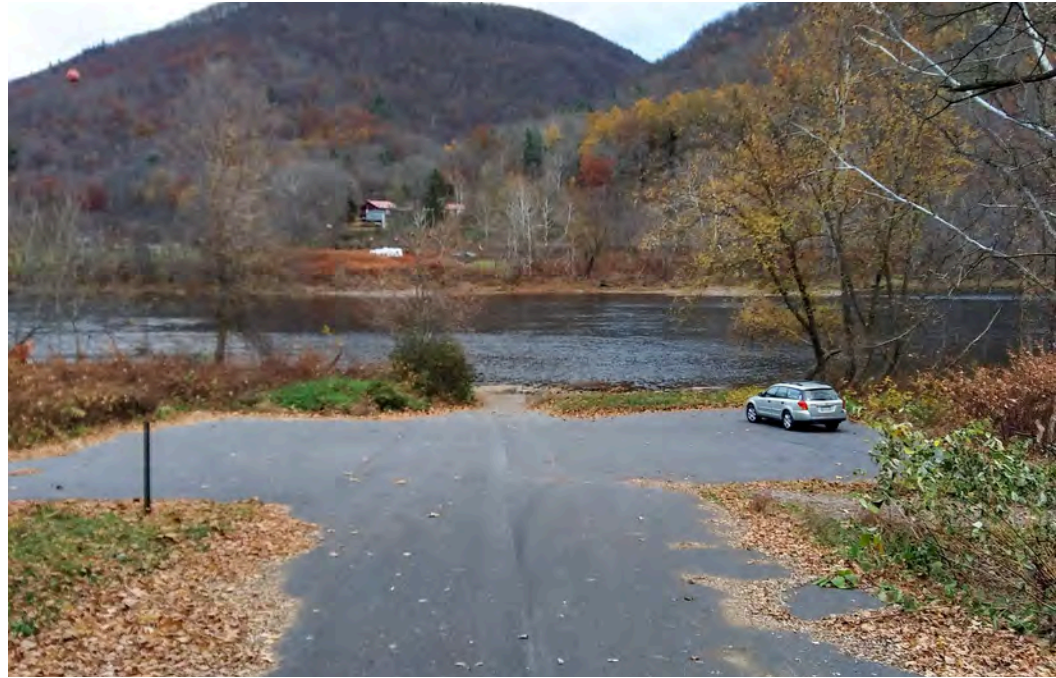
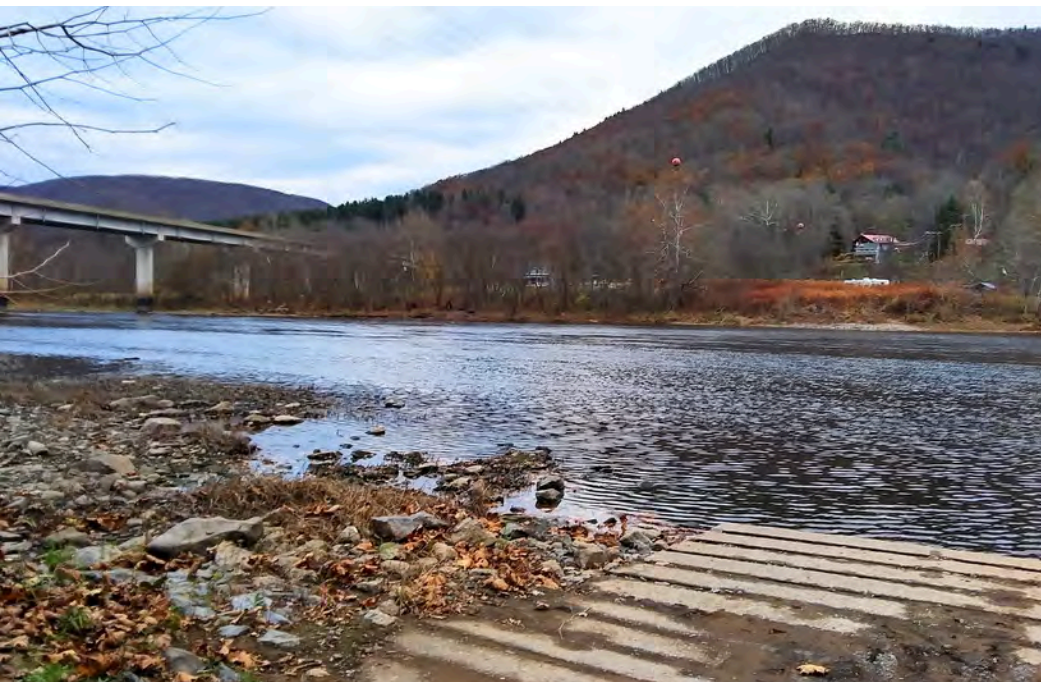
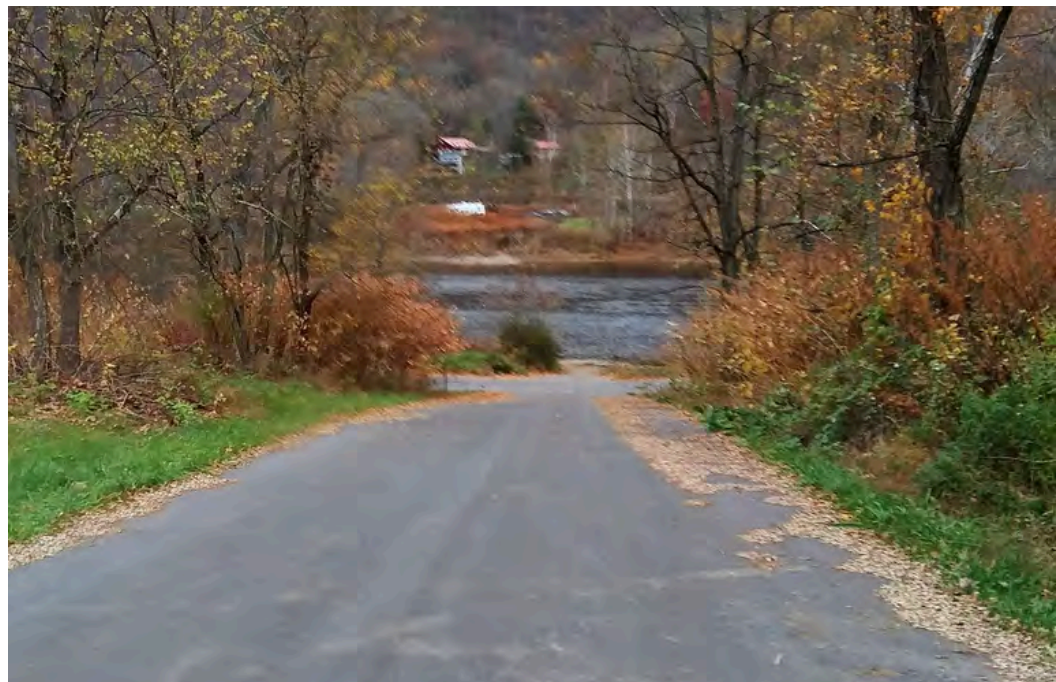
# Hyner Access and Boat Ramp

Hyner Access is a minimally developed river access site along the West Branch Susquehanna River. The site includes an open paved parking area, a concrete boat ramp, limited signage, and a seasonal portable restroom. No formal amenities or dedicated accessibility features are present.

The boat ramp is steep (~19.6°) and narrow (8'4"), and there is no dock, gangway, or adaptive launch system. These conditions, combined with a rocky and eroded shoreline, make independent water access difficult or unsafe for many users.

| PRIORITY | IMPROVEMENT | DESCRIPTION / NOTES |
|---|---|---|
| | Improve shoreline conditions | Stabilize and reduce erosion at water entry point |

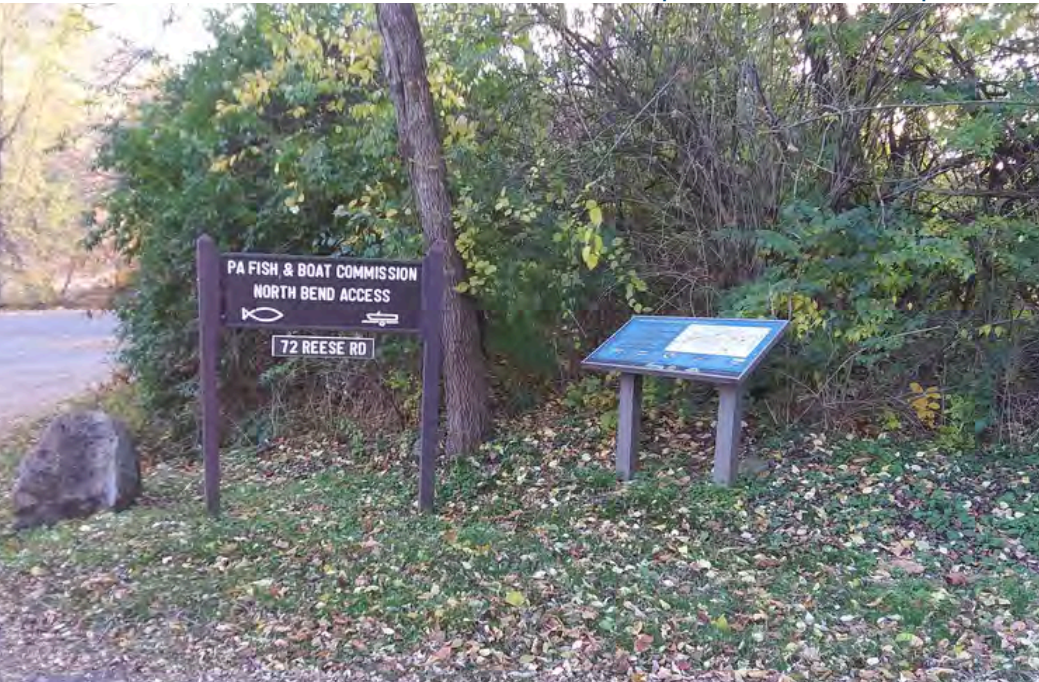
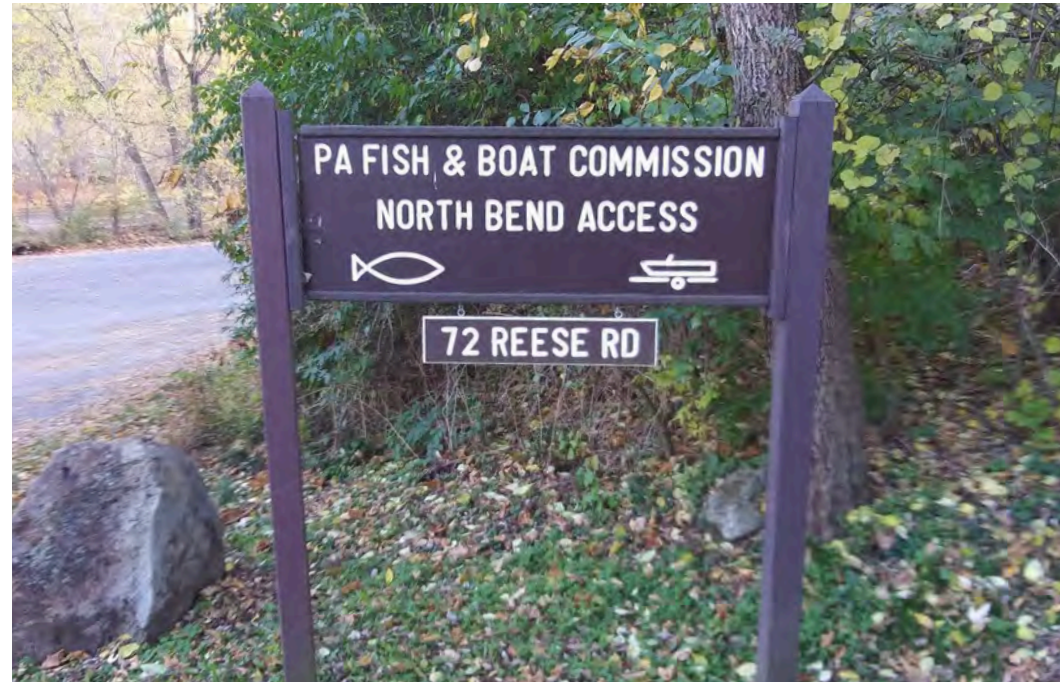
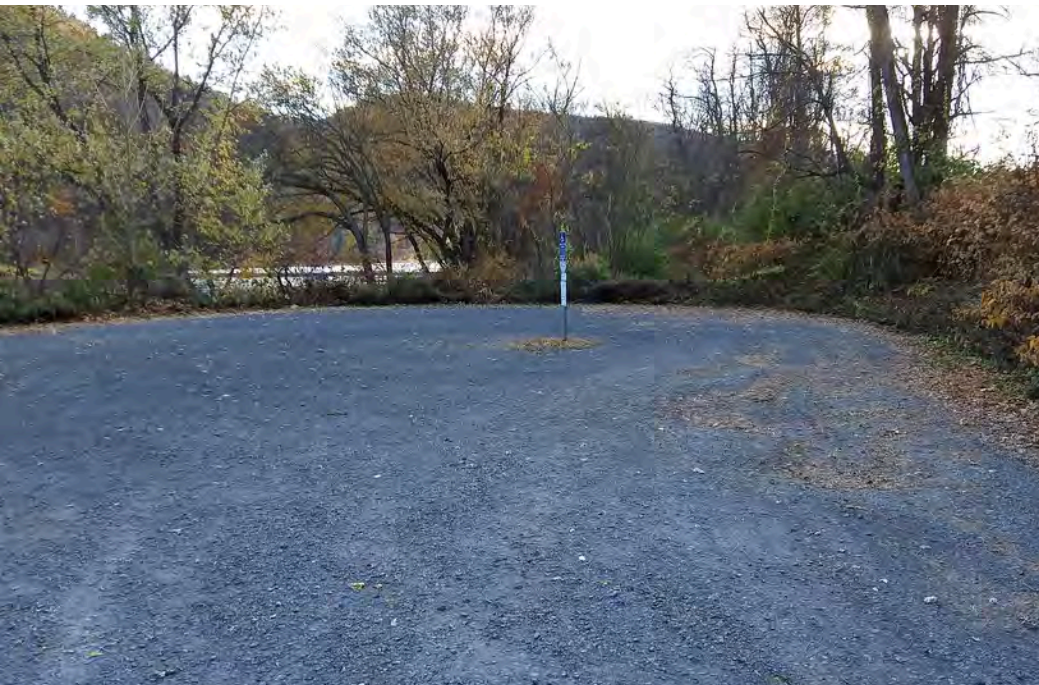
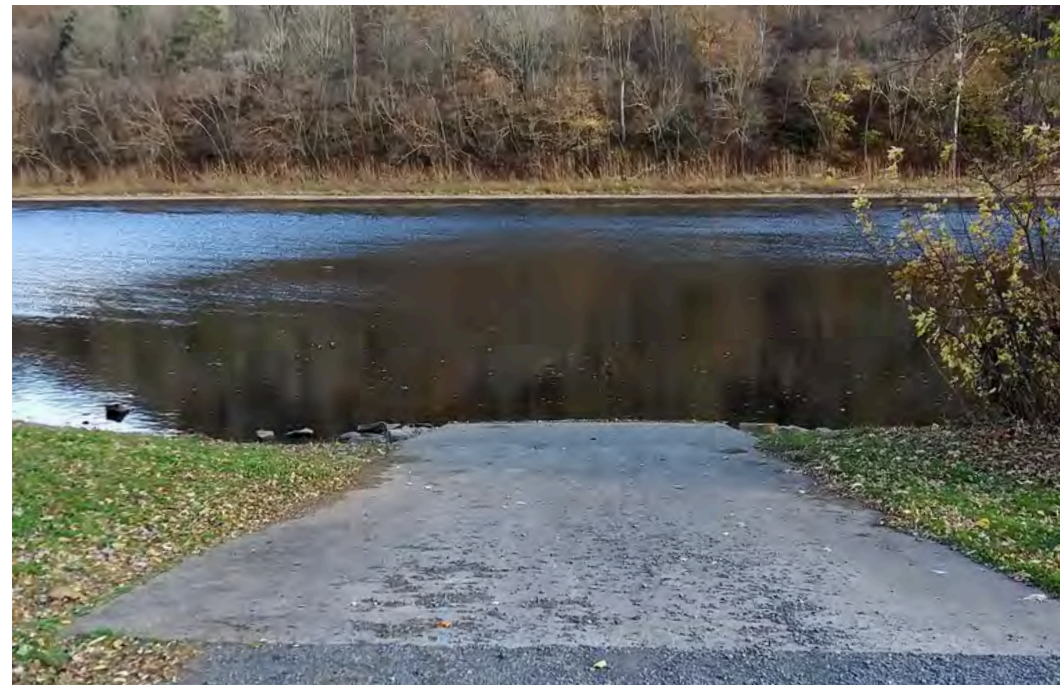
# PFBC North Bend Access & Boat Ramp

PFBC North Bend Access is a lightly developed river access site along the West Branch Susquehanna River. The site includes a stone parking area, a concrete boat ramp, minimal signage, and a single bench, with no restroom facilities or formal amenities. Overall, the site functions as a basic, low-capacity launch with limited infrastructure.

The route from the parking area to the boat ramp is relatively short (approximately 80 feet), but the loose stone surface is not firm or stable, creating challenges for individuals with mobility impairments. While no major vertical barriers are present, the surface condition alone limits independent access.

Water access is further complicated by a steep, rocky shoreline with uneven terrain, making independent entry unsafe or impractical for many users.

Key barriers include the lack of defined ADA parking, unstable travel surfaces, a steep boat ramp, absence of boarding infrastructure, and overall limited site development. Recommended improvements include formalizing accessible parking, stabilizing and defining accessible routes, and installing an accessible dock or adaptive launch system.

| PRIORITY | IMPROVEMENT | DESCRIPTION / NOTES |
|---|---|---|
| | Stabilize parking and route surfaces | Compact or treat stone surface to create firm, stable, slip-resistant conditions |
| | Stabilize shoreline | Reduce erosion and create safer water entry conditions |

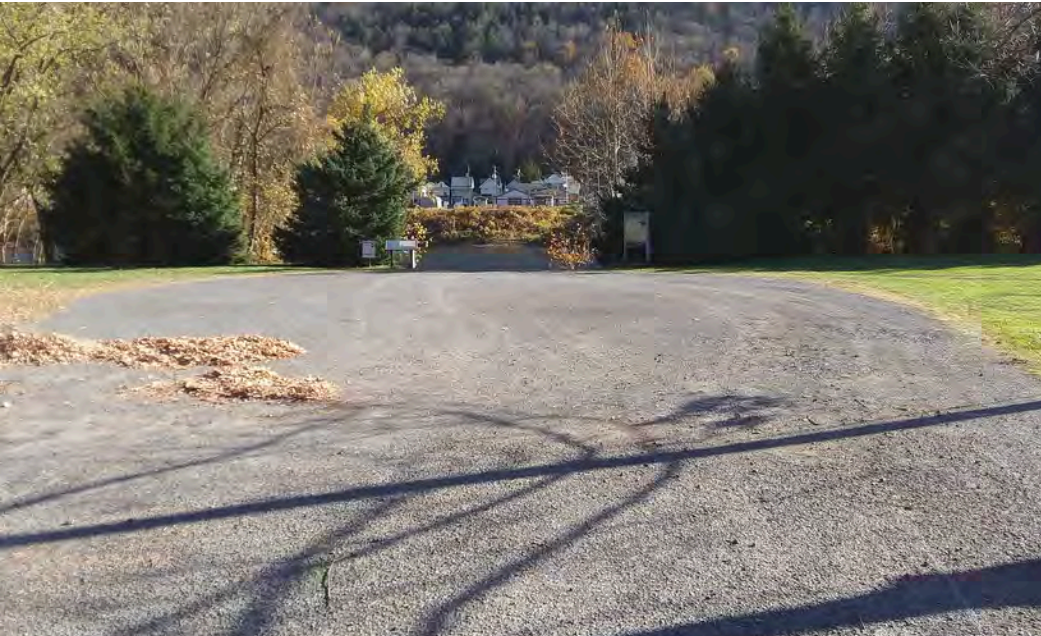
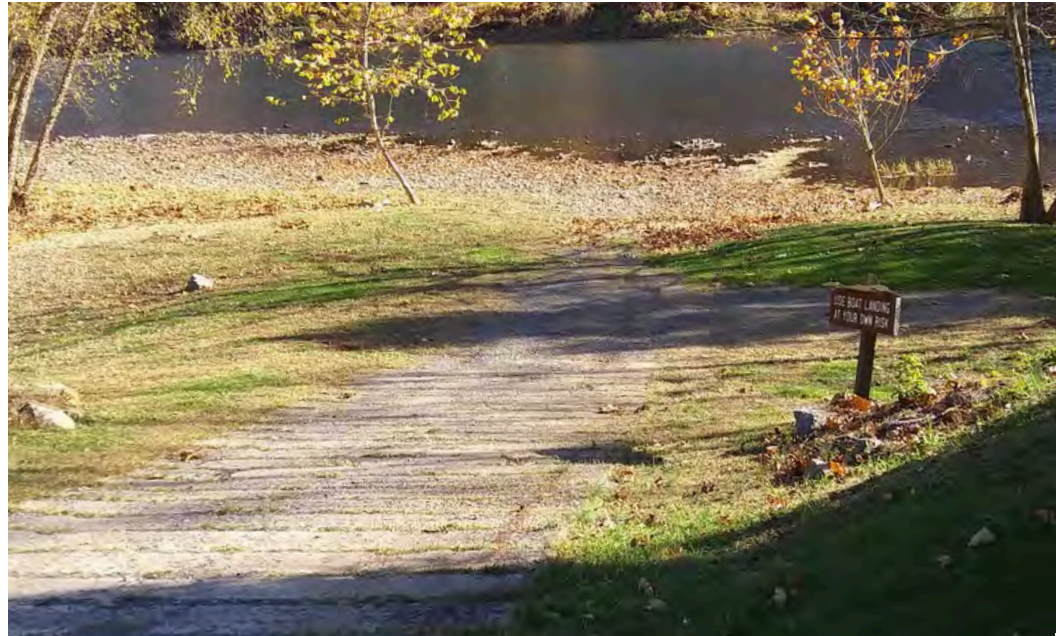
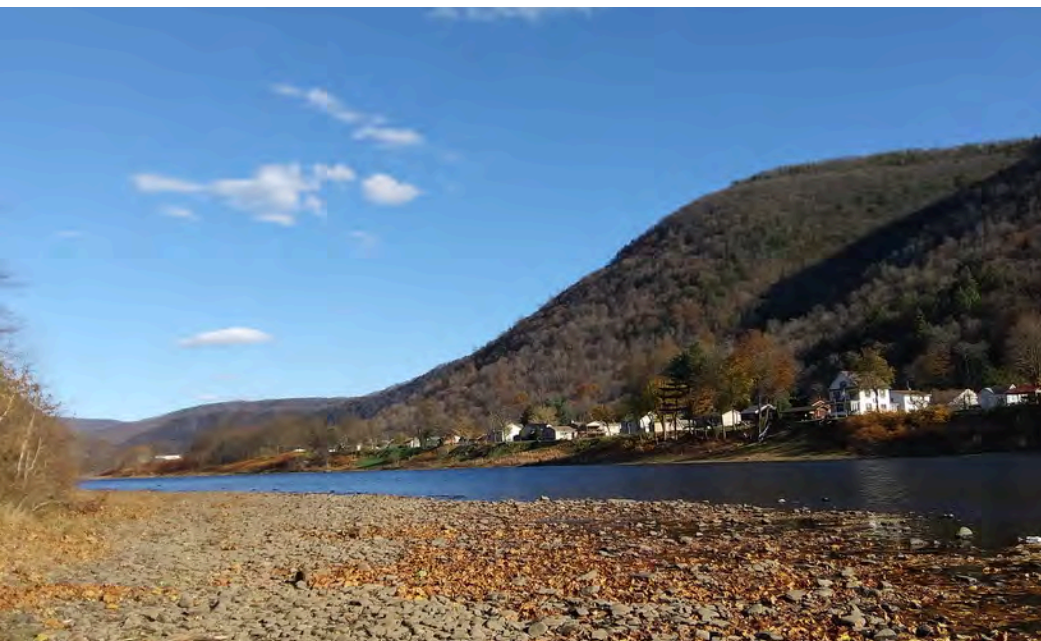
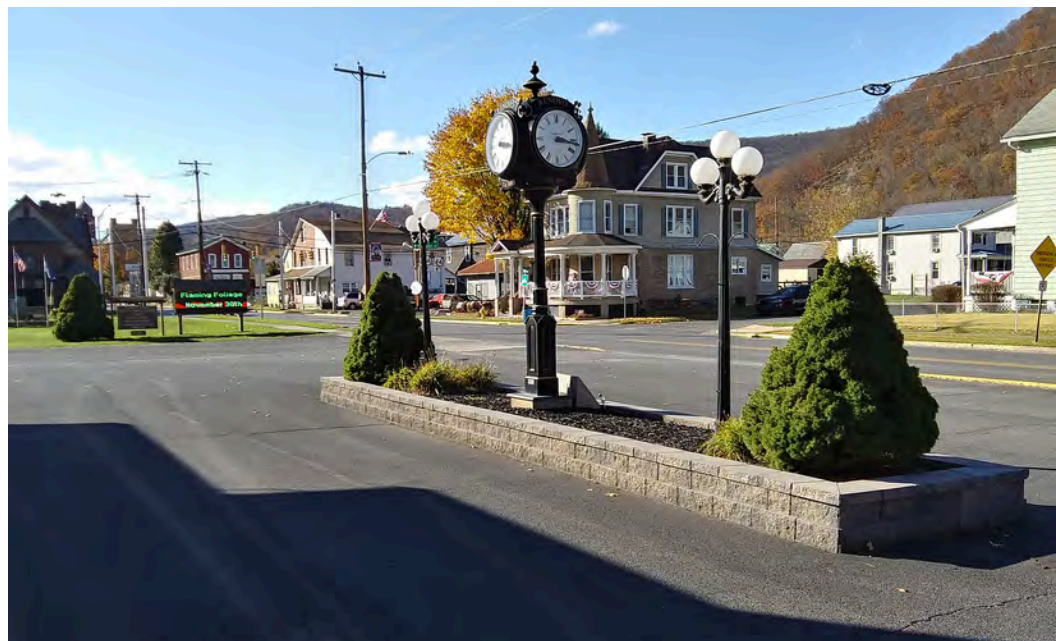
# Pennsylvania State Flaming Foliage Access

The Pennsylvania State Flaming Foliage Access is a moderately sized river access site that provides a concrete parking area, informal river access, and a pavilion with picnic tables. Despite these features, the site lacks key infrastructure needed to support ADA accessibility, including a formal boat ramp, dock, and accessible restroom facilities.

Accessible parking is technically present, with two designated spaces; however, these spaces are not clearly marked or signed and exceed recommended slope limits. The absence of ADA signage, striping, and van-accessible designation significantly reduces usability and compliance. While the parking lot itself is spacious, these deficiencies create barriers at the primary point of entry.

The route from parking to the launch area is relatively long (approximately 279 feet) and consists of mixed surfaces, including concrete, stone, and grass. Although generally passable, the lack of a consistently stable and clearly defined accessible pathway limits independent use. A similar condition exists for access to the restroom area, which is located off-site and appears to be locked and not intended for public use.

Water access is a major limitation at this site. There is no formal boat ramp or dock, and the shoreline consists of large, uneven rocks with extremely shallow water conditions. These features make it difficult to navigate on foot and effectively unusable for individuals with mobility impairments. The absence of any adaptive canoe/kayak launch system further restricts accessibility.

The pavilion and three picnic tables provide some recreational value; however, they are not ADA compliant and lack a clearly defined accessible route. Additional amenities are minimal, and while general signage and lighting are present, there is little to no accessibility-focused information or wayfinding.

Overall, Pennsylvania State Flaming Foliage Access is best characterized as minimally ADA accessible. While the site benefits from a concrete parking area and basic amenities, significant barriers—including non-compliant parking, lack of accessible routes, absence of restroom access, and poor shoreline conditions—limit independent and inclusive use. Substantial improvements to parking, pathways, and water access infrastructure would be required to meet basic ADA standards and enhance usability for individuals with disabilities.

| PRIORITY | IMPROVEMENT | DESCRIPTION / NOTES |
|---|---|---|
| | Improve launch area surface conditions | Remove large rocks and debris at shoreline to create a safer, more accessible water entry point. |
| | Provide accessible restroom option | Replace or supplement existing locked/non-ADA portable restroom with an ADA-compliant, publicly accessible unit. |
| <b>Medium<br/>(1–3 years)</b> | Construct formal accessible boat launch | Improve ramp conditions and consider a more defined, stable launch surface to support safer use. |

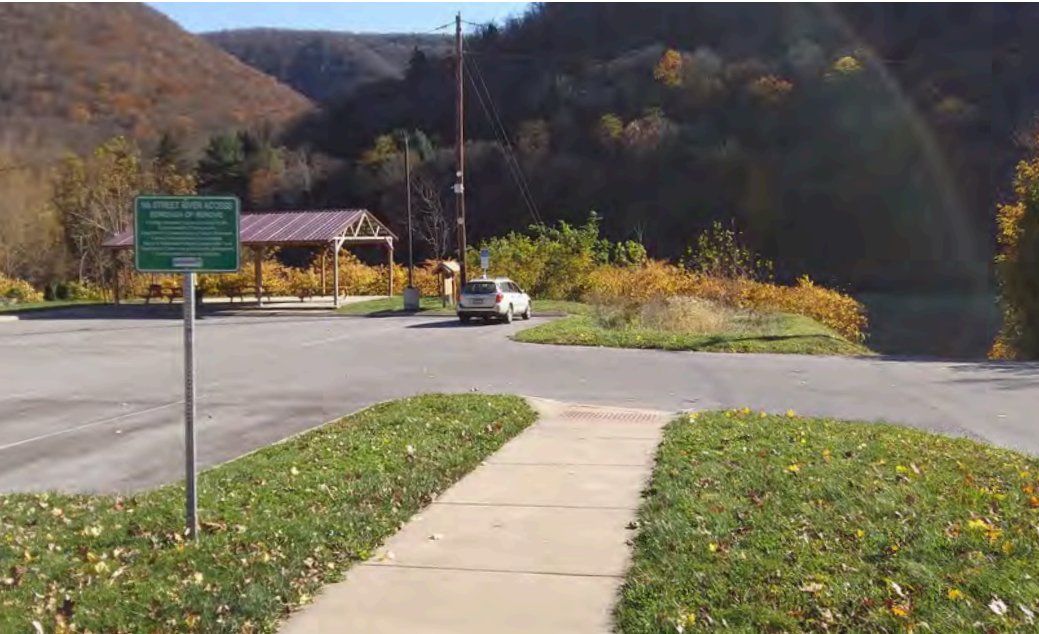
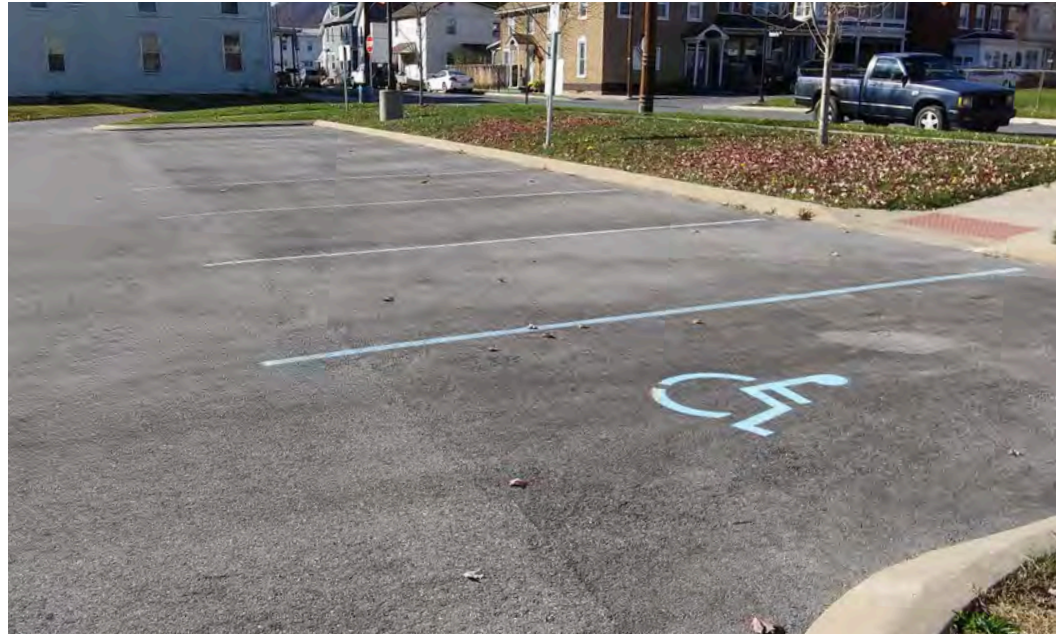
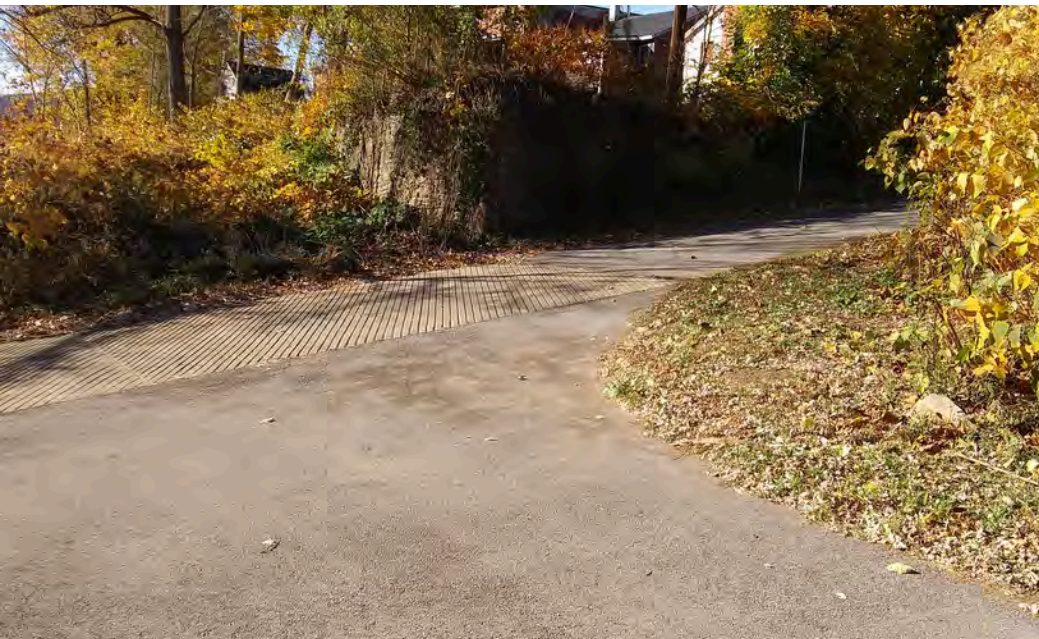
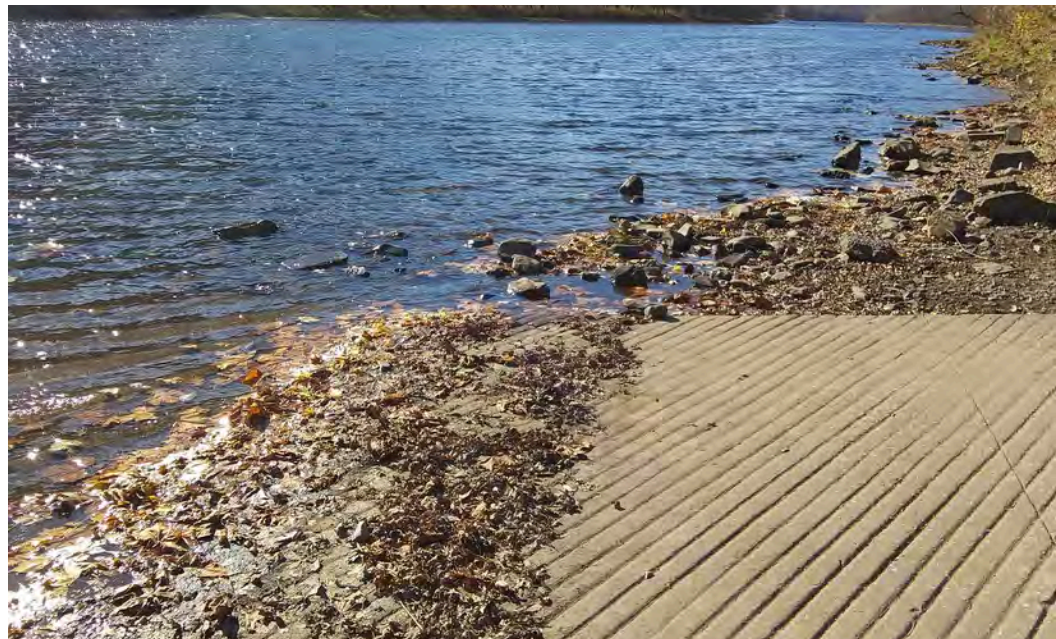
# Ontario Avenue Boat Launch - Renovo or Renovo 5<sup>th</sup> Street Access

Renovo 5th Street Access is a small municipal river access site with a paved parking area, concrete boat ramp, pavilion, and basic signage. The site provides a modest level of development but lacks several key features needed to support full ADA accessibility, including a dock, restroom facilities, and adaptive launch infrastructure.

Accessible parking is present, with one ADA-designated space that is properly marked and signed; however, the slope slightly exceeds ADA recommendations and there is no van-accessible designation or passenger loading zone. While the parking area itself is functional, these limitations reduce usability for some individuals with mobility impairments.

The most significant barrier at the site is water access. The concrete boat ramp is steep (approximately 20.2°) and transitions into a shallow, rocky shoreline with uneven terrain and vegetation. No dock, gangway, or adaptive canoe/kayak launch system is provided. These conditions make independent water entry difficult or unsafe for individuals with mobility impairments and represent a major limitation to overall accessibility.

The site does not provide restroom facilities, further limiting the duration and inclusivity of use. While lighting and general signage are present, there is little accessibility-focused signage or wayfinding to support users with disabilities.

Overall, Renovo 5th Street Access is best characterized as moderately ADA-accessible. While the site benefits from a paved and accessible route and designated parking, significant barriers remain—particularly related to water access, lack of restrooms, and non-compliant amenities. Targeted improvements to launch infrastructure, parking features, and site amenities would greatly enhance accessibility and support more inclusive recreational use.

| PRIORITY | IMPROVEMENT | DESCRIPTION / NOTES |
|---|---|---|
| <b>High<br/>(0–12 months)</b> | Improve water access infrastructure | Evaluate options to address steep ramp conditions (~20.2°), including slope mitigation or alternative launch solutions |
| | Stabilize shoreline and remove hazards | Address rocky, uneven conditions and vegetation at water entry |
| | Install ADA-compliant picnic tables | Replace existing tables under pavilion with accessible models |
| | Perform routine maintenance | Remove debris, maintain shoreline, and ensure paved surfaces remain in good condition |
